The New Piper Aircraft, Inc.
2926 Piper Drive
Vero Beach, Florida, U.S.A. 32960

SERVICE No. 1147 BULLETIN

**INCORRECT TURBOCHARGER CLAMP
SUBSTITUTION**

PA-23-250 (Six Place) Aztec

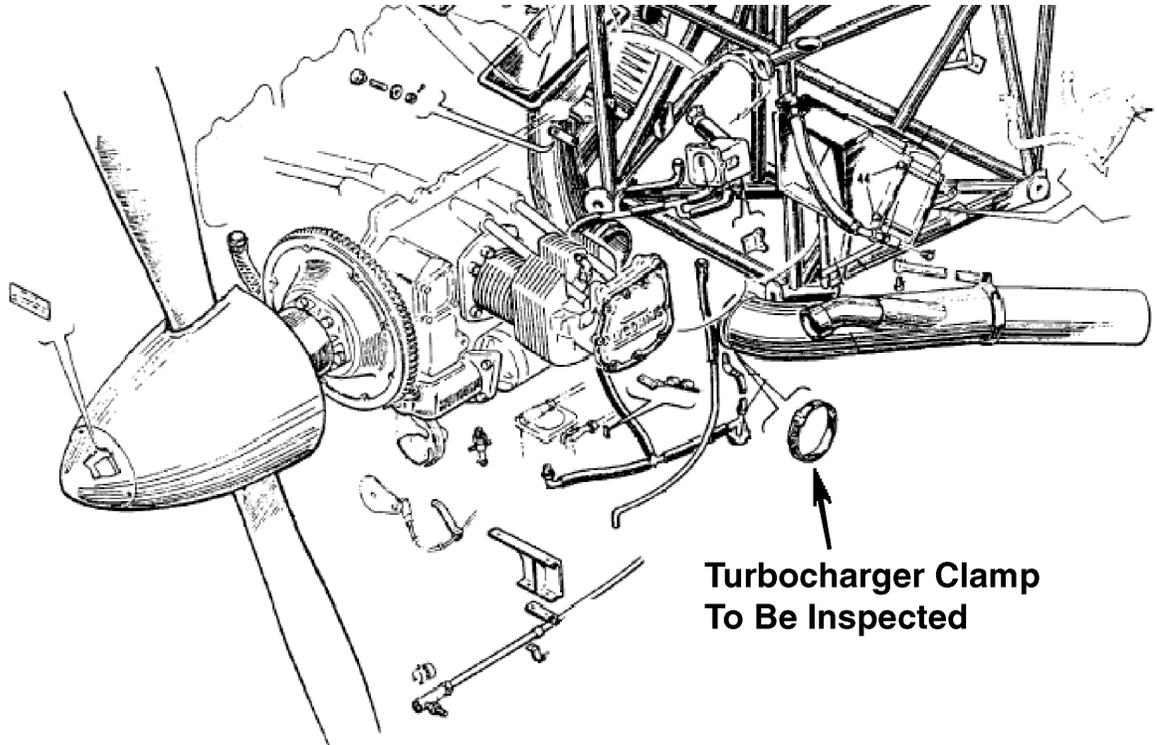
The incorrect clamp (557-584) has a larger nominal inside diameter than the correct clamp (555-511). Installation of the incorrect clamp may lead to hot exhaust gas leakage into the engine compartment that may lead to a fire. This Service Bulletin requires the inspection of aircraft that may have had this clamp replaced for correct part number installation and replacement of the incorrect clamp, if installed, prior to further flight.

Figure 1
Turbocharger Clamp Location

1. Remove the engine cowling, as required, (ref. Service Manual 753-564, Section VIII B) to gain access to the turbocharger clamp for inspection (Ref. Figure 1).
2. Inspect the clamp part number to verify correct installation. The part number marked on the clamp should be MVT69861-377.
3. If this part number clamp is not installed on the aircraft, replacement is required before further flight. Order and install Piper part number 555-511 per Service Manual 753-564, Section VIII B.
4. If the correct part number is installed, no further action is required.
5. Re-install the previously removed engine cowling per Service Manual section VIII B.
6. Make a logbook entry indicating compliance with this publication.
