Service Letter No. 250

SUBJECT: PA-23 Service Bulletin No. 138

MODELS AFFECTED: PA-23, Serials 23-1 to 23-208 inclusive

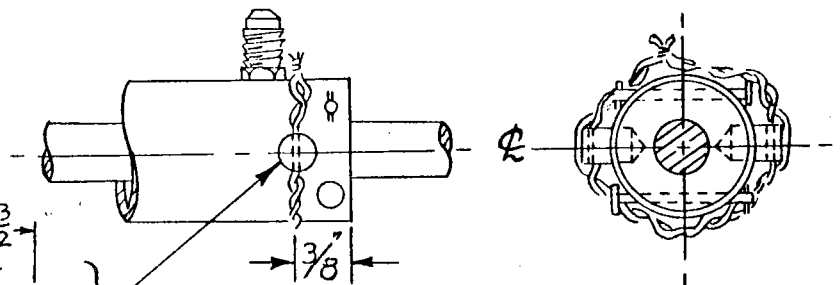
PIN INSTALLATION - Hyd. Cyl. Assy.

DO NOT EXCEED 3/16" DEPTH  
WHEN DRILLING

Drill (2) holes  
.250/.252 Dia. x 3/16" deep

Electrol #849 Cylinder Assembly

This modification, shown on the reverse side of this letter, can be accomplished on the cylinders which do not have upset or fractured cylinder housings. Extreme care should be exercised when drilling the .250 diameter hole to the proper depth. It is recommended that a depth gauge be used. Part 18829-00 can be manufactured locally or can be ordered through your nearest Piper Distributor at no charge.

.032 Brass  
Safety Wire

Material  
#1018 Cold Roll Steel
