## VENDOR SERVICE PUBLICATION

SUBJECT: AVCO Lycoming Service Bulletin No. 464A

<b>Bendix Engine Products Division</b> Jacksonville, Fl. 32245-7880
<b>SERVICE BULLETIN</b> JP- 00278 Engineering Aspects are FAA Approved	<b>Bulletin No.</b> 623A <b>Date</b> 9/1982 <b>Revised</b> 8/1984

SUBJECT: Inspection of impulse coupling cam assemblies.

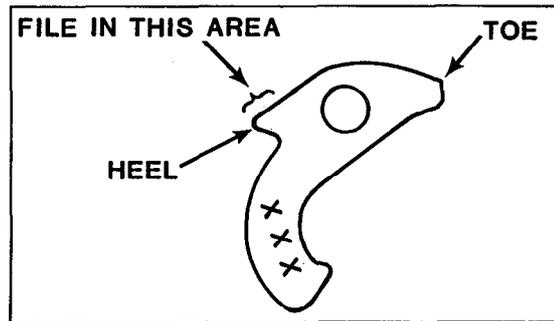
Figure 1.

Some improperly heat treated (soft) flyweights have been reported on impulse couplings currently in service. If this condition exists and is not detected, impulse coupling failure could occur. The flyweights must be inspected in accordance with the instructions in this Service Bulletin and if defective (soft) the impulse coupling or cam assembly must be replaced immediately.

3. Use finger pressure to push inward on the toe (see figure 1) of each flyweight so that the flyweight heel protrudes outward.
4. Using a fine #1, double cut, 1/2 inch wide file, at least 3/32 inch thick, pass the file across the heel of the flyweight attempting to remove material. (See figure 1.) If the flyweight has been properly heat treated the file will "glide" smoothly over the heel of the flyweight, removing no material. If the flyweight is not properly heat treated (soft), the file will not "glide" easily across the surface of the flyweight heel, and material will be removed.

XXX indicates heat treated flyweight by lot number

5. If an improperly heat treated (soft) flyweight is found, immediately remove and replace the cam assembly and/or the impulse coupling assembly following procedures in the magneto overhaul instructions, and paying strict attention to notes and cautions.

11. Any cam assembly with an improperly heat treated (soft) flyweight should be returned to the manufacturer through a currently Authorized Bendix Engine Products Division Distributor.
12. A new method of marking is being implemented to permanently identify heat treated cam assembly flyweights. See figure "1" for location. Pending consumption of current inventory, there will be a mixture of assemblies identified by the following methods.
  1. Original method ---- Yellow paint (Dykem or Lacquer) on the heel of each flyweight.
  2. New method ---- Stamped numbers as indicated in figure "1" on each flyweight.
