SERVICE BULLETIN

No. 604A

Piper Aircraft Corporation

Subject: PART I: Forward Baggage Door Locking System Modification
PART II: Forward Baggage Door Lock Arm Assembly Inspection

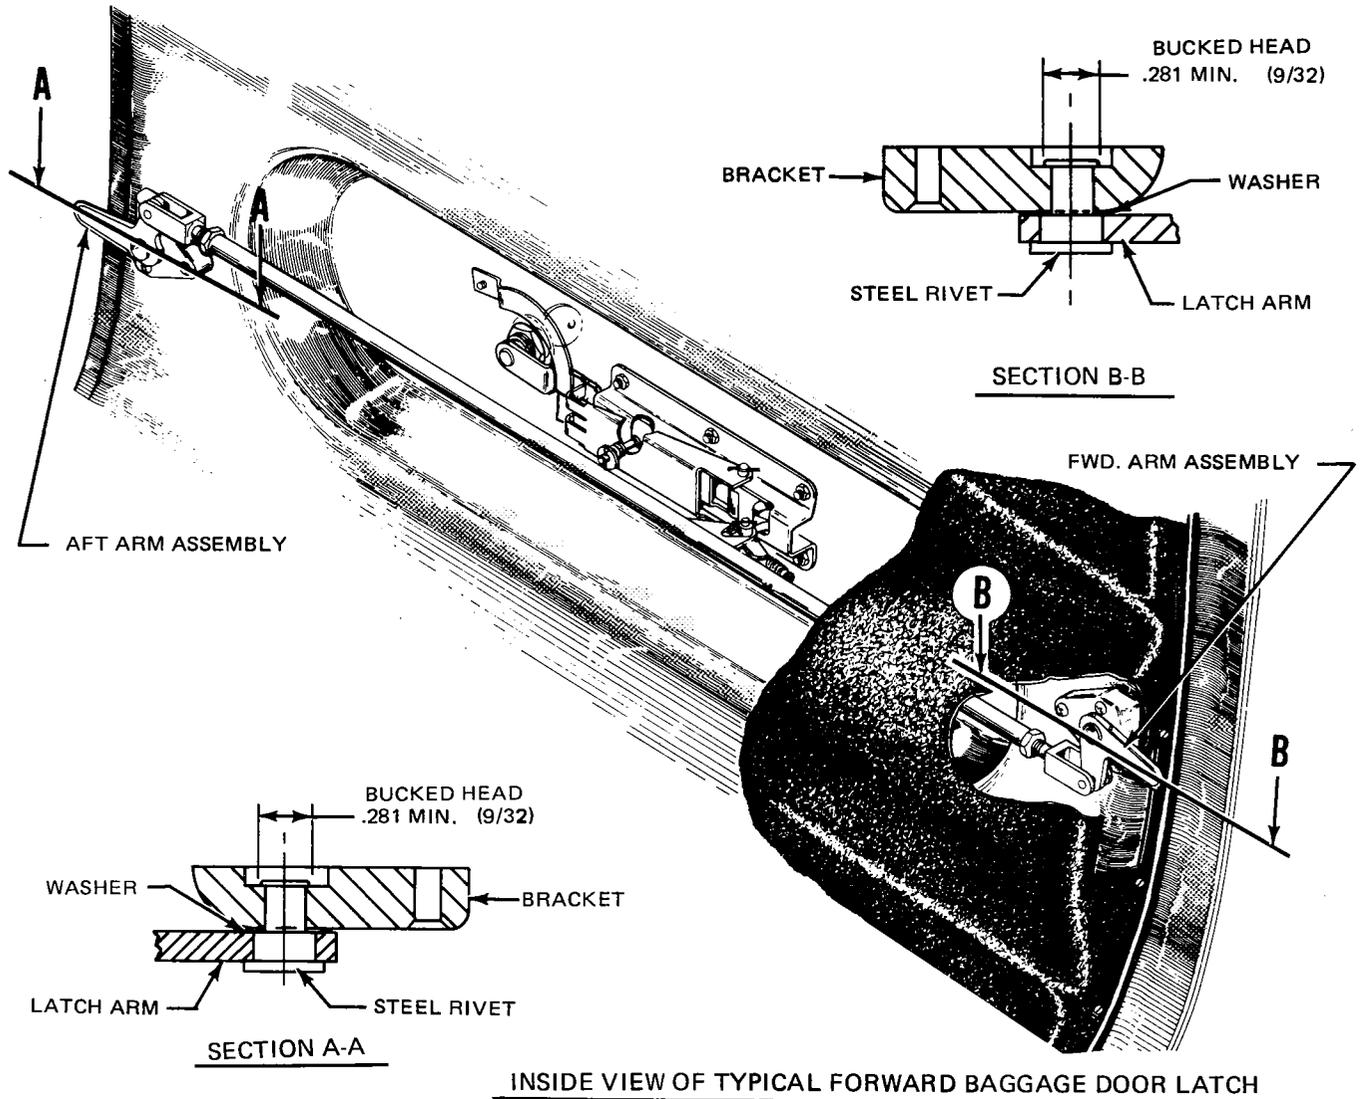
FIGURE 1

Purpose:
The door lock arm assemblies on the forward or nose, baggage door on the above referenced models are secured to brackets by steel rivets. It has been determined that for optimum arm assembly-to-bracket security, the bucked (peened) head of the rivet should have a diameter of .281 inch or greater.

1. Refer to Section IV in the appropriate Service Manual and remove the door latch arm assemblies from the forward baggage door.
2. With the latch arm assemblies removed from the door, inspect as follows.
 - a. Measure the diameter of the bucked head of the steel rivet that secures the latch arm to the bracket (Refer to Section A-A and B-B on Sketch A). This diameter must be . 281 (9/32) or greater.
3. Latch arm assemblies with a bucked head diameter of . 281 (9/32) or greater may be considered acceptable.
4. Latch arm assemblies with a bucked head diameter of less than . 281 (9/32), must either be replaced with a new part as listed in the table below or may be reworked as follows.
 - a. Peen rivet head, in an acceptable manner, to achieve a bucked head diameter of . 281 (9/32) or greater, as shown.

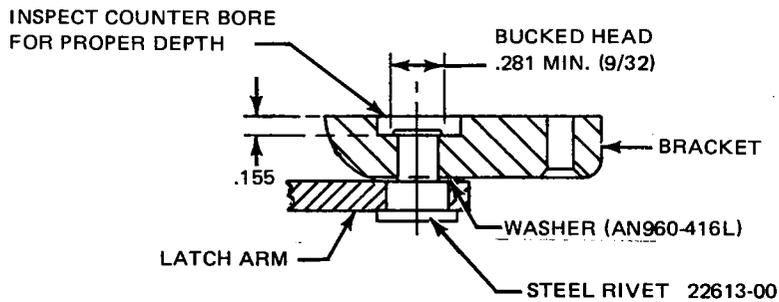
SKETCH "A"

NOTE: Latch arm assemblies not retaining freedom of rotational movement, after head of rivet is peened, must be replaced with a new part as listed in Table below or steel rivet may be replaced as follows. (Refer to Sketch "A", Figure 1.)

- (1) Carefully drill out steel rivet. Maximum allowable hole size after drilling is . 267.
 - (2) Inspect the . 50 diameter counter bore in bracket to determine if counter bore is the proper depth as shown. Counter bore the hole to . 155 if it is not the proper depth.
 - (3) Install new rivet Part No. 22613-00 and peen in an acceptable manner to achieve a bucked head diameter of . 281 (9/32) or larger.

NOTE: Latch arm assemblies not retaining freedom of rotational movement after rework, must be replaced with a new part as listed in Table below.
5. Install new or reworked latch arm assemblies to forward baggage door. Refer to Section IV in the appropriate Service Manual.
6. Make proper Logbook entry of Service Bulletin 604A "Part II" compliance.
