SERVICE LETTER

No. 683

Piper Aircraft Corporation

Subject: Stabilator Control Cable Attachment Fittings Inspection

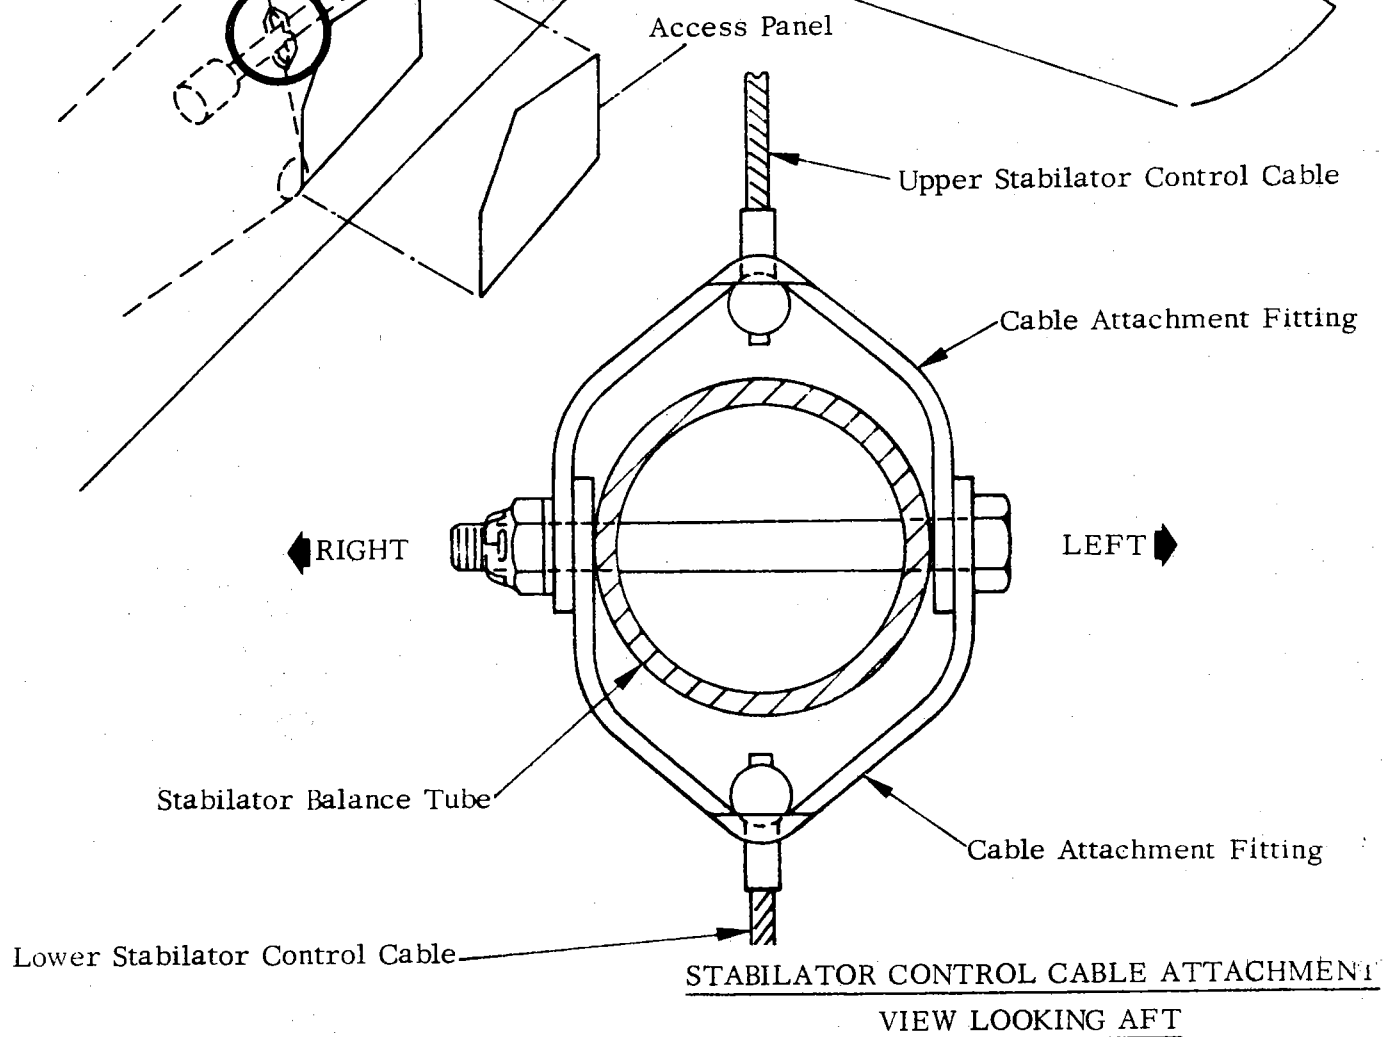
Purpose: One report has been received from the field describing improper attachment of the upper and lower stabilator control cable attachment fitting (yoke) to the stabilator horn tube; the attaching bolt was installed through one side of the fittings (yokes) only.

This service release provides instructions to inspect the upper and lower stabilator control cable fittings to insure that they are properly attached to the stabilator horn tube, with the attaching bolt installed through both sides of the fittings. (Refer to sketch on reverse side of this letter for a pictorial illustration of this area.)

1. Remove side access panel from aft fuselage.
2. Inspect stabilator control cable attachment fittings to insure they are properly attached to the balance tube as shown.
3. Make corrections if required and reinstall access panel.
