SERVICE No. 1026 BULLETIN

SUBJECT:

Distribution of Parker Hannifin Airborne Service Letter 48, "Inspection/Replacement of dry air pump flexible couplings".

Subject: Inspection/Replacement of dry air pump flexible couplings.

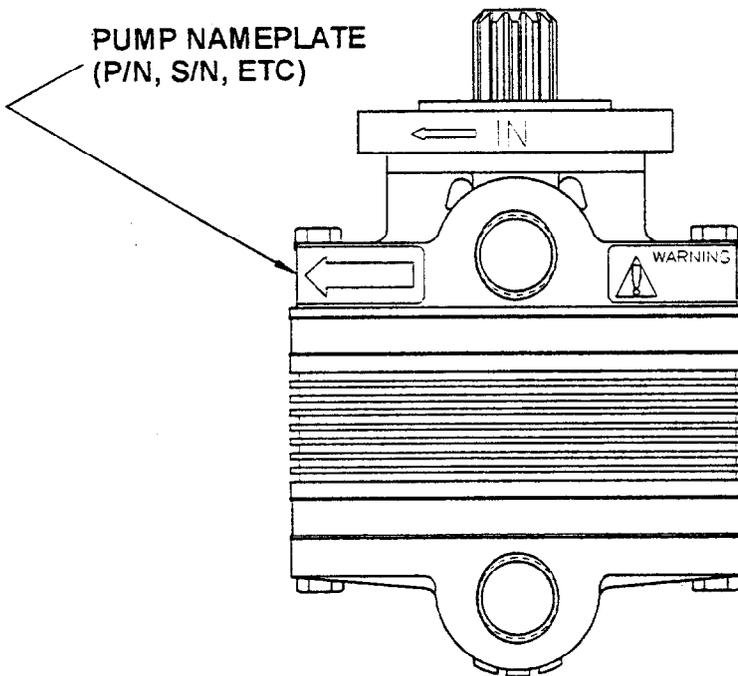
FIGURE 1

Applicability: Airborne dry air pumps, conversion kits and flexible coupling kits with the following part numbers/serial numbers which have not been inspected per this service letter as identified in step number seven of the procedure listed below. These components were shipped from Airborne between 1/1/98 and 10/13/98. Refer to Figure 1 for location of part number/serial number nameplate.

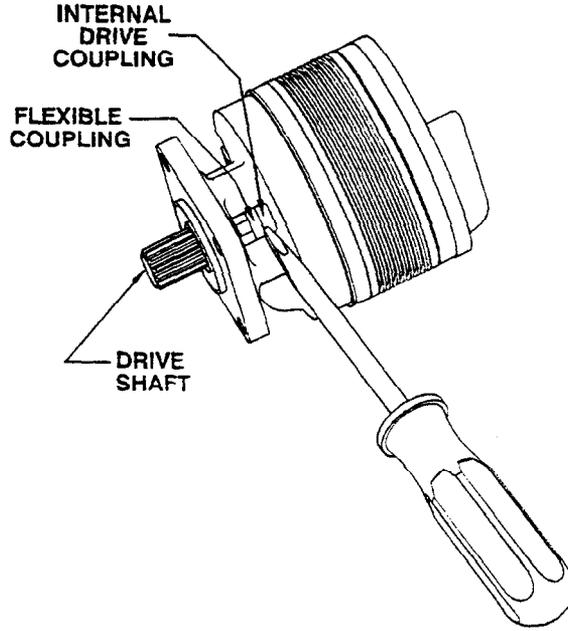
FIGURE 2

- 1) Remove dry air pump from engine accessory pad per instructions provided by the airframe manufacturer in the appropriate maintenance publication.
- 2) Insert a screwdriver or similar tool between the flexible coupling assembly (2-piece) and the pump's internal drive coupling. Remove the flexible coupling assembly from pump, taking care not to damage any of the eight drive pins. Refer to Figure 2.
