SERVICE LETTER

No. 629

Piper Aircraft Corporation

Fuselage Frame Tube Corrosion Inspection

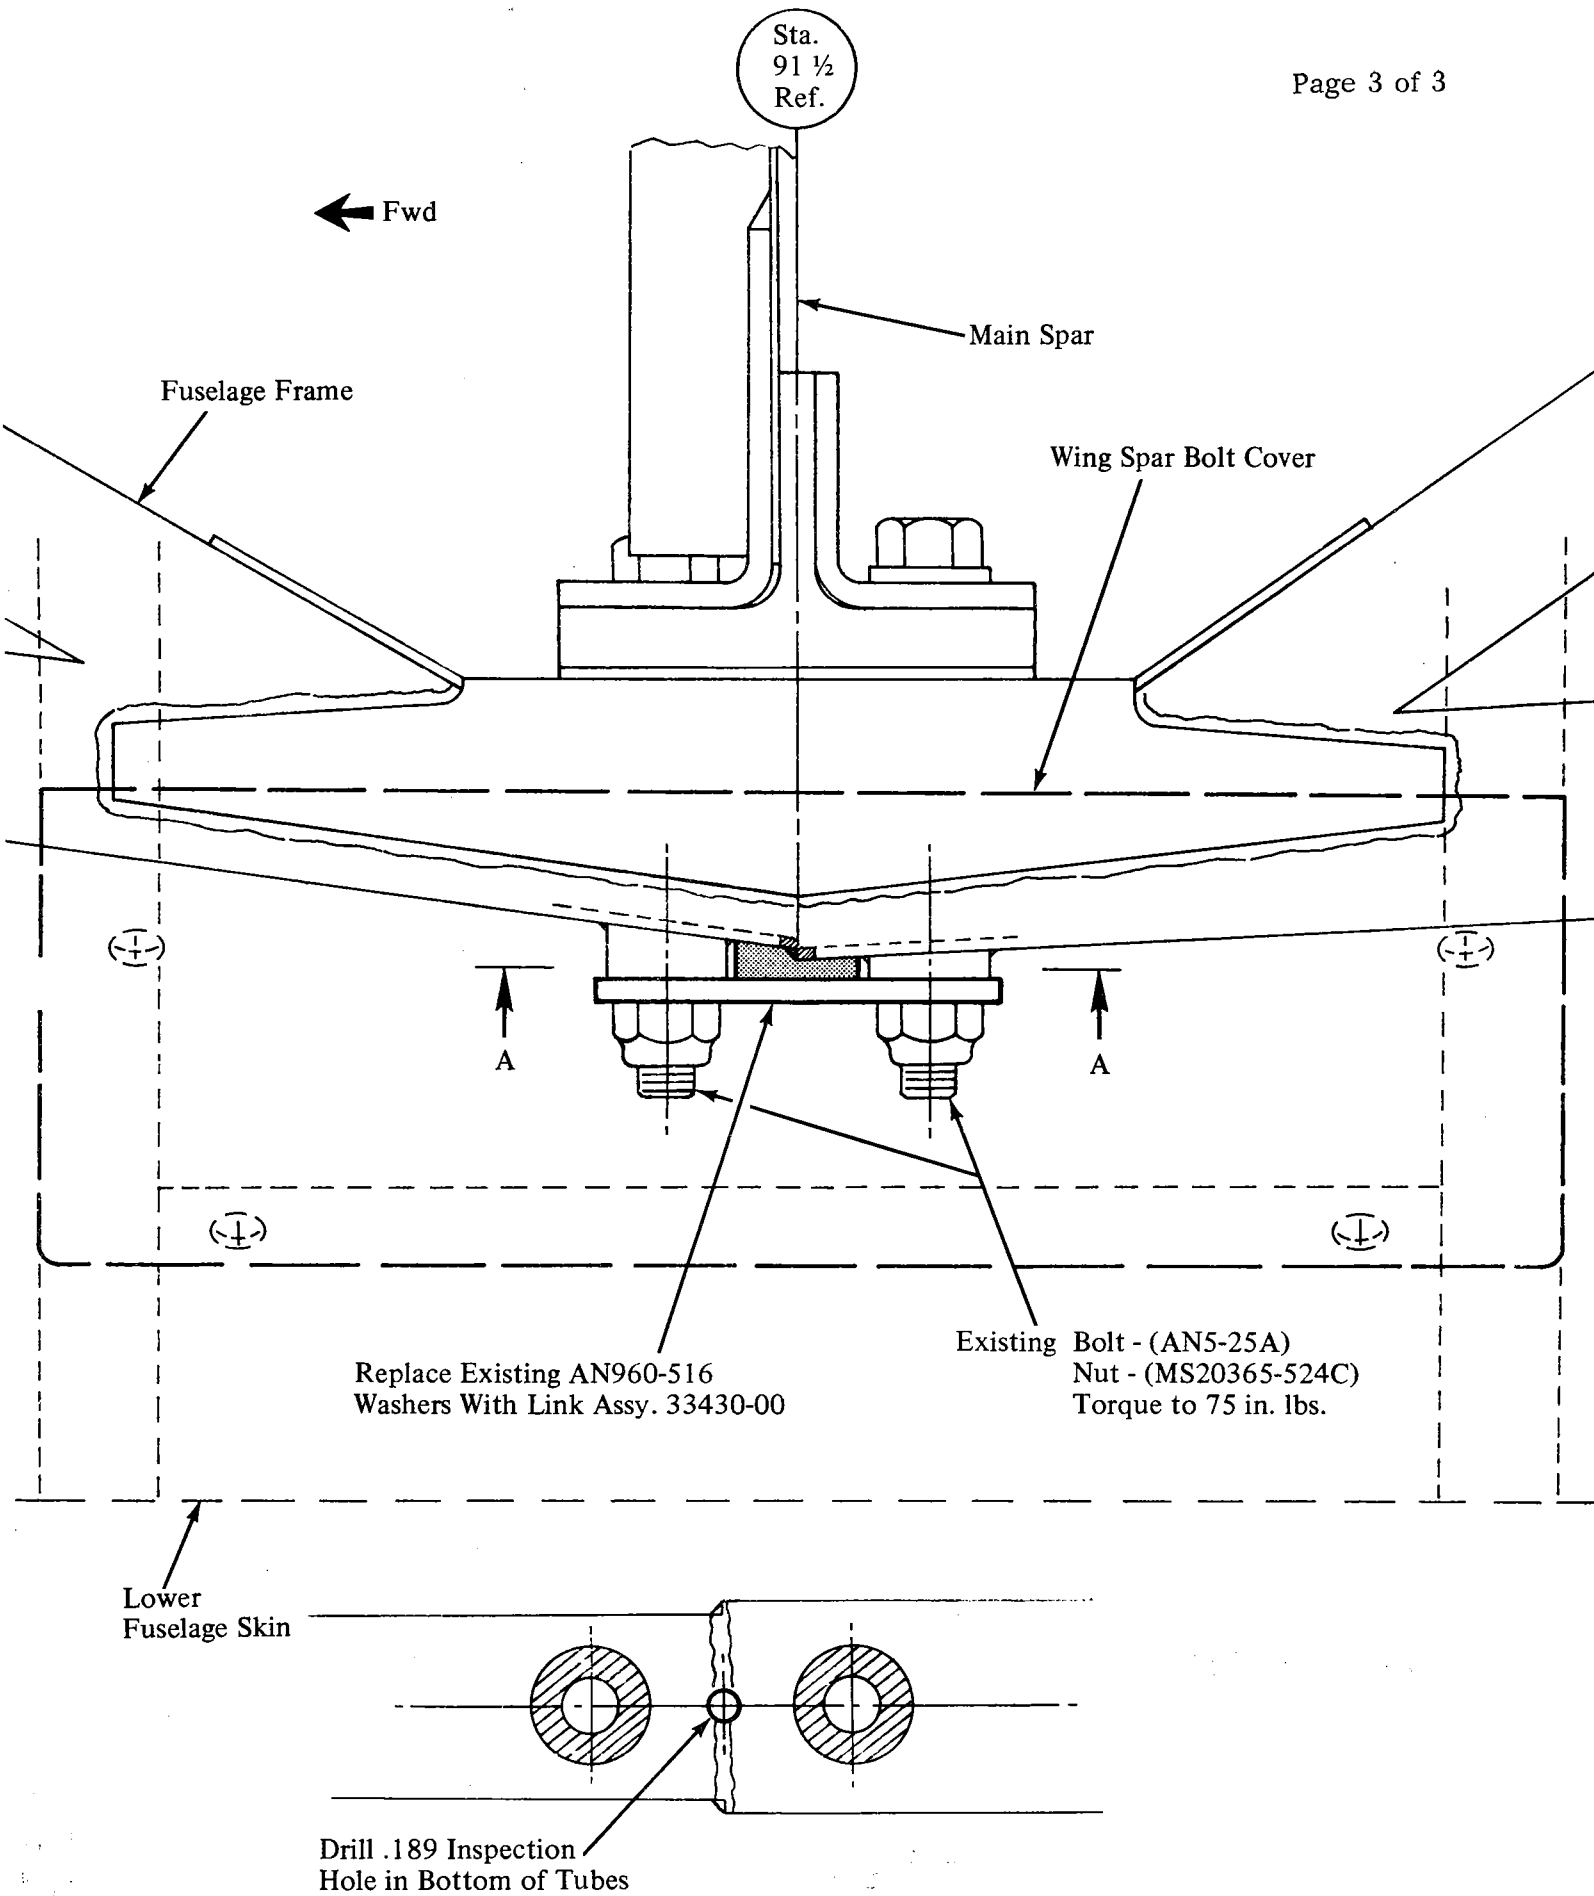
1. Level the aircraft, in accordance with appropriate service manual Longitudinal and Lateral Leveling Procedures.
2. Remove the wing spar bolt cover plate, left and right side; exposed to view are the two front spar side attachment bolts (refer to attached sketch for a pictorial description).
3. Drill a 3/16 inch hole in each lower longeron equidistant between the two bolts referenced above.
4. Visually inspect the interior surface of the longeron through the 3/16 inch hole for evidence of internal corrosion; this point is the lowest point of the fuselage frame structure and would be the area where corrosion

5. Should evidence of corrosion be detected by Step No. 4, above, repair in accordance with F.A.R. 43:13:1, Inspection and Repair Section. Then, accomplish Steps (a) thru (e) inclusive, below.
6. If no evidence of corrosion is detected by Step No. 4, above, proceed with the following corrosion prevention procedure:
 - a. Pump approximately one quart of L-1 Lionoil through each 3/16 inch inspection hole.
 - b. Drain into drip pans for approximately two hours.
 - c. Purge excess oil from tubes by applying air pressure to each 3/16 inch inspection hole, one at a time.
 - d. Insure that at least a total of one quart of Lionoil is retrieved in the drip pans.
 - e. Install Longeron Reinforcement Kit, Part No. 760 703, which will insure that the 3/16 inch inspection hole is sealed and that the structural integrity of the frame is maintained.
7. Make appropriate log book entry.
