SERVICE No. 133 BULLETIN

Piper Aircraft Corporation

SUBJECT: Landing Gear Down Lock Latches

MODELS AFFECTED: PA-23, 23-1 to 23-63 inclusive, 23-65 to 23-111 inclusive

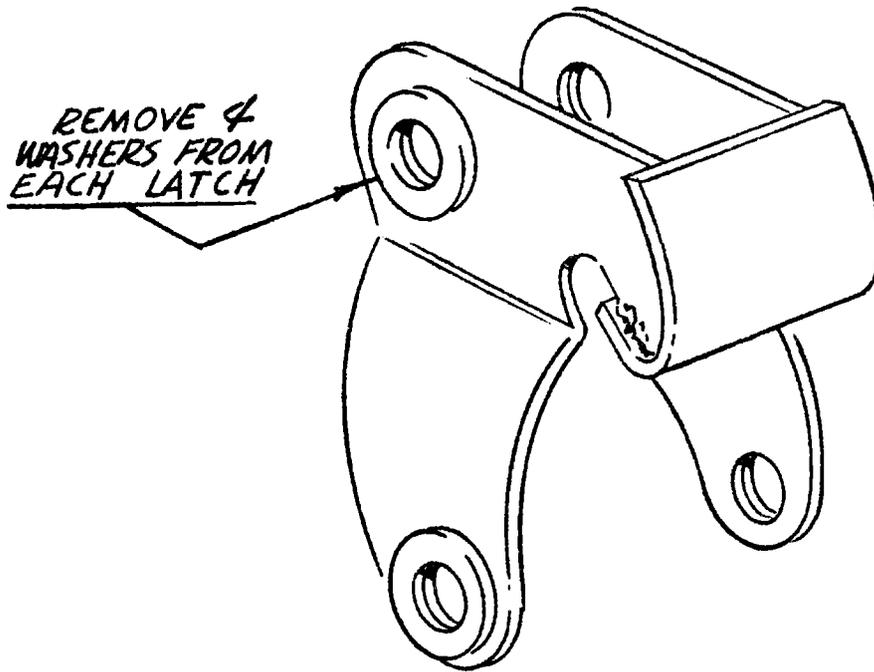
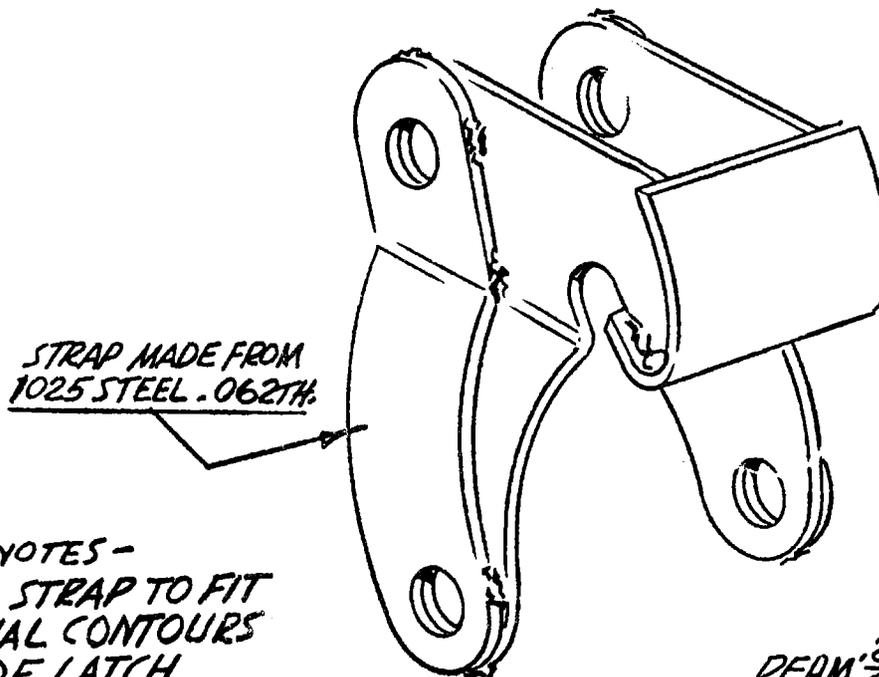
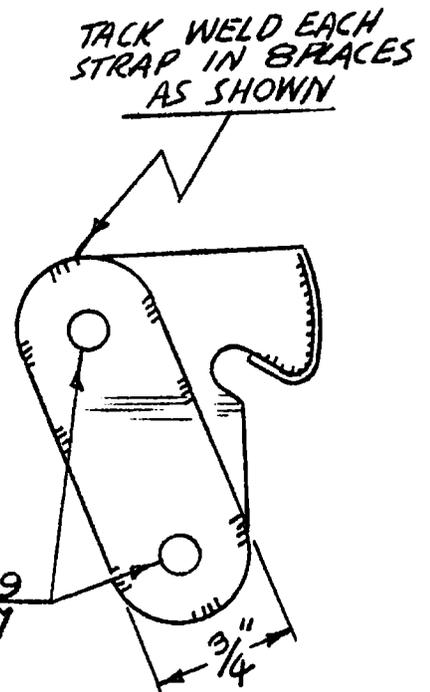
SERVICE BULLETIN 133

Two Apaches have been found with broken down lock latches and, as yet, it has not been determined what the exact cause is. It may be a weak fitting or the gear actuating cylinder may be out of adjustment. However, to preclude the possibility of cracks starting because of a weakness in the material, it is requested that all three latches be removed and reinforced according to the instructions on the reverse side of this bulletin. It is also requested that the actuating cylinders be adjusted as follows AFTER the latches have been modified.

1. FORM STRAP TO FIT ORIGINAL CONTOURS OF LATCH.
2. MAGNIFLUX OR DYE CHECK AFTER WELDING. THIS MODIFICATION APPLIES TO NOSE GEAR AND BOTH MAIN GEARS.
