SERVICE BULLETIN

No. 672A

Piper Aircraft Corporation

Subject: Step Attachment Area Inspection/Reinforcement

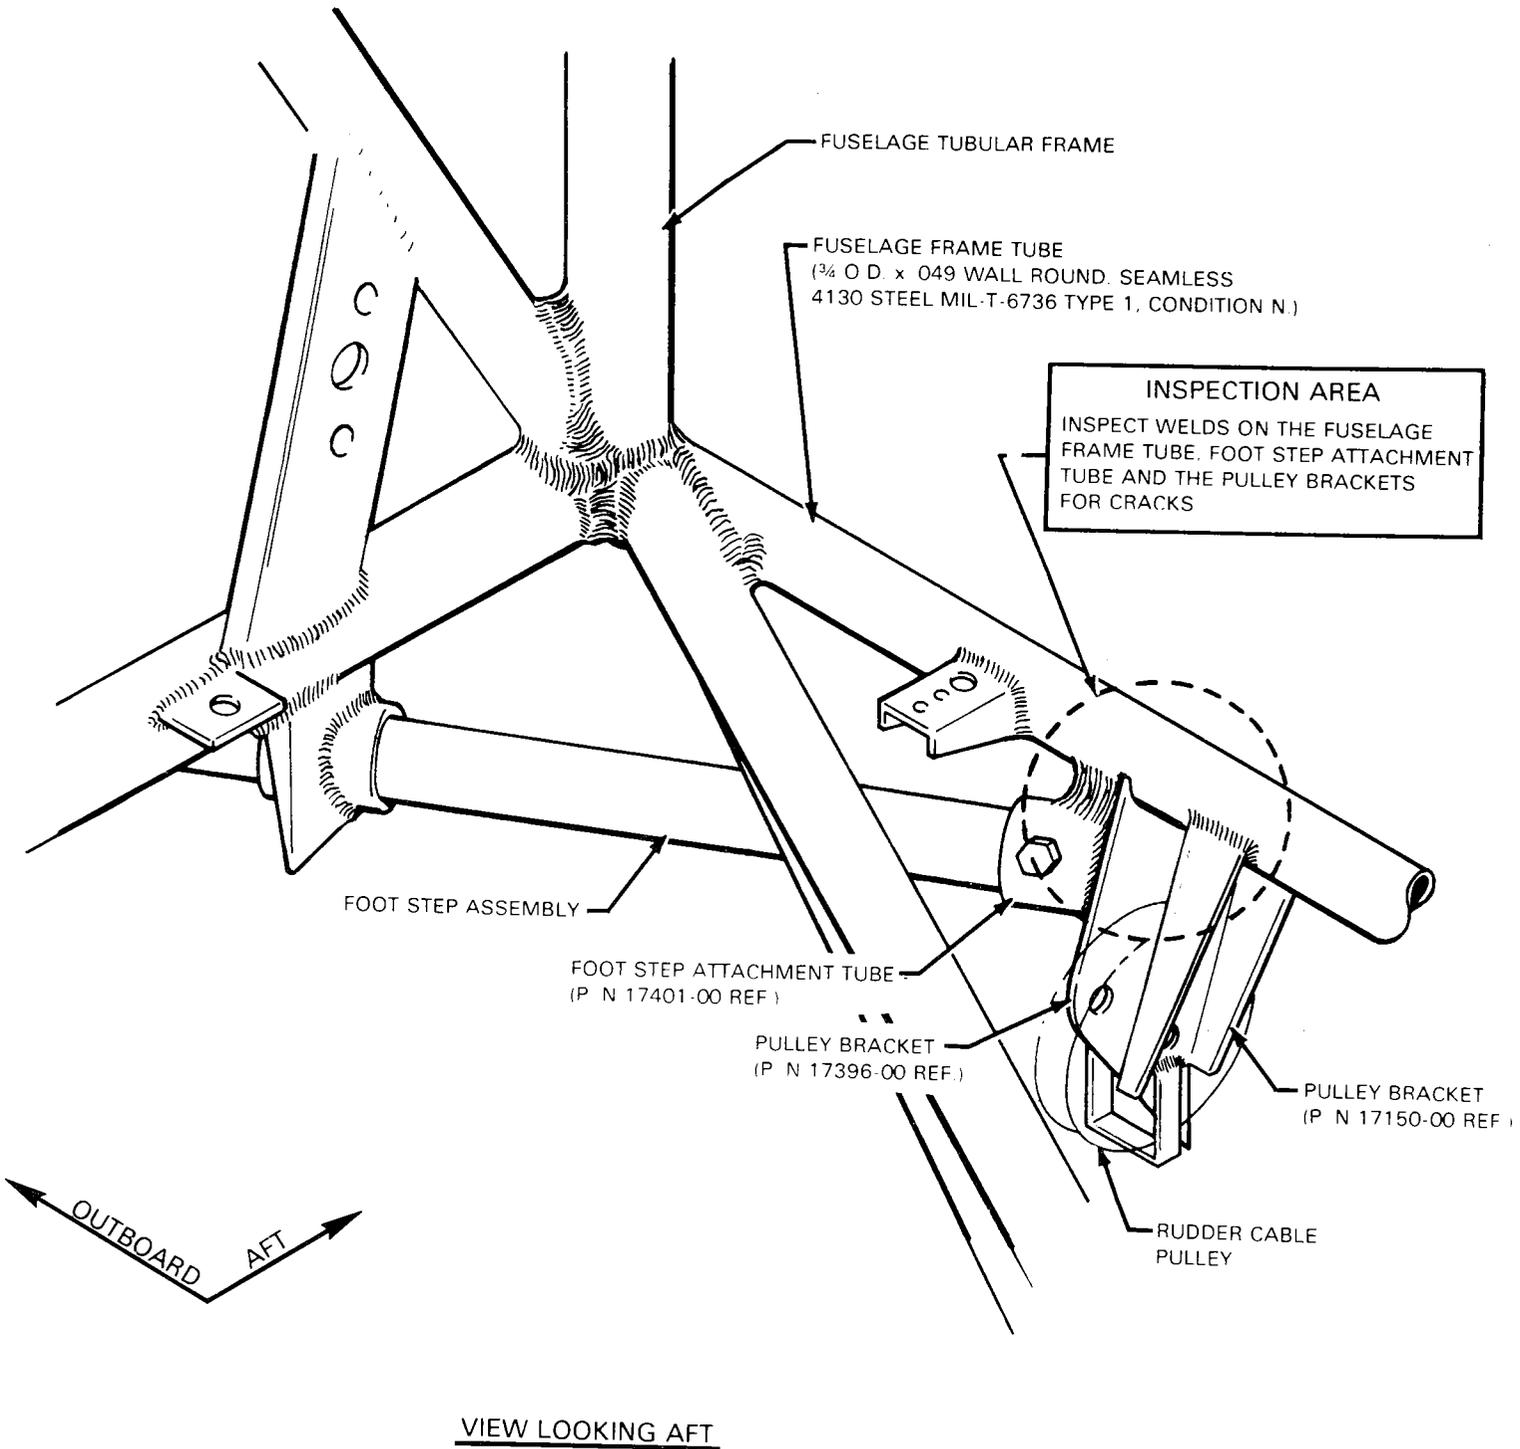
SKETCH "A"

Field reports indicate that some aircraft, depending upon the type of use, may develop cracks in the fuselage tubular crossmember adjacent to the cabin entry step attachment. Cracks and eventual separation of the crossmember will adversely affect the integrity of the step installation, and may also cause misalignment of the rudder cable pulley in the same area, possibly resulting in impairment of rudder control.

3. Remove the footstep assembly.
4. Inspect, using 10X magnification, the welds on the fuselage frame tube, footstep attachment tube and rudder cable pulley brackets, in the area shown on Sketch "A", for cracks. If no cracks are found, proceed to step 5. If cracks are found proceed as follows (NOTE: All repairs must be done by gas welding):
