# SERVICE LETTER

No. 582A

Subject: Turbocharger Exhaust System Inspection and Modification -- reference attached Avco Lycoming Service Bulletin No. 339A, dated March 29, 1974.

SUBJECT: Turbocharger Exhaust System Inspection and Modification

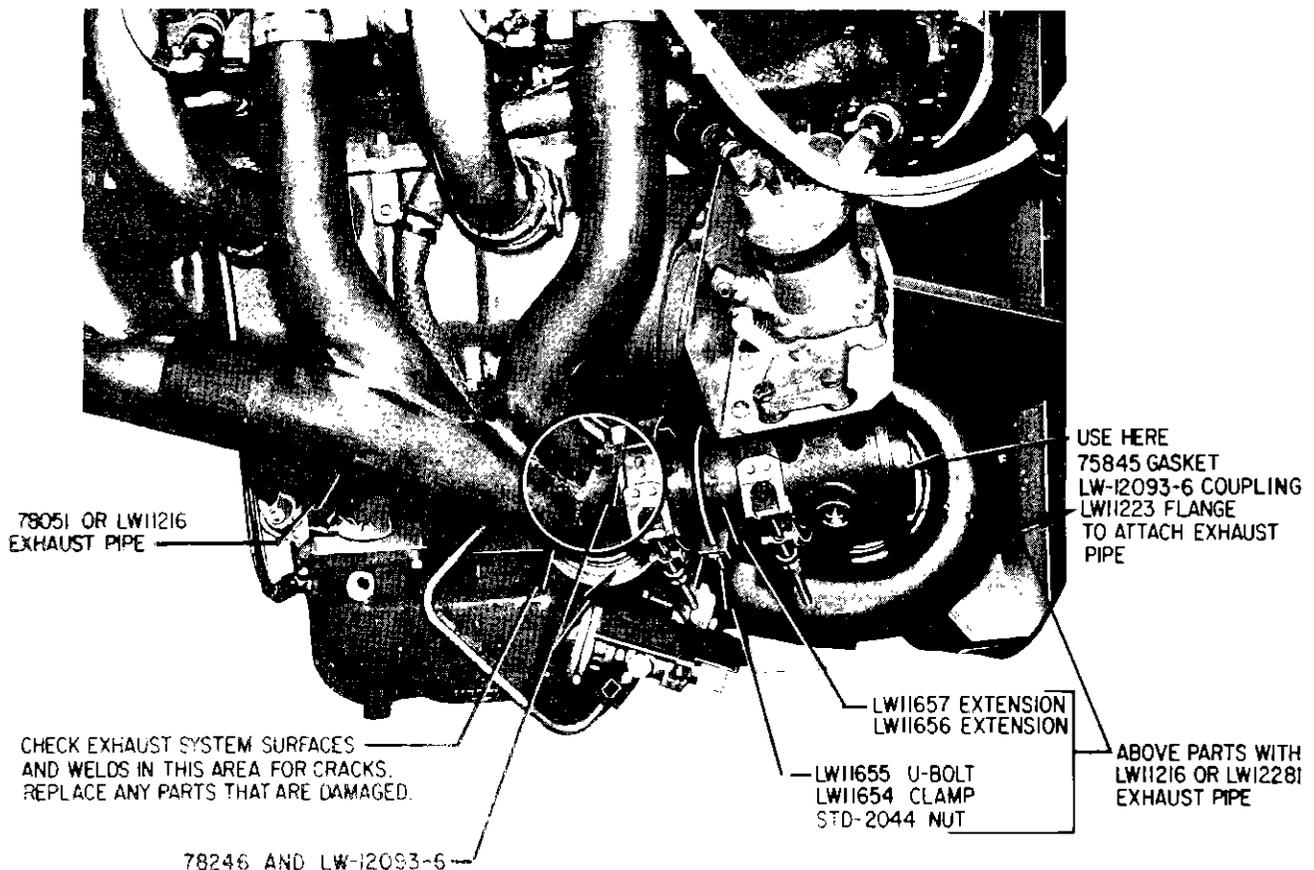
Figure 1. Left Side of Engine Showing Area for Inspection

To provide information to inspect the exhaust manifold on the left side of the right engine and the turbine outlet/tailpipe v-band coupling for possible cracks in the welded area. Also to install a supporting member and bracket for the tailpipe on the right hand engine to minimize motion, which could cause damage in the area.

3. With the aid of a flashlight and mirror, visually examine the exhaust system on the left side of the engine; pay particular attention to the surfaces and weldments of the pipe leading to the exhaust bypass valve. Replace any part of the exhaust assembly that shows any evidence of cracks. See figure 1; also see Parts Data list for replacement parts information.

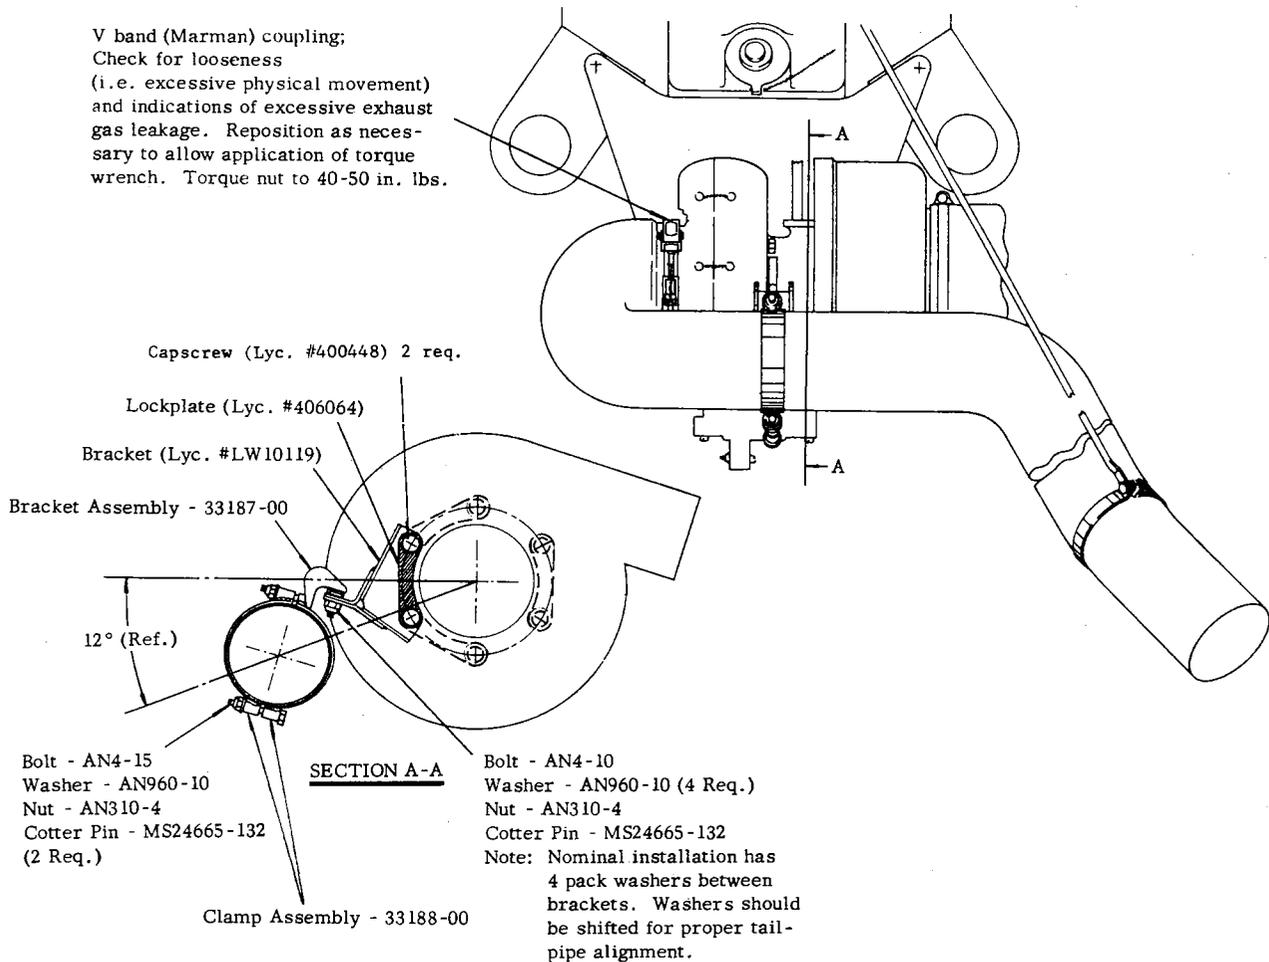
Figure 3. Assembly Procedure for Tailpipe Bracket and Clamp Components

1. Remove inboard and outboard engine cowl panel assemblies and grasp the tailpipe assembly to determine if movement is discernible between the tailpipe and the turbine outlet at the v-band coupling (Maraman clamp). See figure 3. If movement is evident remove the bottom cowl assembly and remove the v-band coupling; reinstall it and tighten the coupling nut to 40-50 in. lbs. torque.
2. Again check the tailpipe for movement. If still loose, install a new v-band coupling (Piper part no. 555376) and safe-tie the nut after tightening to 40-50 inch lbs. torque.

Evidence of excessive exhaust gas leakage around the v-band coupling is also indicative of improper assembly of the tailpipe to the turbine outlet.

5. See figure 3 for installation of tailpipe bracket and clamp assembly.
6. Indicate compliance with this bulletin in aircraft records.
