# SERVICE LETTER

No. 584

Piper Aircraft Corporation

Subject: 90 AMP Alternator Circuit Breaker Switch Inspection

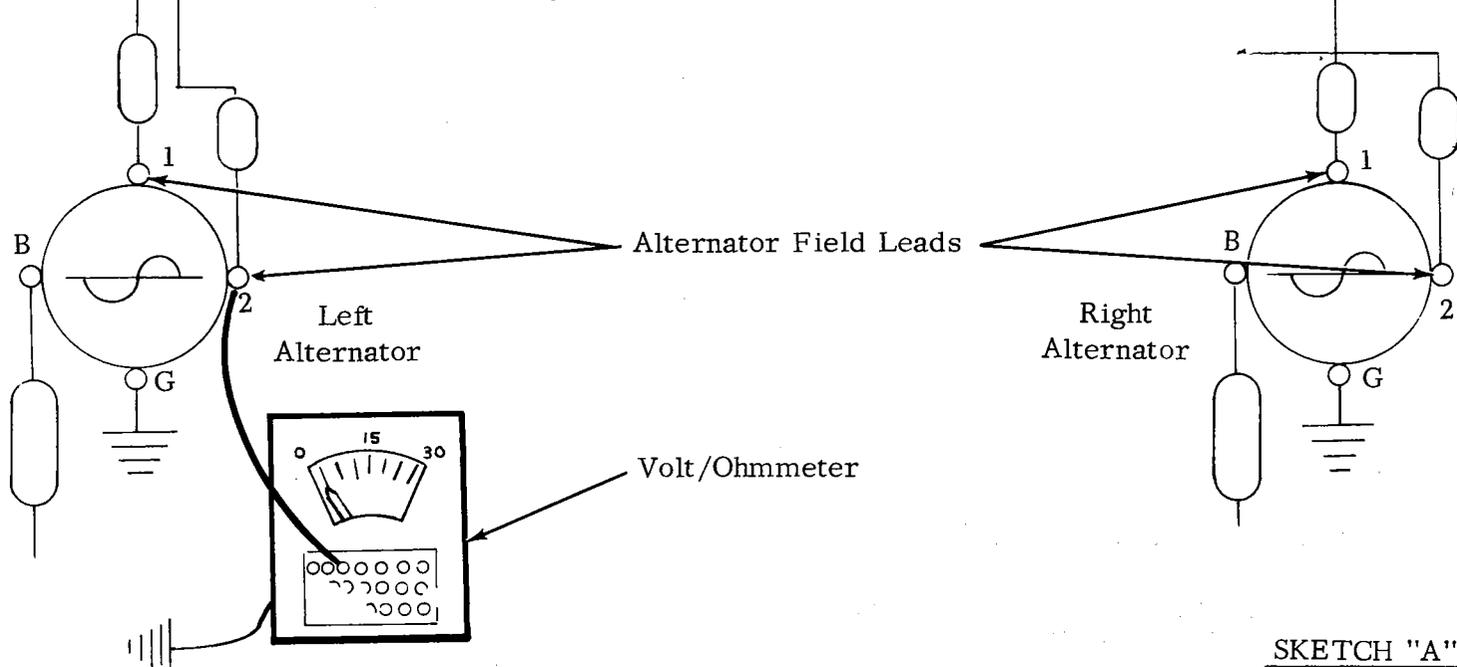
SKETCH "A"

Purpose: Several recent product condition reports indicate that the subject switch, in the "OFF" position did not disarm the alternators, due to a circuit breaker switch internal malfunction.

1. Turn the left and right 90 AMP Alternator Circuit Breaker switches both OFF.
2. Turn the aircraft Master Switch ON.
3. Connect a volt/ohmmeter as shown in Sketch "A".
4. Check the #2 Terminal of each alternator for voltage. Then connect the instrument lead to the #1 Terminal and check for voltage at this point. Do this on both alternators. If voltage is indicated at any of these terminals, proceed with Step 5. If there is no voltage, the alternator circuit breaker switch is all right.
5. Connect volt-ohmmeter as shown in Sketch "B". Check pin 4C of each alternator circuit breaker switch to determine if voltage is present. There should be voltage present; if there is, the switch is all right. If unable to obtain a voltage reading at pin 4C, the alternator circuit breaker switch being tested is defective and must be replaced with Part No. 454 667 (Wood #302-290-102).

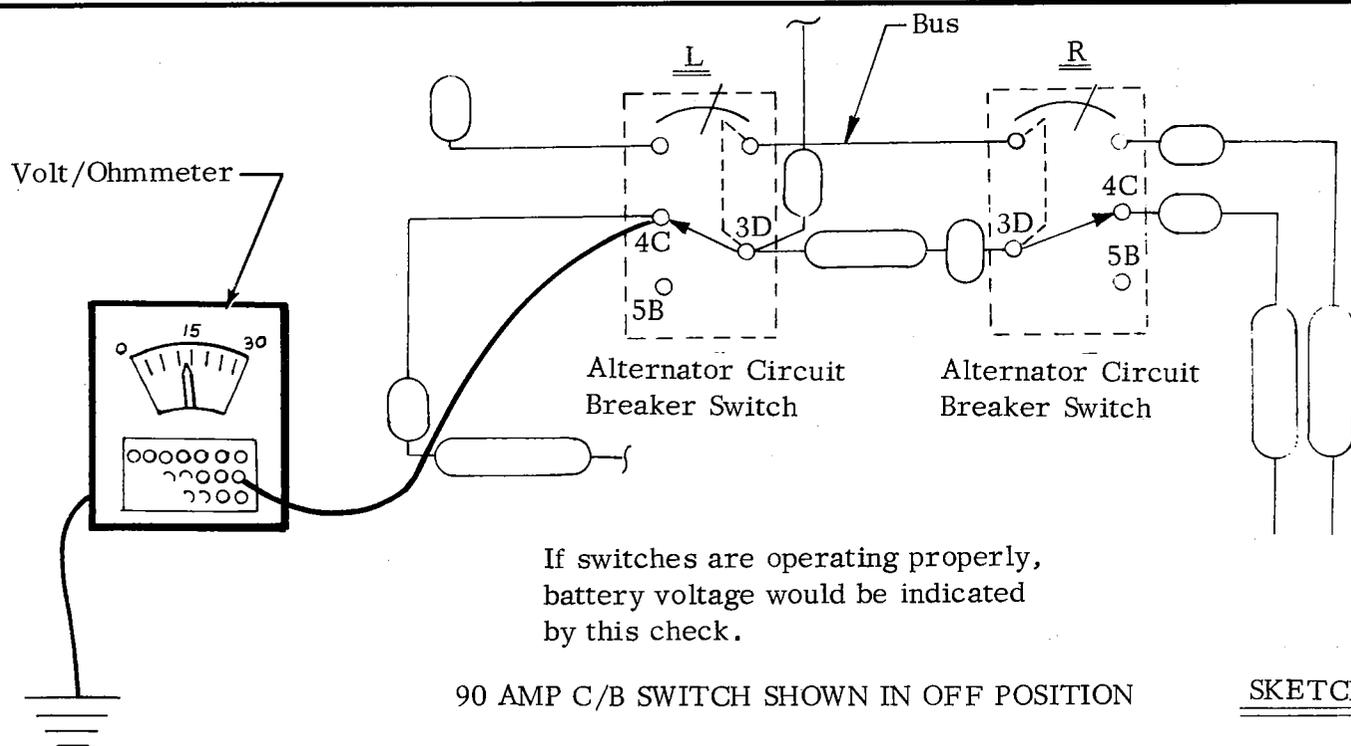
SKETCH "B"

If switches are operating properly,  
battery voltage would be indicated  
by this check.

90 AMP C/B SWITCH SHOWN IN OFF POSITION
