Service Letter No. 462

SUBJECT: Inspection of Engine Mount Tubes

MODELS AFFECTED: PA-23-250 Aztecs, Serials 27-2505 to 27-2922 inclusive

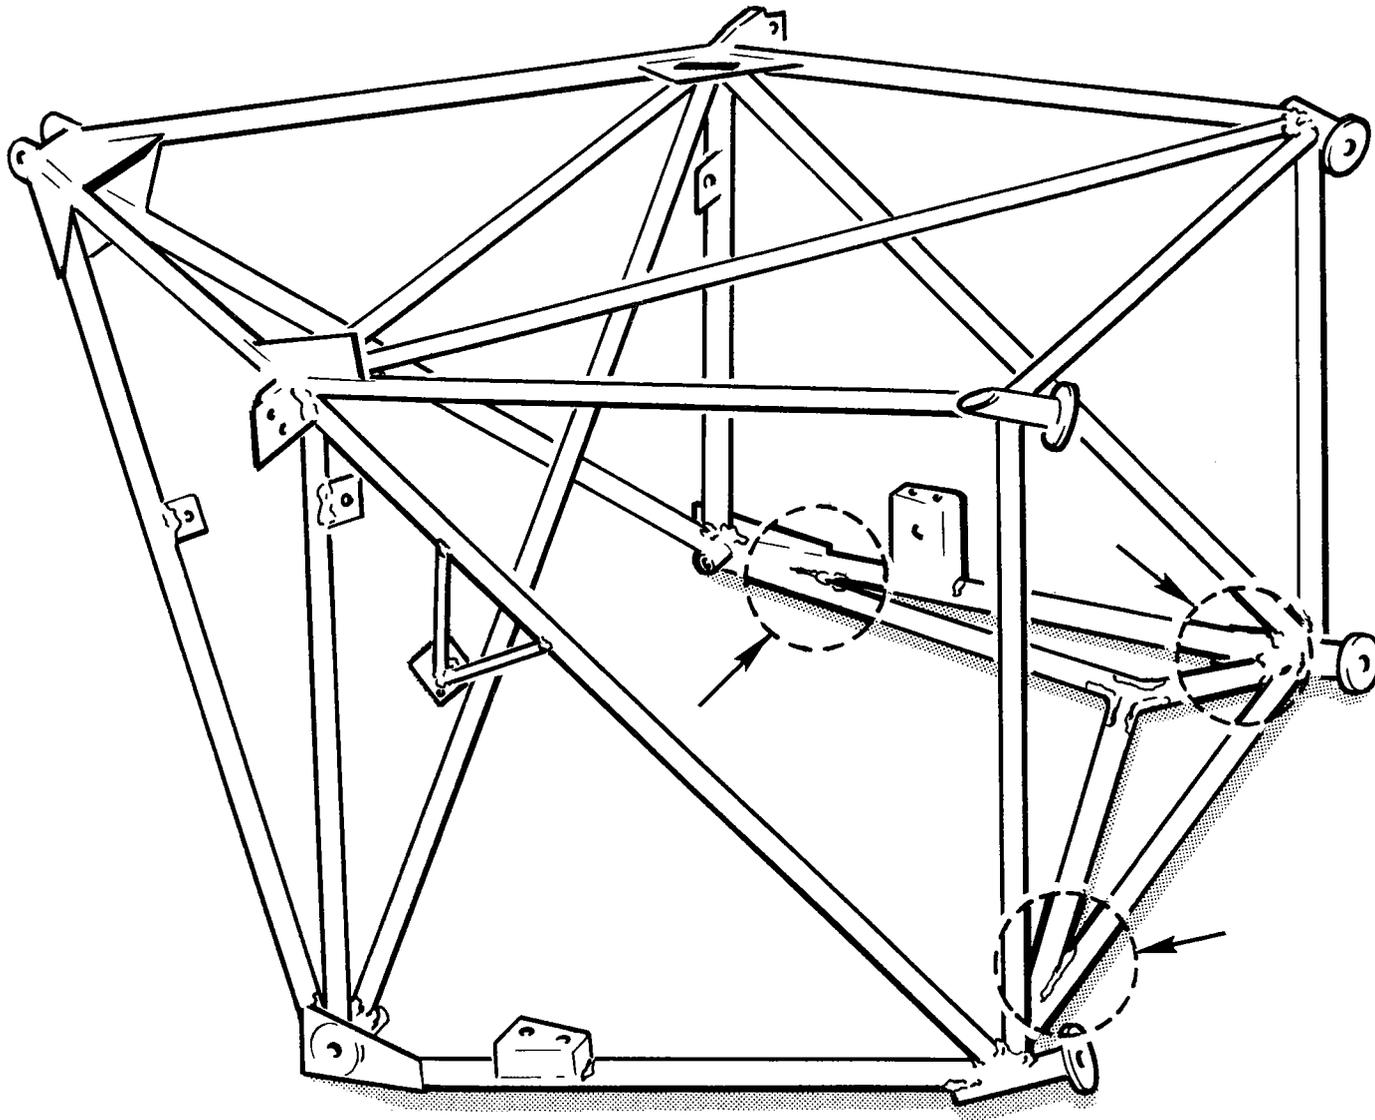
A number of reports have been received indicating that cracks have been observed in the engine mount tubes of the subject aircraft. These cracks have been noted in aircraft with 200 hours or more total operating time and in most instances have occurred in commuter air service where frequency of engine starts are at an unusually high level due to short flights and heavy daily schedules.

It is requested that the engine mount tubes of the aircraft indicated by the above serial numbers be inspected for cracks. The sketch on the reverse side of this Service Letter indicates points where cracks have been more commonly observed.

Engine mounts, part numbers 31215-00 and 31215-01, with cracked tubes must be replaced. Replacement mounts will be provided in accordance with the following schedule:
