VENDOR SERVICE PUBLICATION

One time Main Wheel Tie Bolt Inspection: Cleveland ESL-7007,
Dated August 24, 1978 (Attached).

Subject: ONE TIME MAIN WHEEL TIE BOLT INSPECTION

Aircraft Effectivity: PIPER AIRCRAFT PA-23-250 (AZTEC)

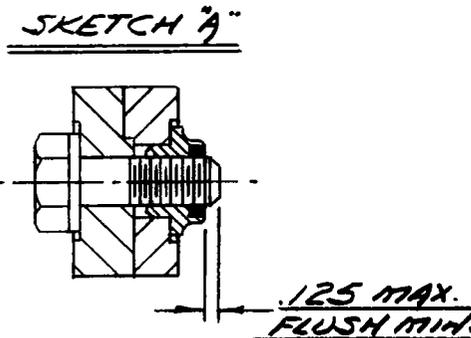
Inspection: At the next regularly scheduled maintenance period, visually inspect the relationship between each tie bolt and spline nut per Sketch "A" - Thread protrusion should be flush to .125 maximum.

Bolts that are below flush, may not engage the self-locking feature of the spline nut. It is recommended that this condition be corrected by replacing the existing bolts with P/N AN4-7A; torque existing and/or replacement bolts to 90 in-lbs.

If the thread protrusion per Sketch "A" exceeds .125 inch, the bolt may be shanked out. If this condition exists, it is recommended that it be corrected by replacing the existing bolts with P/N AN4-7A; torque existing and/or replacement bolts to 90 in-lbs.
