SERVICE LETTER

No. 559

Piper Aircraft Corporation

Subject: Inspection of Alternate Air System

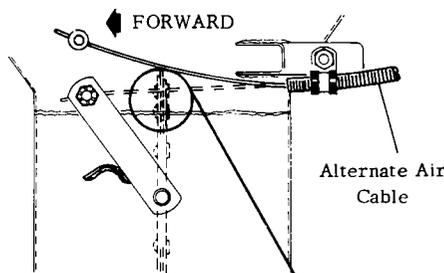
1. Remove the necessary cowling from the engines to gain access to the air filter and remove the air filter by removing the two attachment brackets.
2. With the alternate air cable disconnected, ascertain that the valve is fully open when the arm is against the stop as shown in Figure 2, and that the valve is properly installed in the induction tube as shown in Detail A.

3. If the valve is fully open as in Figure 2, but not installed in accordance with Detail A, disassemble the valve from the arm assembly by drilling out the four rivets and re-install in accordance with Detail A using new Rivets MS20470AD3-8.

4. If the valve is not fully open as shown in Figure 2, it will be necessary to disassemble the valve from the arm assembly and replace the existing arm with a new arm assembly, P/N 32343-00 and reassemble per Figure 2 and Detail A.
