# SERVICE No. 134 BULLETIN

**SUBJECT:** Main Landing Gear Attachment Points

**MODELS AFFECTED:** PA-23, Serials 23-1 to 23-109 inclusive

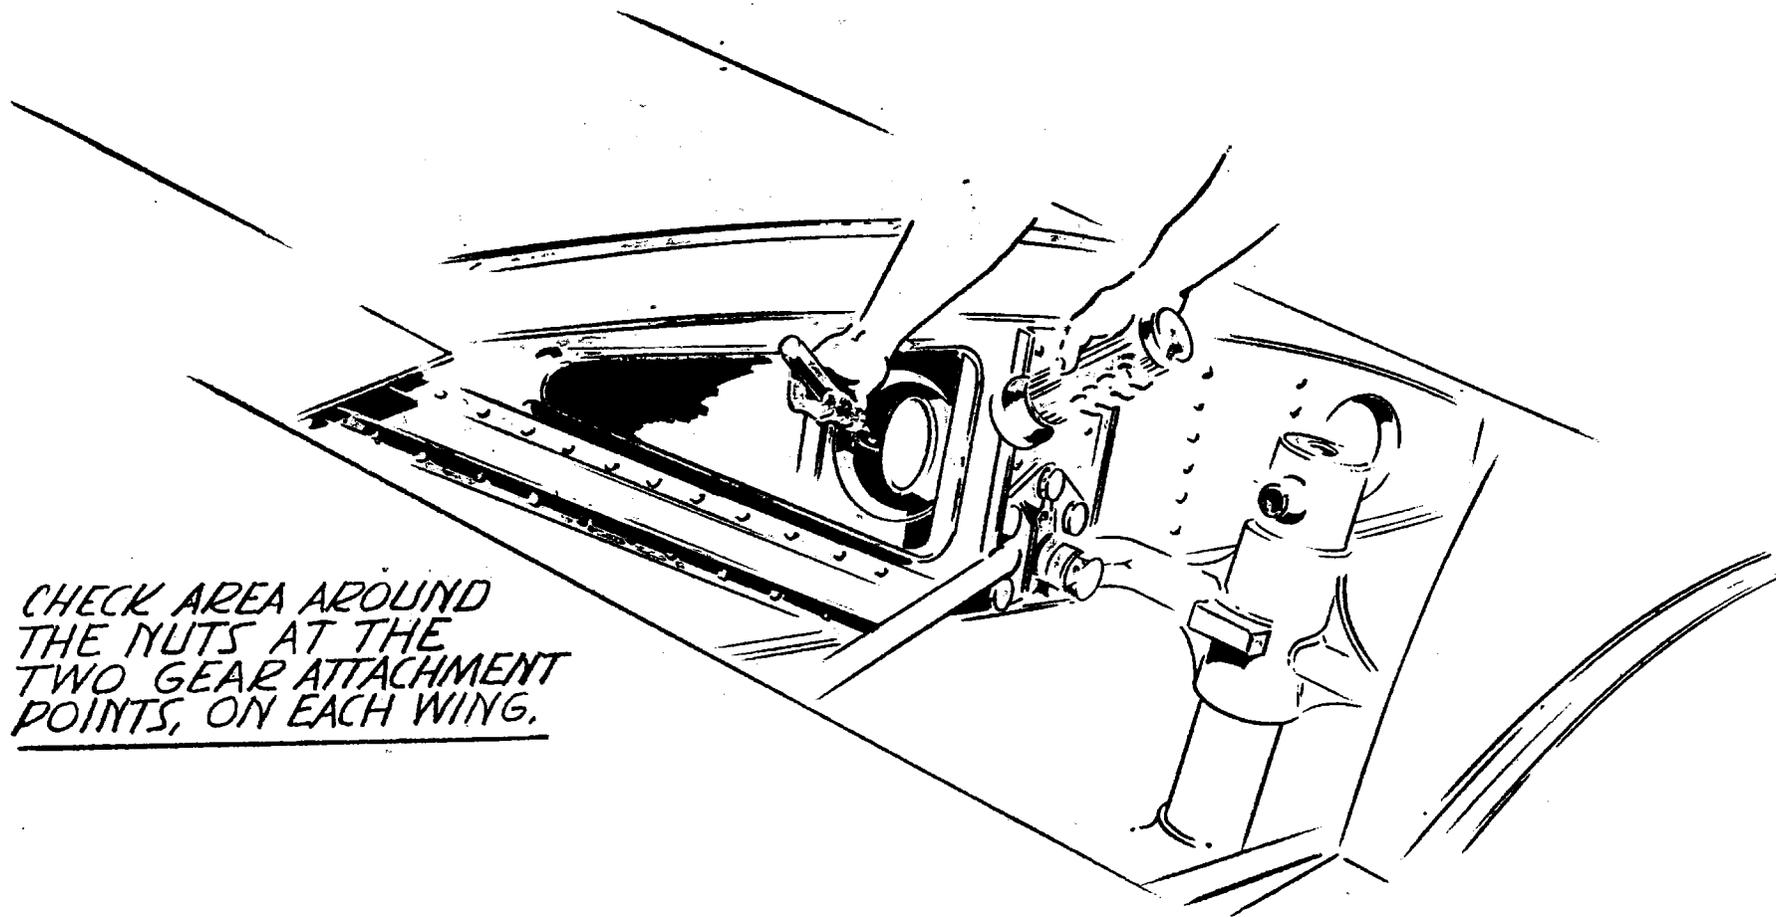
We have found that cracks have developed in the bulkhead flange of the torque rib at a point where the main landing gear mounting casting attaches to the wing structure.

CHECK AREA AROUND  
THE NUTS AT THE  
TWO GEAR ATTACHMENT  
POINTS, ON EACH WING.

It is requested that the above listed airplanes be inspected, and if there is any evidence of cracks, Piper Kit 754 076 should be installed immediately. If there are no cracks present, Kit 754 076 should be installed at the next 100 hour inspection.
