SERVICE No. 671 BULLETIN

Piper Aircraft Corporation

Subject: Flap Control System Inspection and Reinforcement

PA-23/PA-23-160 Apache
PA-23-235 Apache
PA-23-250 Aztec
PA-23-250 (6 Place) Aztec

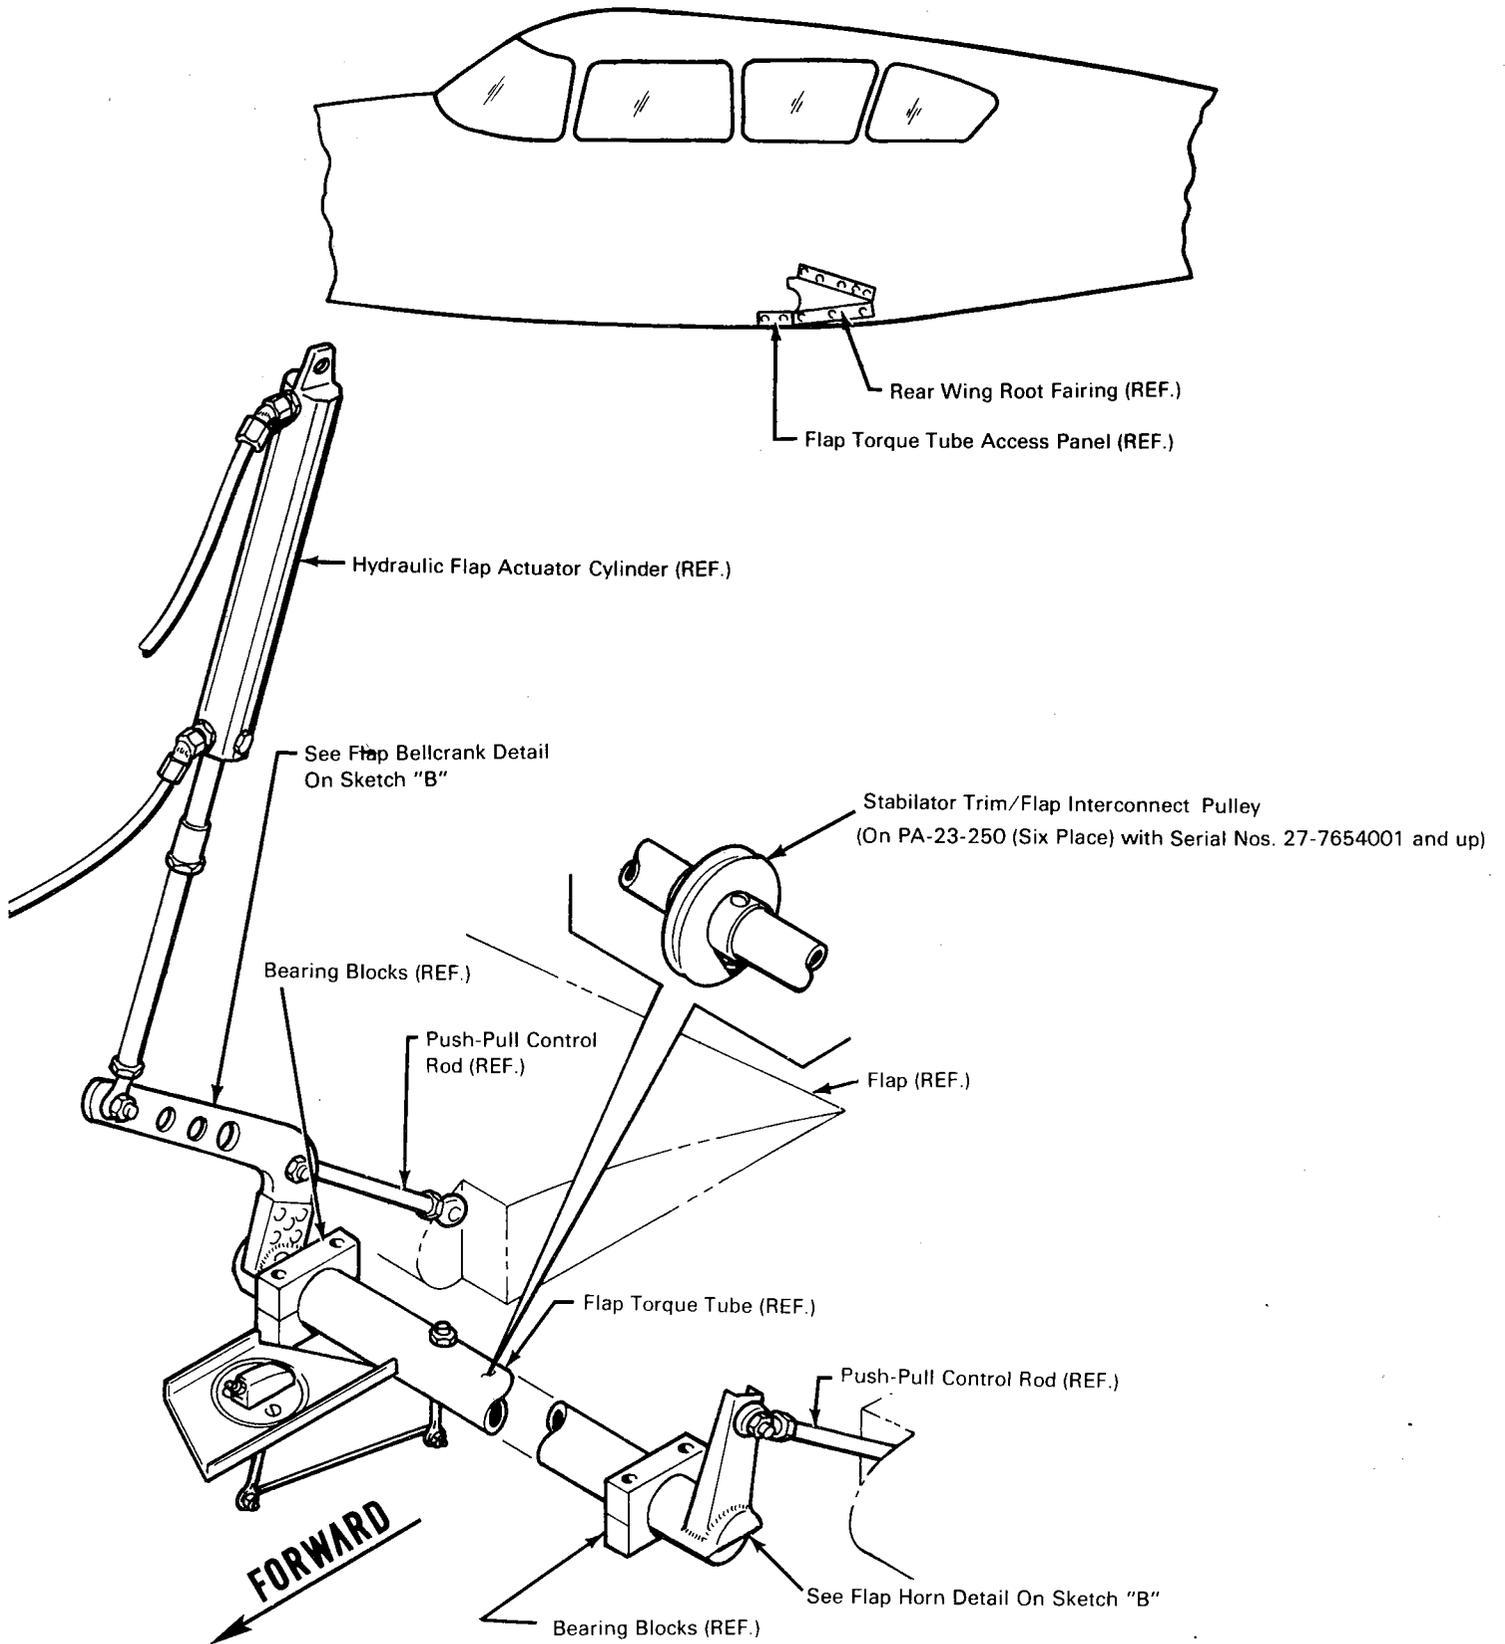
SKETCH A

Field reports indicate that after one thousand (1000) hours in service, some Models Affected, above, depending upon the type of use, may develop cracks in components of the flap control system. Left unattended, such cracks could eventually lead to separation of components attended by possible operational interference or a split flap condition.

2. Remove the left and right rear wing root fairings and the left and right flap torque tube access panels. Refer to sketch "A".
 3. Disconnect the push-pull control rods from the flaps by removing the attachment hardware at the inboard flap rib.

4. Refer to sketch "A". Remove the flap bellcrank assembly from the right side of the flap torque tube by disconnecting the hydraulic flap actuator cylinder and the push-pull control rod and removing the bellcrank attachment hardware from the torque tube. Refer to sketch "B" and proceed as follows.

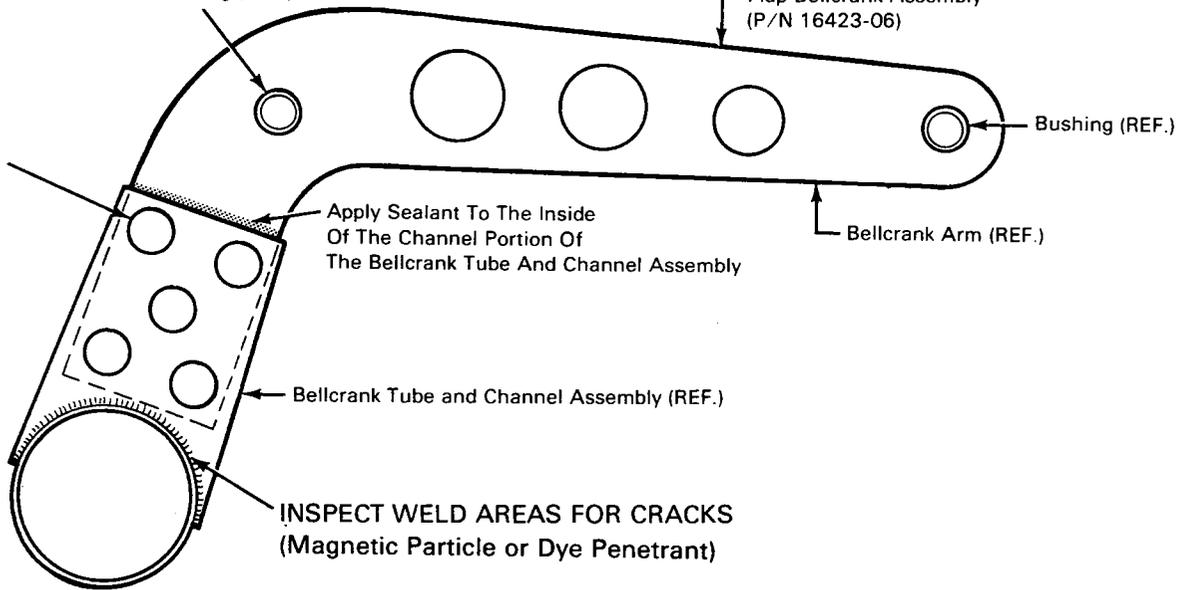
FLAP BELLCRANK DETAIL

- c. Inspect the bellcrank tube and channel assembly, in the weld area, for cracks using the magnetic particle or dye penetrant inspection method as described in the F. A. A. Aircraft Inspection and Repair Manual A. C 43. 13-1A, Chapter 7, Section 3. Also clean and check general condition of bellcrank arm.

- a. Remove the five (5) rivets which attach the bellcrank arm to the bellcrank tube and channel assembly and remove the arm from the channel.
 - b. Remove all paint and corrosion from the inside and outside of the bellcrank tube and channel assembly to facilitate inspection.

- d. If a crack or excessive corrosion is found, replace with new flap bellcrank assembly (P/N 16423-06) as described in the Drilling Procedure for Replacement of Flap Bellcrank Assembly and Flap Horn Assembly on page 3.

- e. If no crack or excessive corrosion is found, reassemble bellcrank as follows:
 1. Apply sealing compound RTV-102 or PRC 1221-B2 (Piper P/N 914 046 - 6 oz. or P/N 914 047 - 2.5 oz.) or equivalent to the inside of the channel portion of the bellcrank tube and channel assembly.

2. Insert the bellcrank arm into the bellcrank tube and channel assembly. Remove excess sealant. NOTE: Assemble arm in proper direction. Refer to sketch "A".

3. Fasten the bellcrank arm to the channel using five (5) rivets (P/N 420 252/MS20470AD6-12).
 4. Prime and repaint the bellcrank assembly.
- NOTE: When Bellcrank, Piper Part No. 16423-00 is reassembled in accordance with Instruction 4, step e, a visual inspection of the bellcrank must be repeated at intervals not to exceed 100 hours time in service after initial inspection of Instruction 4.

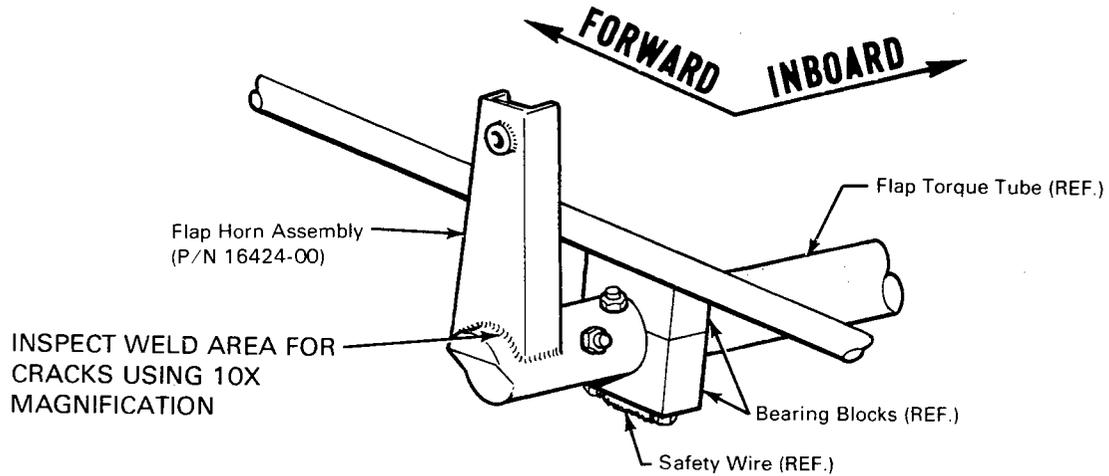
FLAP HORN DETAIL
(View Looking In From Left Side)

6. Refer to sketch "B". Inspect the weld on the flap horn assembly for cracks using 10X magnification.
 - a. If cracks are found, replace with new flap horn assembly (P/N 16424-00) as described in the Drilling Procedure for Replacement of Flap Bellcrank Assembly and Flap Horn Assembly on page 3.

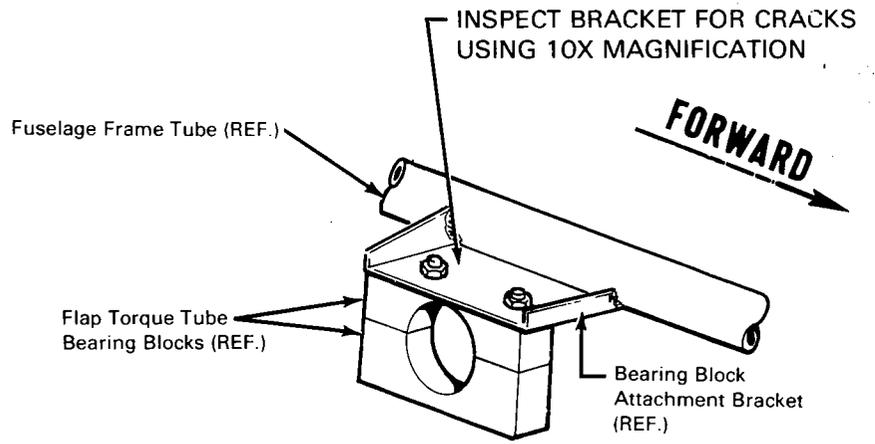
BEARING BLOCK ATTACHMENT BRACKET INSPECTION DETAIL
 (Left Side Shown, Right Side Opposite)

7. Refer to sketch "C". Remove paint and inspect the torque tube bearing block attachment brackets, which are welded to the fuselage frame tube, for cracks using 10 X magnification.

- a. If cracks are found, repair or replace with new bearing block attachment bracket (s) (P/N 28624-03 on left side - P/N 28624-02 on right side). NOTE: New right side bracket assembly (P/N 28624-02) will include the reinforcement gusset being added per step 9. If new right side bracket (P/N 28624-02) is being installed, disregard step 9 in its entirety.
