SERVICE No. 140 BULLETIN

SUBJECT: PA-23 Landing Gear CO₂ Extension System

MODELS AFFECTED: PA-23, Serials 23-1 to 23-246 inclusive

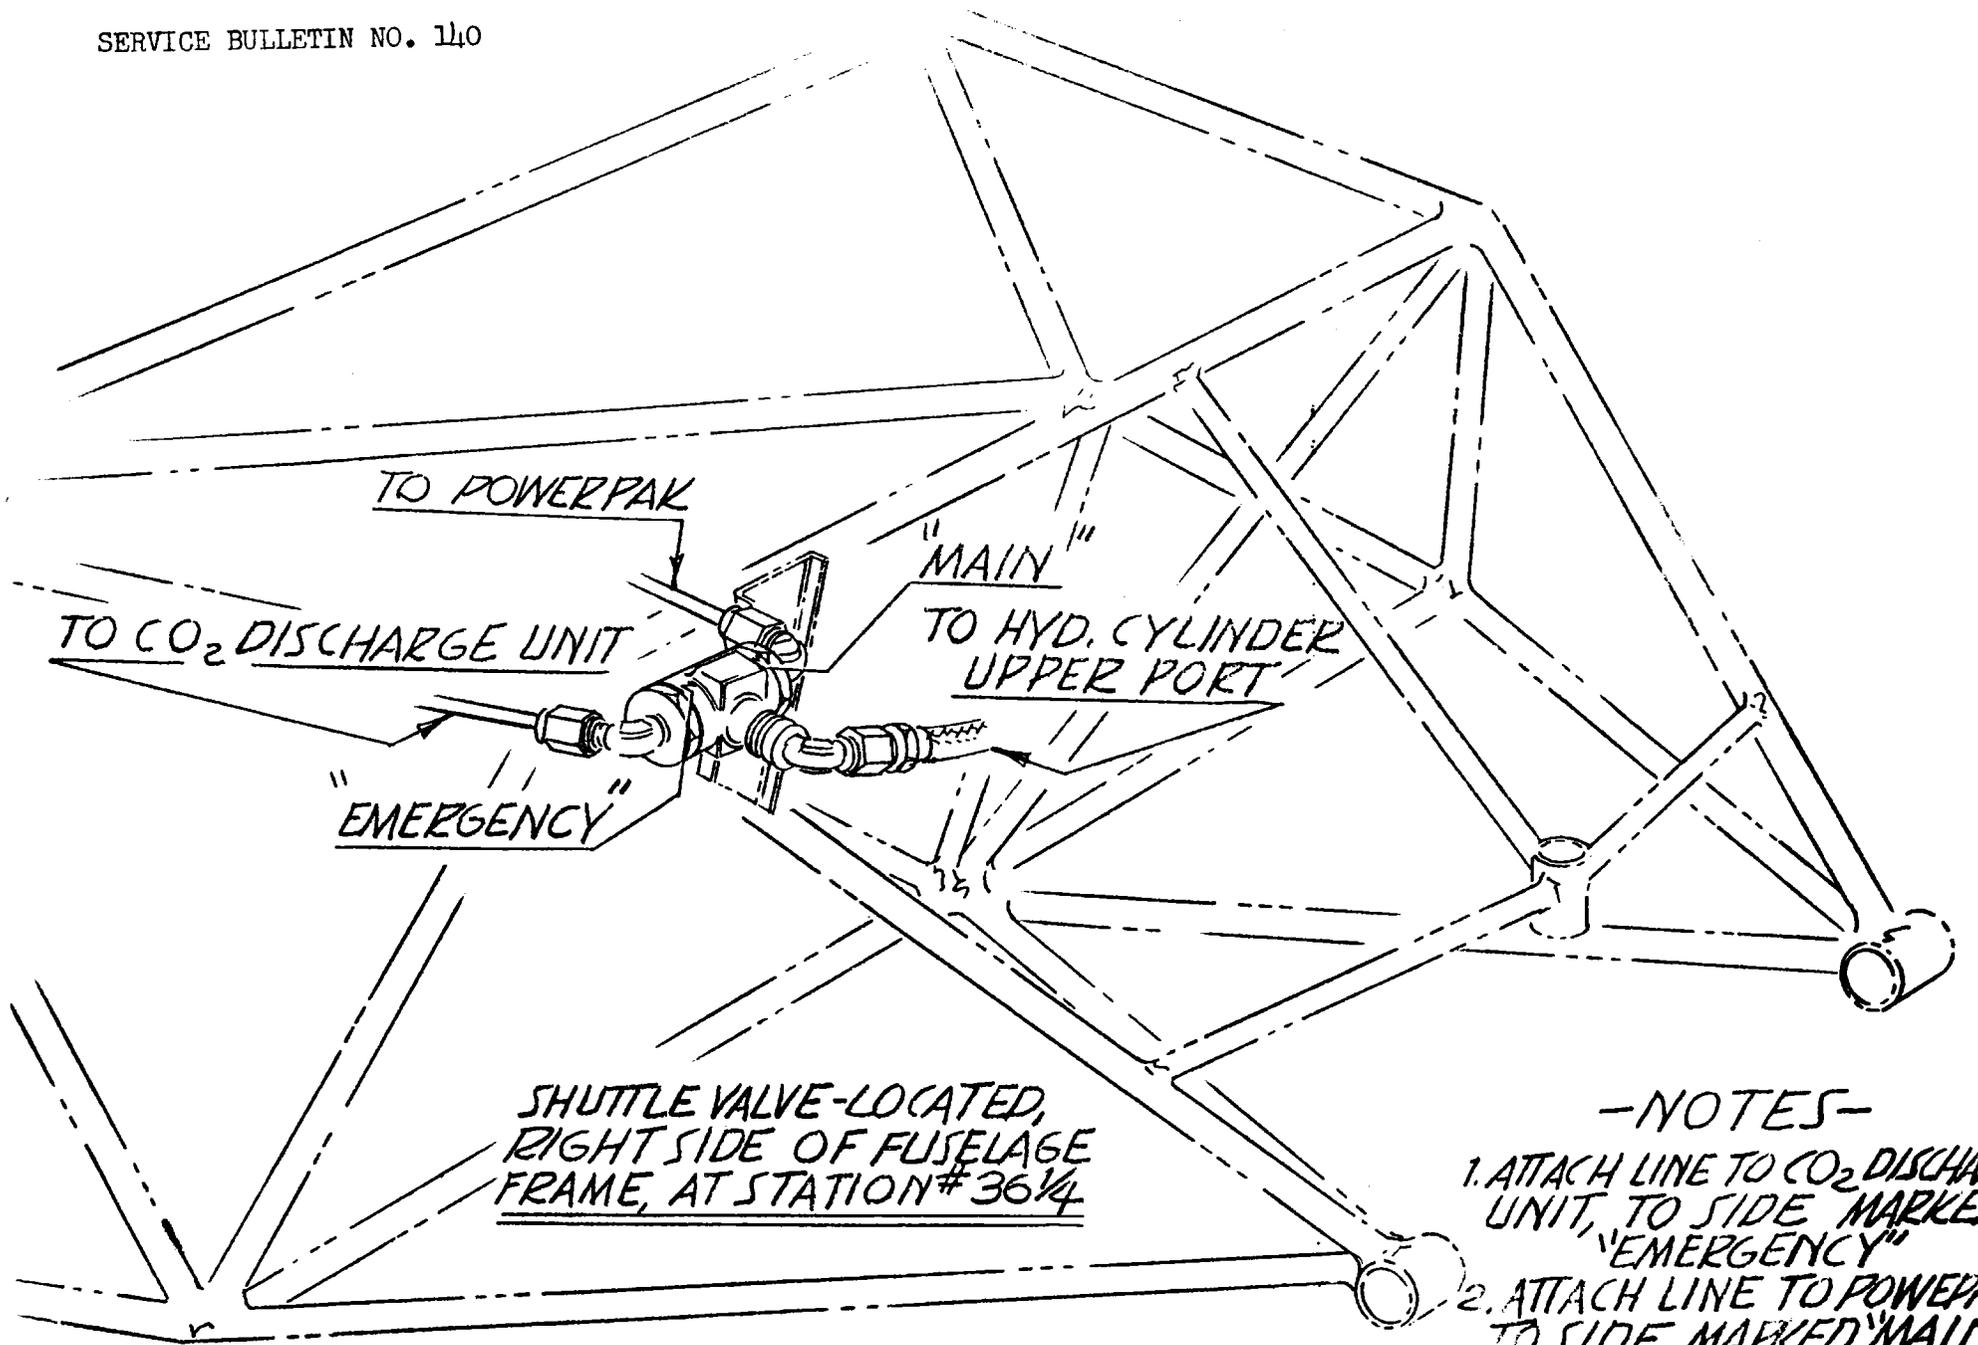
SHUTTLE VALVE-LOCATED,
RIGHT SIDE OF FUSELAGE
FRAME, AT STATION #36 1/4

From operational experience in the subject airplanes it has been found that the nose wheel shuttle valve can become unseated, thereby permitting the CO₂ system lines to be filled with hydraulic fluid locking the landing gear in the down position.

The only means of retracting the gear is to bleed the CO₂ system lines. Therefore, in order to eliminate this condition it is necessary to immediately install one spring loaded shuttle valve at the nose wheel actuating cylinder in accordance with the sketch shown on the reverse side of this bulletin.

NOTE: Care should be taken in installing the new nose wheel shuttle valve to see that the airplane is put on jacks and that the main hydraulic line is attached to the end of the shuttle valve marked MAIN, and the CO₂ line is attached to the end of the shuttle valve marked EMERGENCY.

1. ATTACH LINE TO CO₂ DISCHARGE UNIT, TO SIDE MARKED "EMERGENCY"
2. ATTACH LINE TO POWERPAK TO SIDE MARKED "MAIN"
