SERVICE LETTER

No. 628

Subject: Stabilator Trim Control System Inspection

Models Affected:
PA-23-250 (Six Place) and
PA-E23-250 (Six Place) Aztec

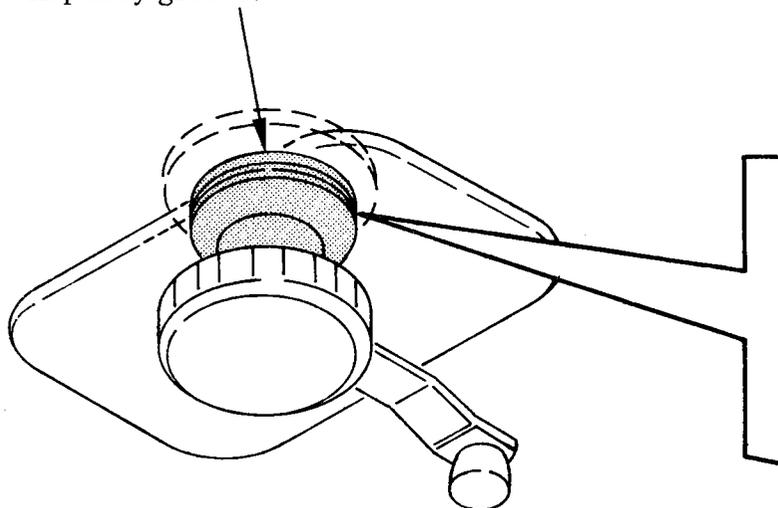
STABILATOR TRIM CONTROL PULLEY

- Instructions:
1. Gain access to the stabilator trim control system as prescribed in the Aztec Service Manual, Section V, Surface Controls.
 2. Inspect stabilator trim cable pulley, Part No. 31970-00, to insure that cable is not "bottoming" in pulley groove -- see attached sketch. Cable "bottoming" in pulley groove is caused by a worn pulley -- replace pulley.

Inspect Stabilator Trim Cable Pulley to insure that cable is not "Bottoming" in pulley groove.

Pulley Worn:
Cable "Bottoms"
in pulley groove.

Serviceable Pulley:
Cable rides above
bottom of pulley
groove.

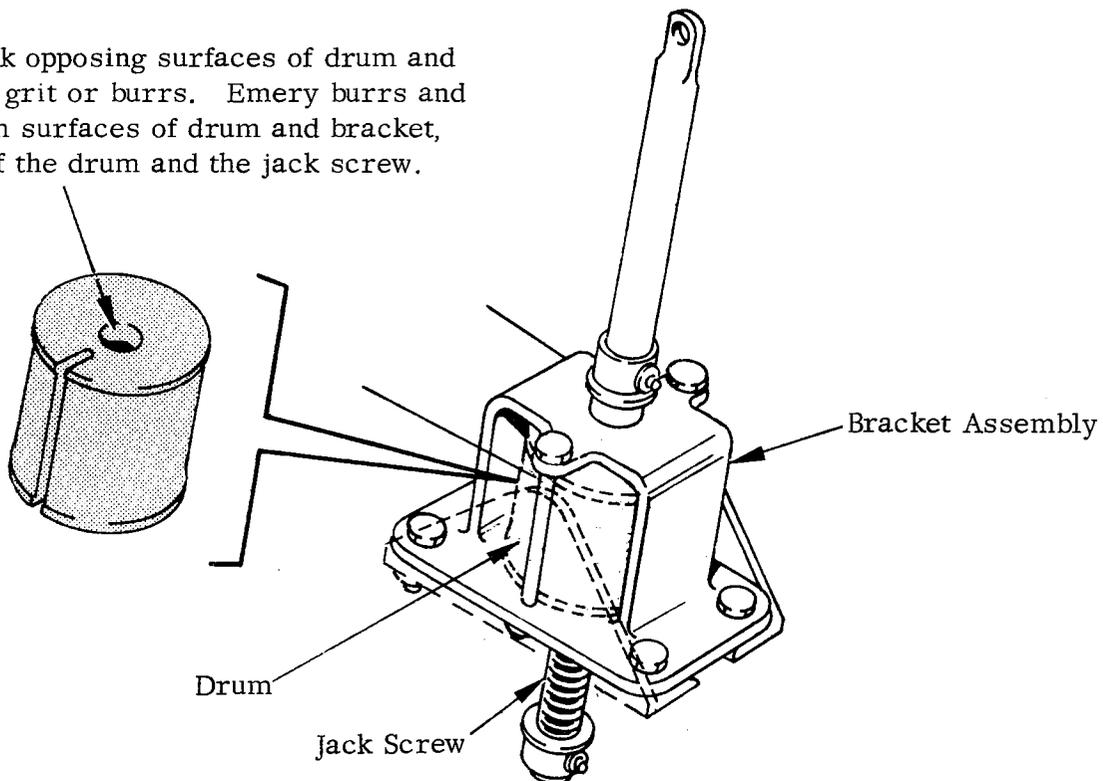
STABILATOR TRIM TAB CONTROL DRUM

- a. Check opposing surfaces of the drum and the drum bracket for dirt, grit, burrs, etc. which, if present, could cause drum binding (see attached sketch).

- b. Brush away dirt or grit with an artist's brush; use MEK sparingly, if necessary. For metal burr removal, emery the burred surfaces. If emery cloth is used, be certain to clean emiered surfaces with an artist's brush and/or MEK.

Remove drum and check opposing surfaces of drum and drum bracket for dirt, grit or burrs. Emery burrs and clean dirt and grit from surfaces of drum and bracket, and from the threads of the drum and the jack screw.
