SERVICE BULLETIN

No. 635

Piper Aircraft Corporation

Subject: Landing Gear Selector Lever Inspection and Replacement

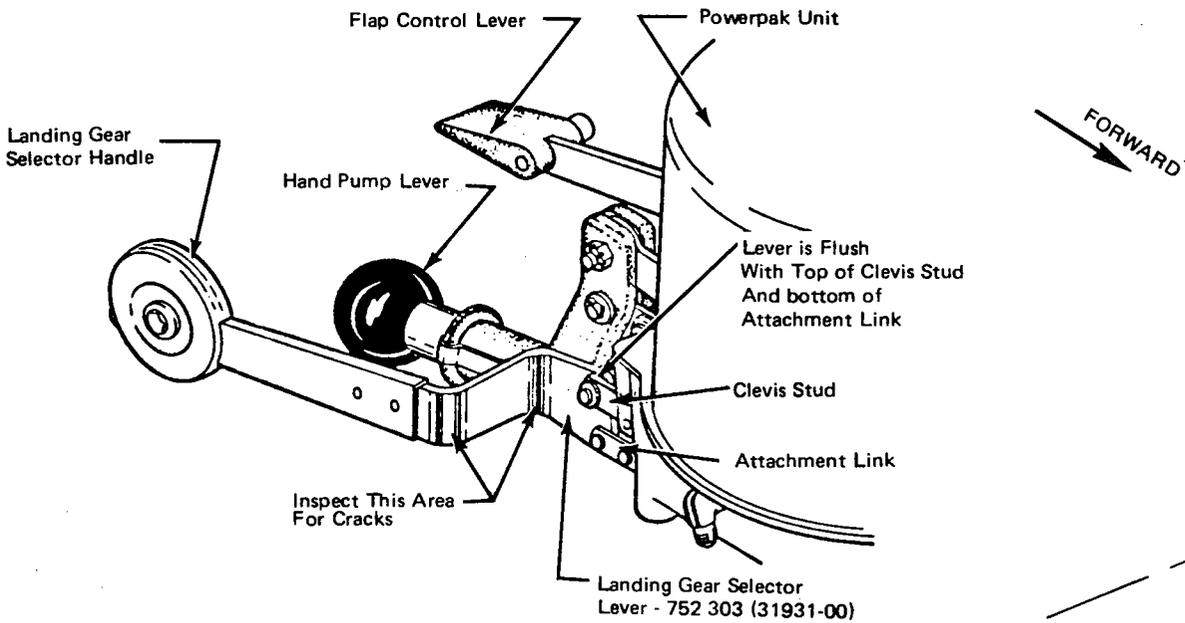
FIGURE 1

Field reports have been received of several instances of landing gear selector handles breaking off as a result of cracks developing at the bend radii of the Gear Selector Lever, Piper Part Number 752 303.

4. If the landing gear selector lever installed is Part No. 752 303 (31931-00), as shown in Figure 1, proceed to step 4a.
 - a. Inspect the two bend radii (See Figure 1) for evidence of cracks, using a 10X magnifying glass.

- b. If no cracks are found, the landing gear selector lever must be inspected at each 100 hours of operation unless landing gear selector lever Part No. 761 213 (28468-02) is installed.

- c. If cracks are found, replace existing landing gear selector lever with new heavy duty lever Part No. 761 213 (28468-02) as shown in Figure 2.
5. Reinstall rectangular access plate on right side of pedestal.

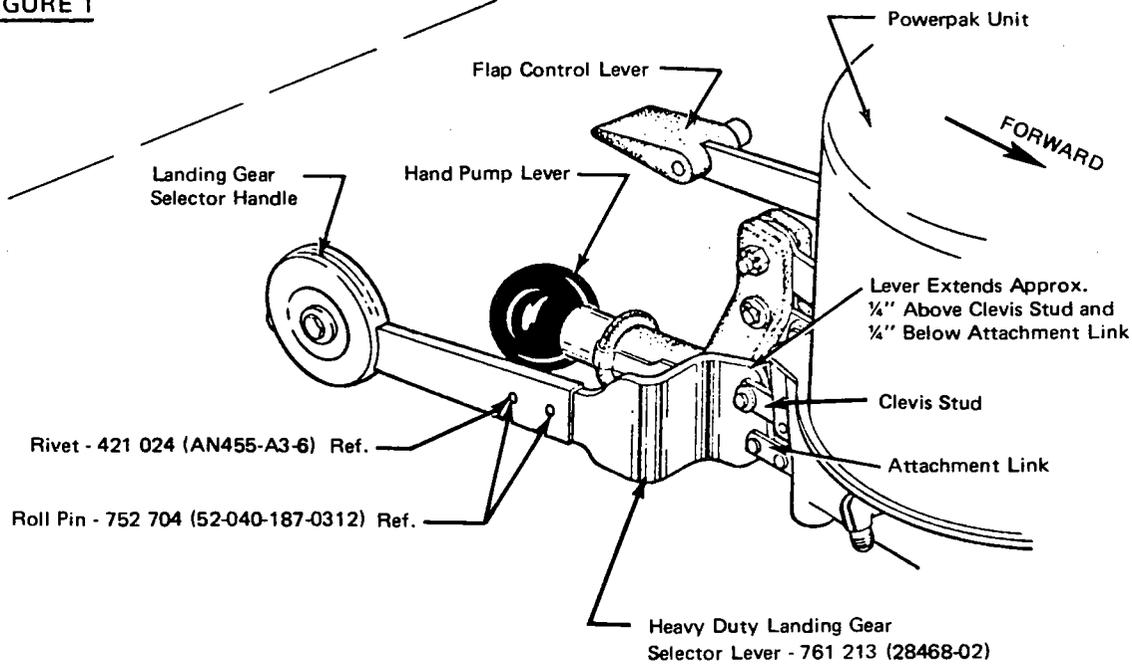
FIGURE 2

3. If the heavy duty landing gear selector lever Part No. 761 213 (28468-02) is installed, as shown in Figure 2, no further action is required. Proceed to step 5.
