Service Letter No. 249

SUBJECT: PA-23 Heater Fuel Line

MODELS AFFECTED: PA-23, Serial 23-1 to 23-224 inclusive

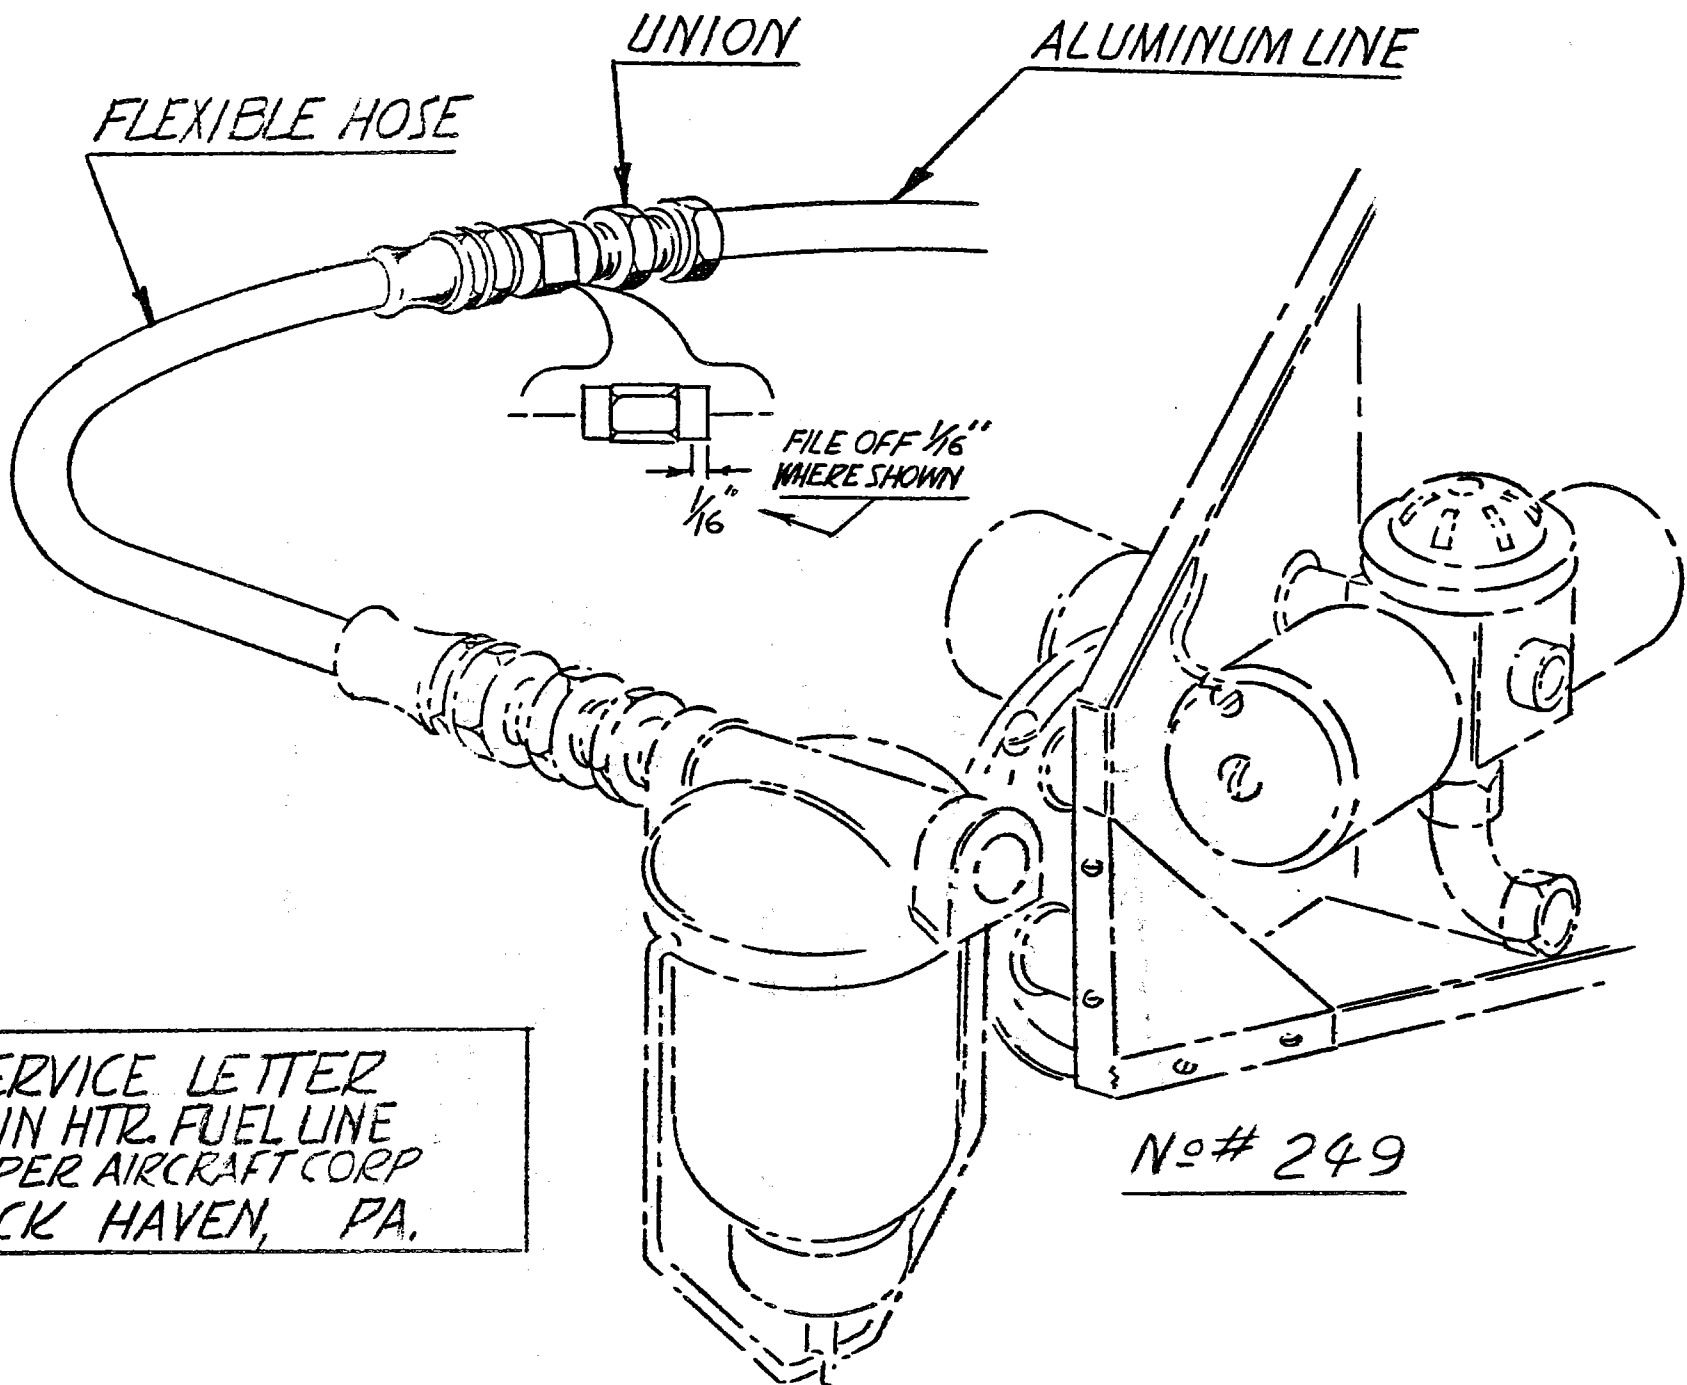
SERVICE LETTER
CABIN HTR. FUEL LINE
PIPER AIRCRAFT CORP
LOCK HAVEN, PA.

The coupling nut on the flexible hose must not butt against the shoulder of the flared tube union which connects the flexible hose and the aluminum line. If this condition does exist, the coupling nut on the flexible line must be modified as shown on the reverse side of this letter.
