**PIPER**

# SERVICE LETTER

**No. 593**

Subject: Harness Connector Plug Strain Relief Hood Installation

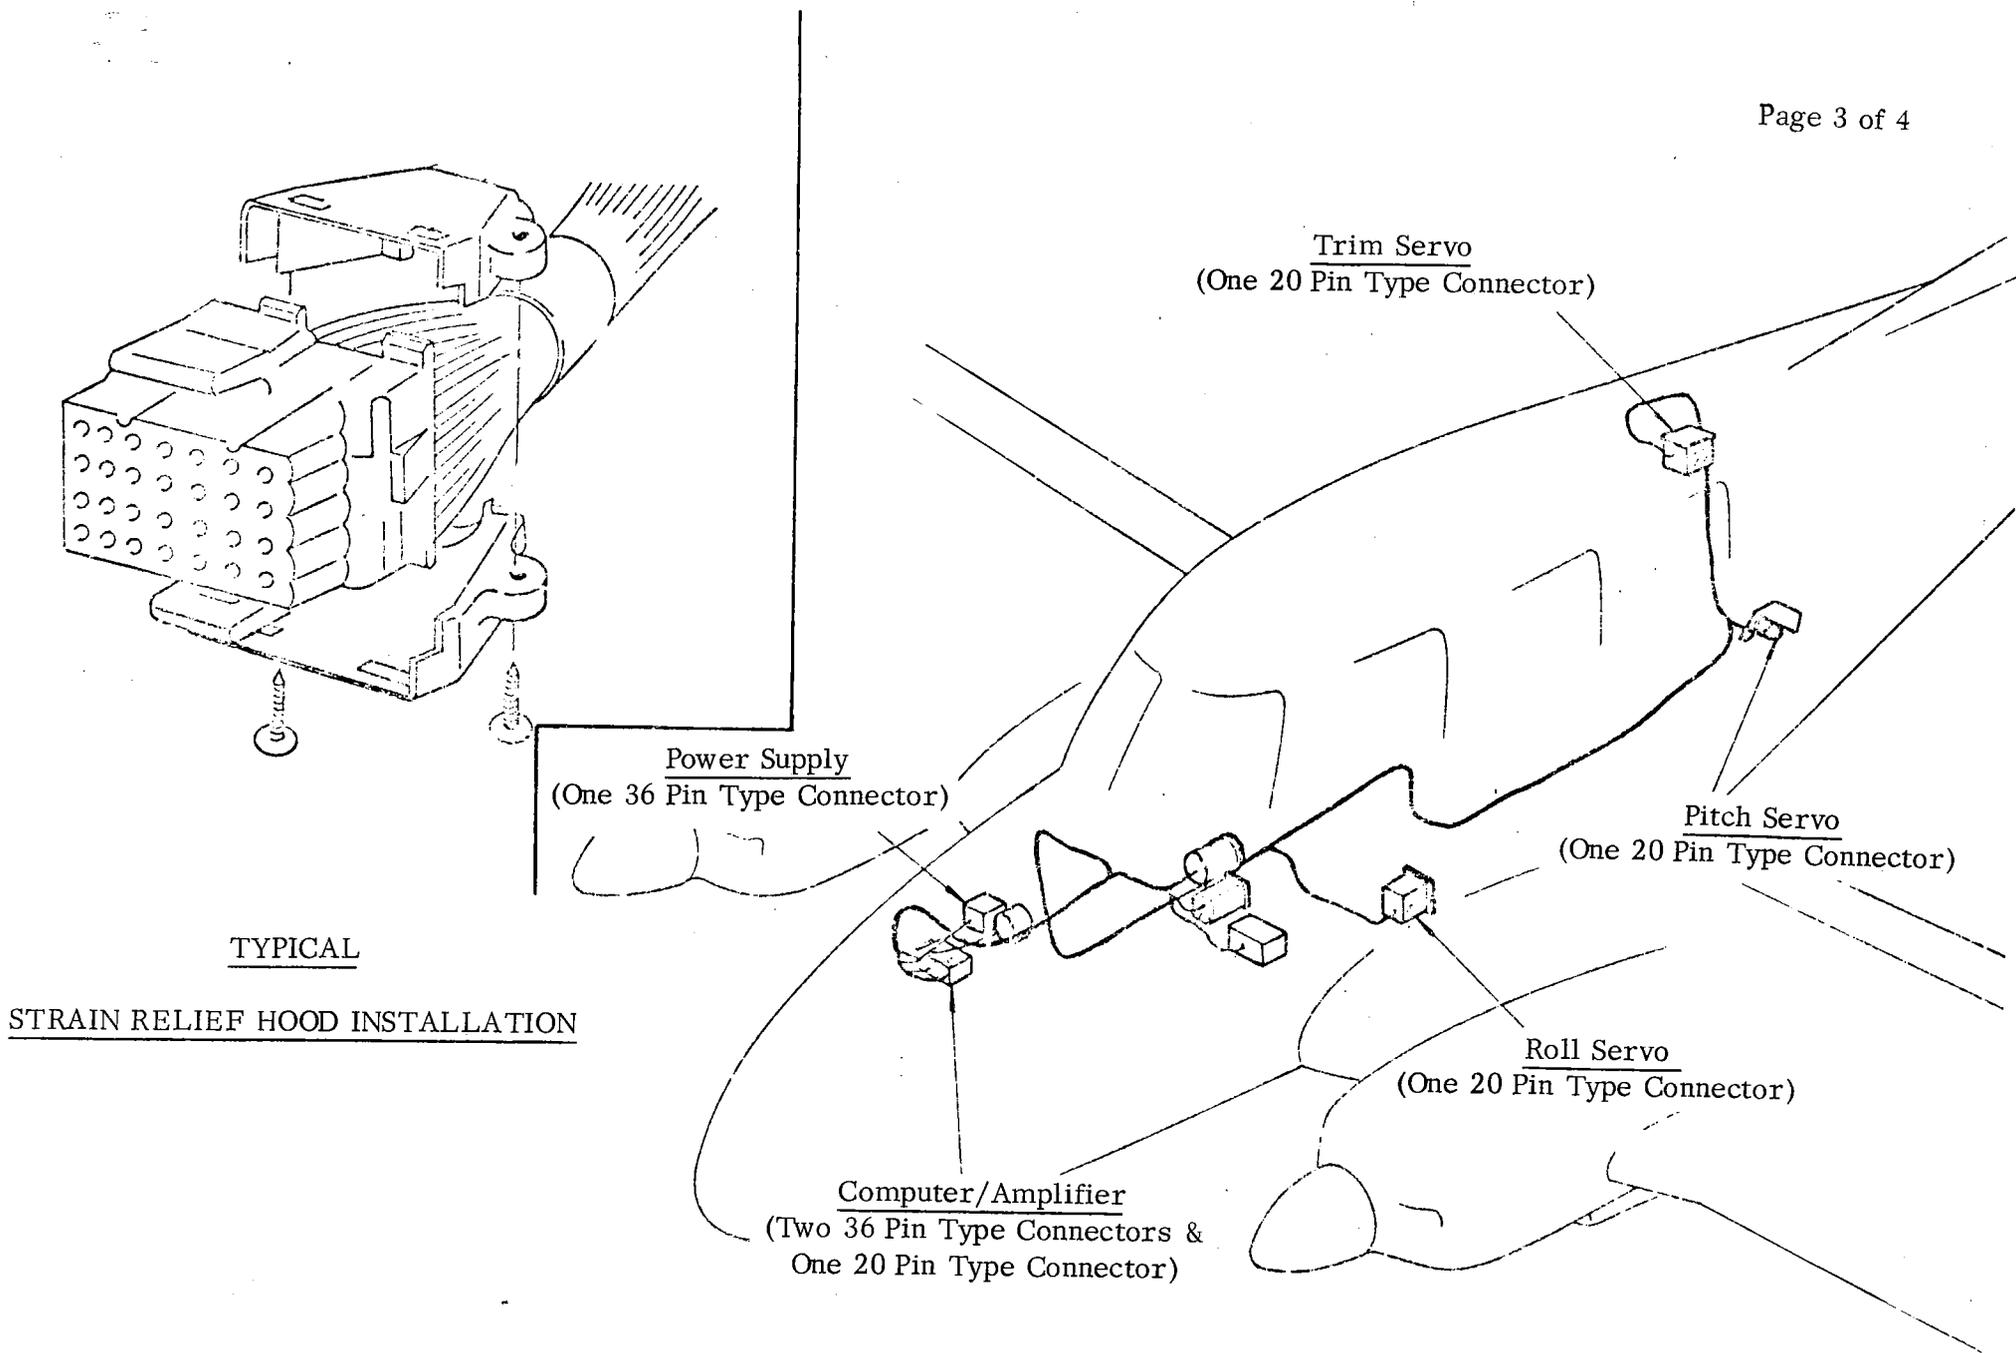
General Illustration of Affected Alt. V and  
Alt. V F/D System Components (Typical PA-23-250 - 6 place)

Purpose: Recent reports relative to the AltiMatic V series automated flight control systems have indicated the need for strain relief at connector plugs.

1. Main harness junction (PA-31 only-located at upper left rear of pedestal).
2. Power supply.
3. Computer Amplifier.
4. Trim Servo.
5. Pitch Servo.
6. Roll Servo.

This Service Letter provides material and instructions to install connector plug strain relief hoods on the harness/connector plug assemblies at the following system component locations:

Instructions: Contained in the following AltiMatic V and AltiMatic V / FD Connector Plug Relief Hood Installation Kits;  
PA-23-250 (Six Place) Aztec-Piper Kit No. 760 555  
PA-31 Navajo-Piper Kit No. 760 556

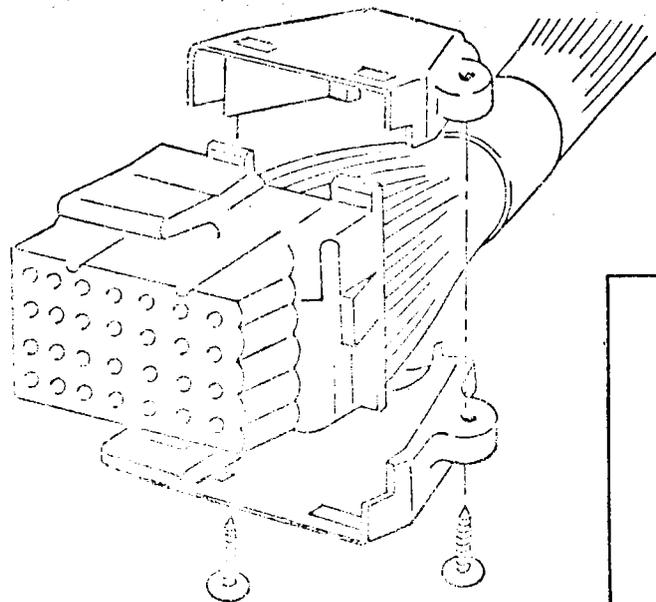
STRAIN RELIEF HOOD INSTALLATION

Computer/Amplifier  
(Two 36 Pin Type Connectors &  
One 20 Pin Type Connector)

Trim Servo  
(One 20 Pin Type Connector)

Power Supply  
(One 36 Pin Type Connector)

Pitch Servo  
(One 20 Pin Type Connector)

Roll Servo  
(One 20 Pin Type Connector)

Harness Assembly (PA-31 only)  
(Four 36 Pin Type Connectors)  
Connectors located at upper left  
rear of pedestal.
