SERVICE BULLETIN

No. 540A

Piper Aircraft Corporation

Inspection and Reinforcement of Stabilator Tip Tube and Weight Assembly.

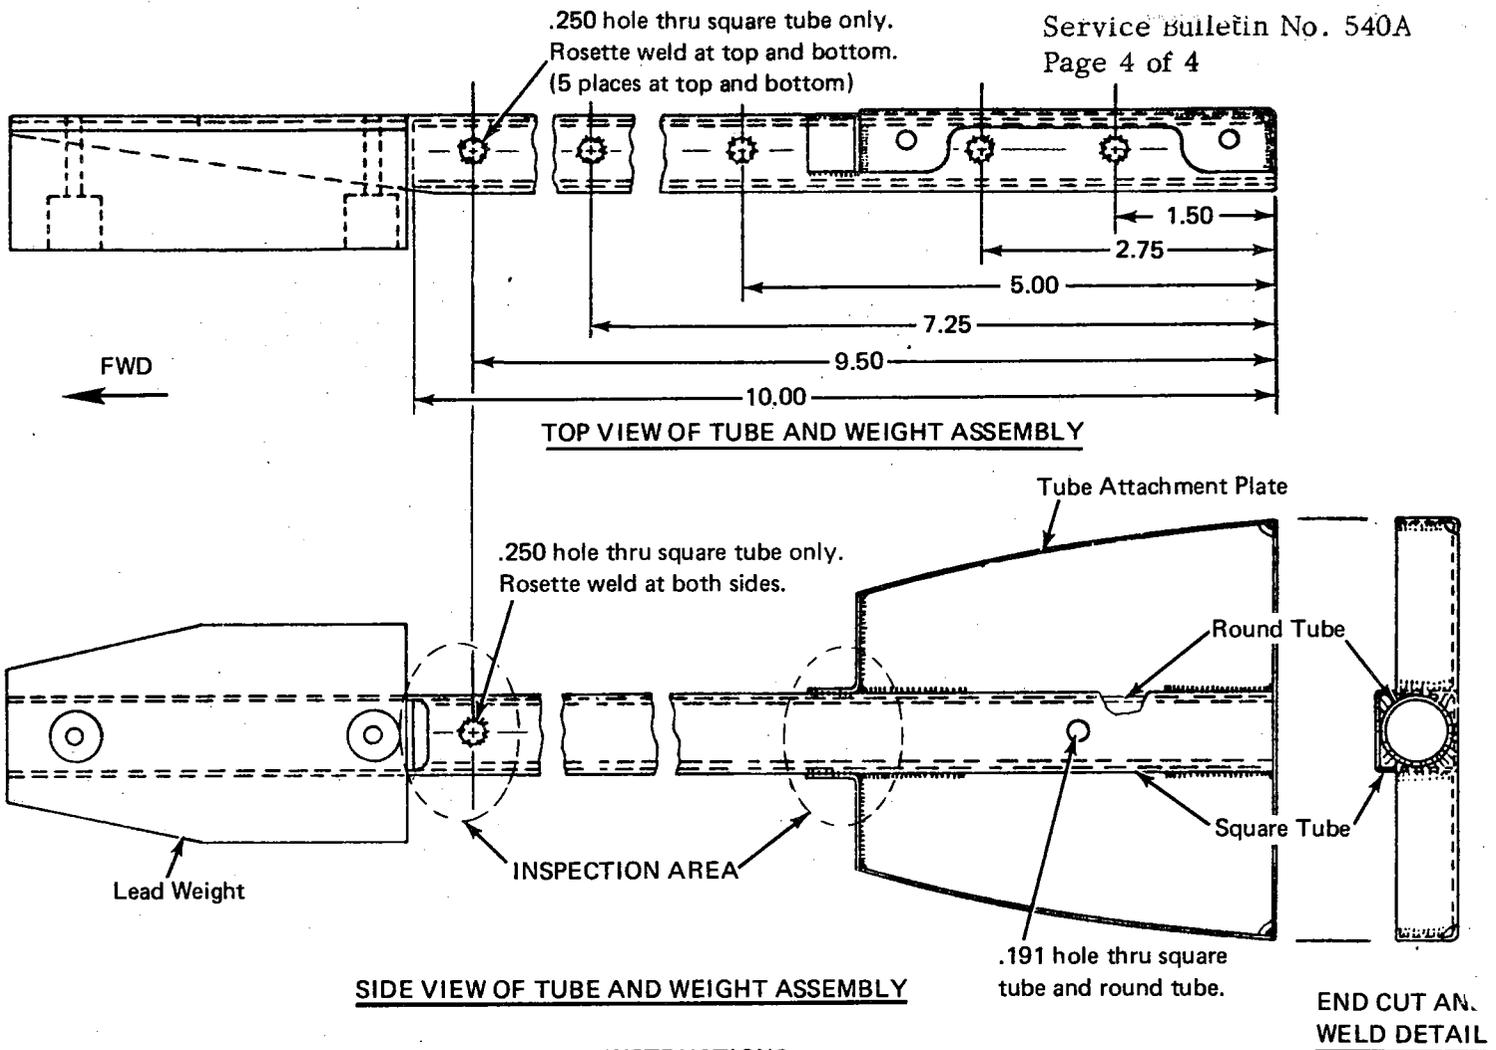
Field reports indicate cracks have been found in the Stabilator Tip Tube and Weight Assembly, Piper Part Number 15658-20. The cracks may be located at either or both ends of the squared tube portion of the assembly (i.e., where the tube joins the weight, and/or where the tube joins the outboard rib attachment plate). If cracks are present - and corrective action not taken - this condition could result in separation of the weight from the tube.

1. Remove tip assembly from left and right stabilators.
2. Using a magnifying glass, inspect the square tube on the tube and weight assemblies to determine if any cracks are evident. See inspection area on above sketch.

4. If any cracks are detected, modify both tube and weight assemblies per the following steps.
 - a. Remove tube and weight assembly (P/N 15658-20) from both stabilators. Retain screws, washers and nuts for reinstallation.

- b. Cut or drill hole in the end of the tube attachment plate to allow a 5/8 inch diameter tube to be inserted into the square tube.
 - c. Locate and drill twelve (12) .250 holes in the square tube as shown.

- d. Insert a 10 inch length of round steel tube (5/8" x .058 Type 4130 Cond. N) into the square tube and rosette weld the tubes together at the twelve (12) .250 holes.

- e. Weld shut the area around the hole in the attachment plate and the tubes.
 - f. Weld all cracks shut that were discovered when inspecting the square tube. CAUTION: If welding cracks near the lead weight, use TIG or MIG weld instead of Oxy-Acetylene.

- g. Drill a .191 hole through the round tube using existing hole in square tube as a guide.
 - h. Clean, prime and paint tube and weight assembly.
 - i. Reinstall the tube and weight assembly to the stabilator using existing attachment hardware.
