Service Letter No. 359

SUBJECT: Modification of Fuel Cell Vent Tubes

MODELS AFFECTED: PA-23 Apaches - Serials 23-1 to 23-1026 inclusive

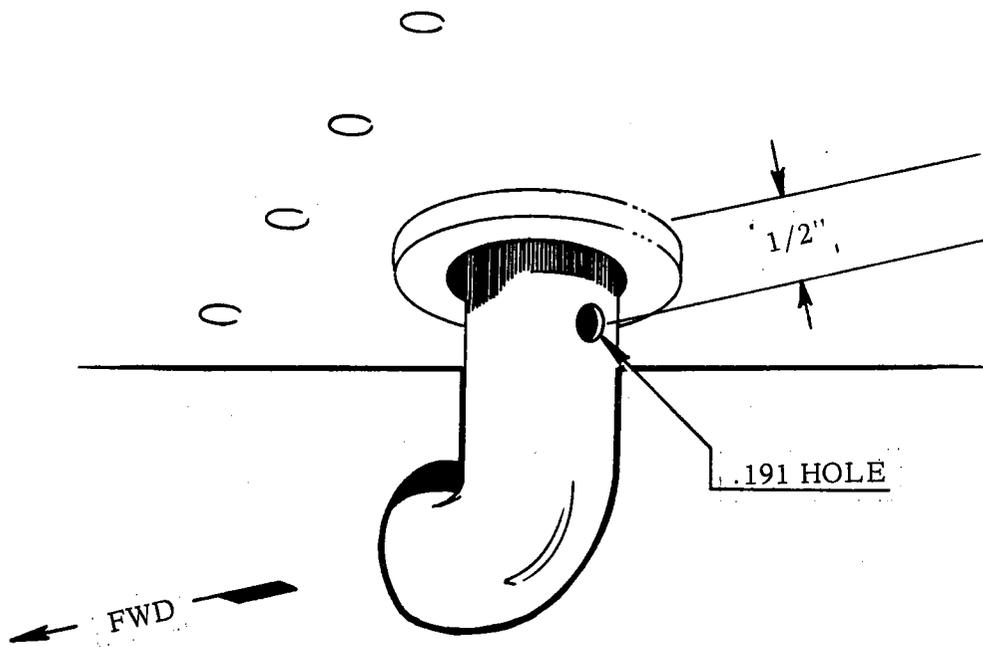
SERVICE LETTER NO. 359

Due to the design of the fuel cell vent tubes on the above mentioned aircraft, there is a possibility of water collecting in the vent tubes and forming ice at freezing levels. Foreign particles may also become lodged in these tubes.

Restriction of the fuel cell venting action may follow.

Drill a .191 hole in the aft side of each vent tube at a point 1/2" down from the bottom wing skin, as shown in the sketch on the reverse side of this Service Letter.
