SERVICE BULLETIN

No. 550

Piper Aircraft Corporation

Engine Control Cable Inspection

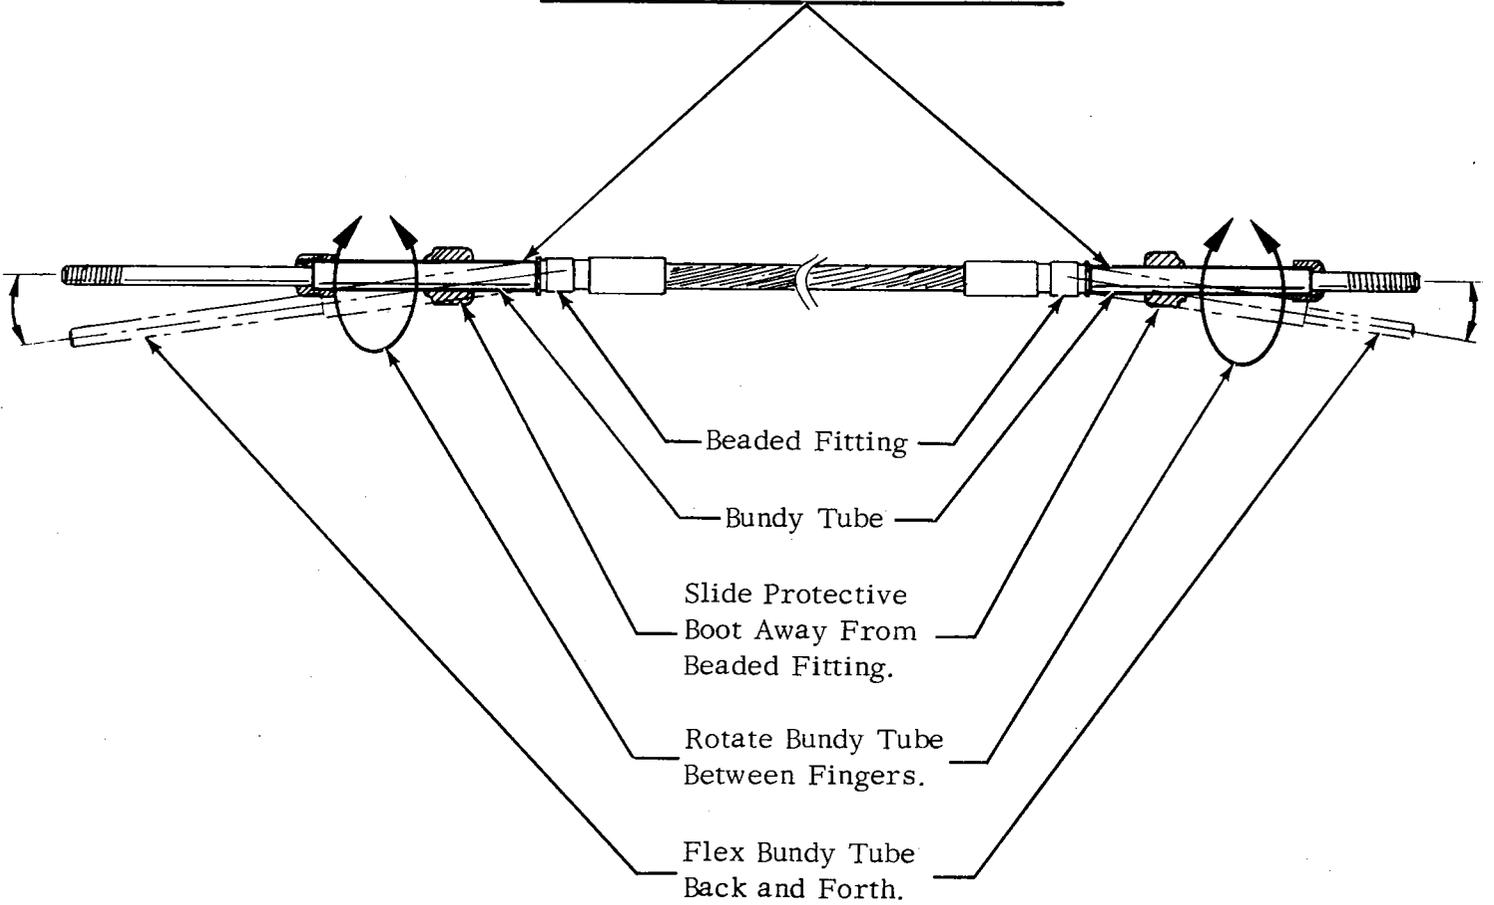
Purpose: During installation of the engine throttle and mixture control cables, in some cases, the cable Bundy Sleeve would crack or break where it enters the cable housing. Investigation revealed that the Bundy Sleeve on certain groups of cables received from the manufacturer had been improperly heat treated. This condition could result in the Bundy Sleeve becoming detached from the cable housing and thereby limiting throttle and/or mixture control cable travel.

Inspect Bundy Tube and Beaded Fitting for Cracks or Other Damage.

5. Visually inspect the Bundy Sleeve in the area of the beaded fitting for cracks or other damage; also, inspect the end of the housing for any damage.
6. If no sleeve cracks are present and there is no damage to the housing, reinstall rubber boot and reconnect cable; insure proper cable/control function.
7. If the Bundy Sleeve is cracked or broken and/or the housing is damaged, replace applicable cable (see Material Required, below).
8. Enter service bulletin compliance data in aircraft log book.
