SERVICE BULLETIN

No. 389

Piper Aircraft Corporation

Subject: Bridle Cable and Bridle Cable Clamp Inspection; AltiMatic V and AltiMatic V Flight Director Series Automatic Flight Control Systems

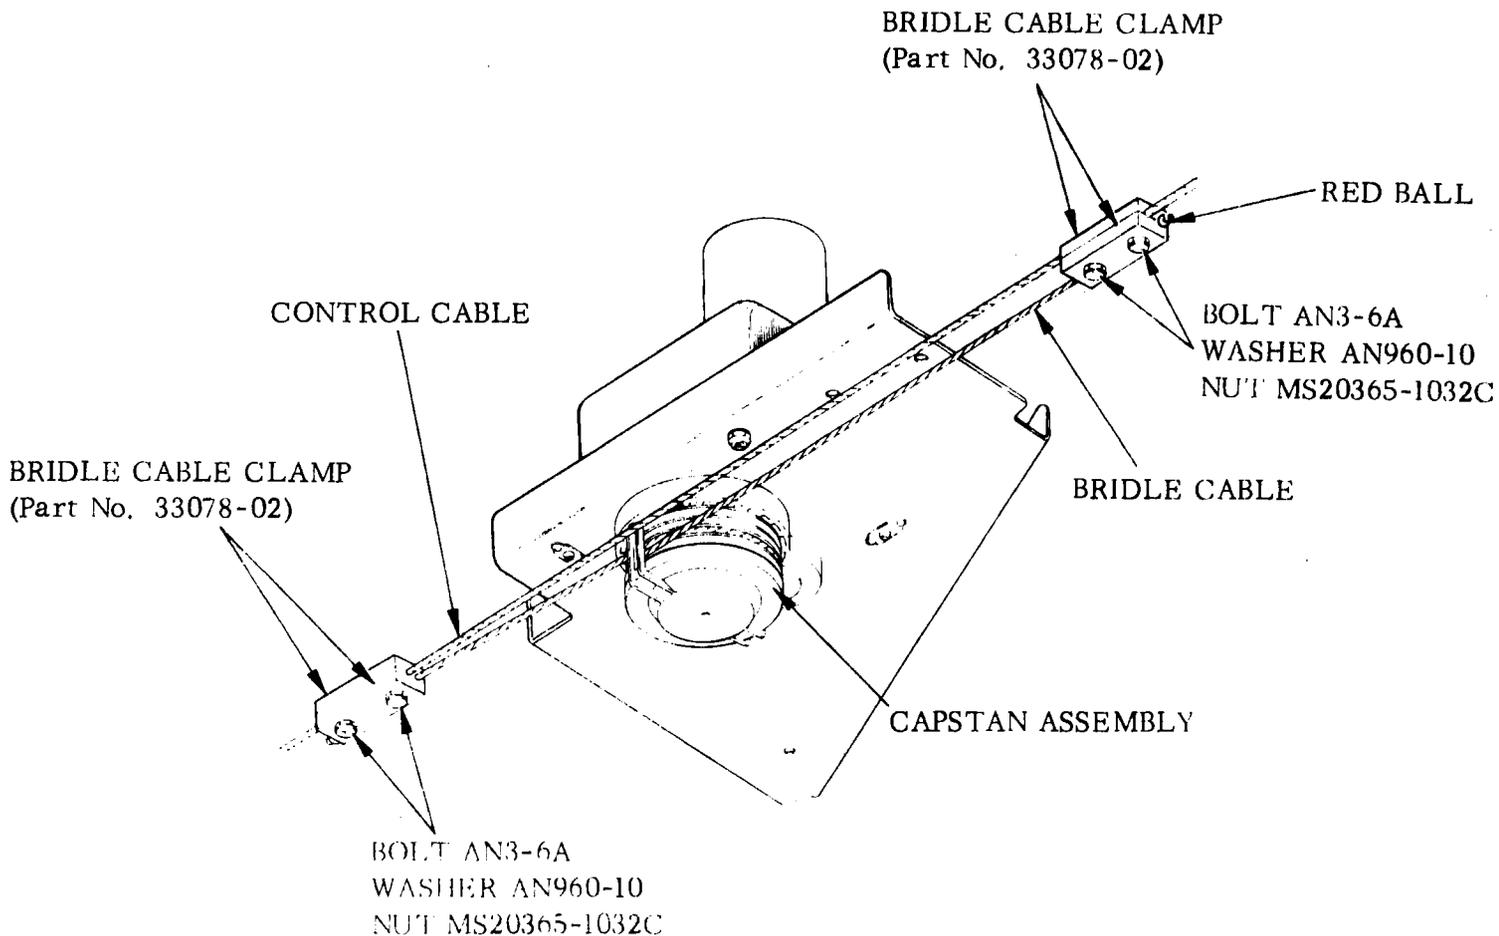
TYPICAL BRIDLE CABLE INSTALLATION
(PA-31 Series Roll Servo Shown)

Purpose: Two reports have been received which described the slippage of the roll servo bridle cable clamps on the above referenced aircraft. It appears possible that the lock nuts used in the bridle cable clamp assemblies may have loosened, causing subsequent bridle cable clamp slippage. This condition can normally be prevented by routine inspections of the Automatic Flight Control System components as specified in the appropriate Piper periodic inspection forms, airplane service manuals and appropriate Automatic Flight Control System service manuals.

2. Loosen the nuts on the bridle cable clamps - one at a time, then retighten; ascertain that the MS20365-1032C nuts retain their self-locking capabilities. If the nuts run freely on the AN3-6A bolts, replace nuts as required.

3. Check the control cable and bridle cable tension in accordance with the Roll and/or Pitch Servo Capstan Assembly Installation Instructions in the appropriate V Series Service Manual.

4. Torque the bridle cable clamp bolts to 23 + 2 inch-pounds, above the nut running torque.
5. Check for proper position and security of bridle cable clamps and for proper servo function as outlined in the roll and/or pitch servo installation instruction in the appropriate V Series service manual.
