SERVICE No. 1035 BULLETIN

Distribution of Textron Lycoming Service Bulletin 529A, "Reprint of Crane/Lear Romec Service Bulletin No. 101SB020, Rev.2"

Service Bulletin No. 529A
(Supersedes Service Bulletin No. 529)
Engineering Aspects are
FAA Approved

FUEL PUMP – Torquing of Relief Valve Cover Screws.

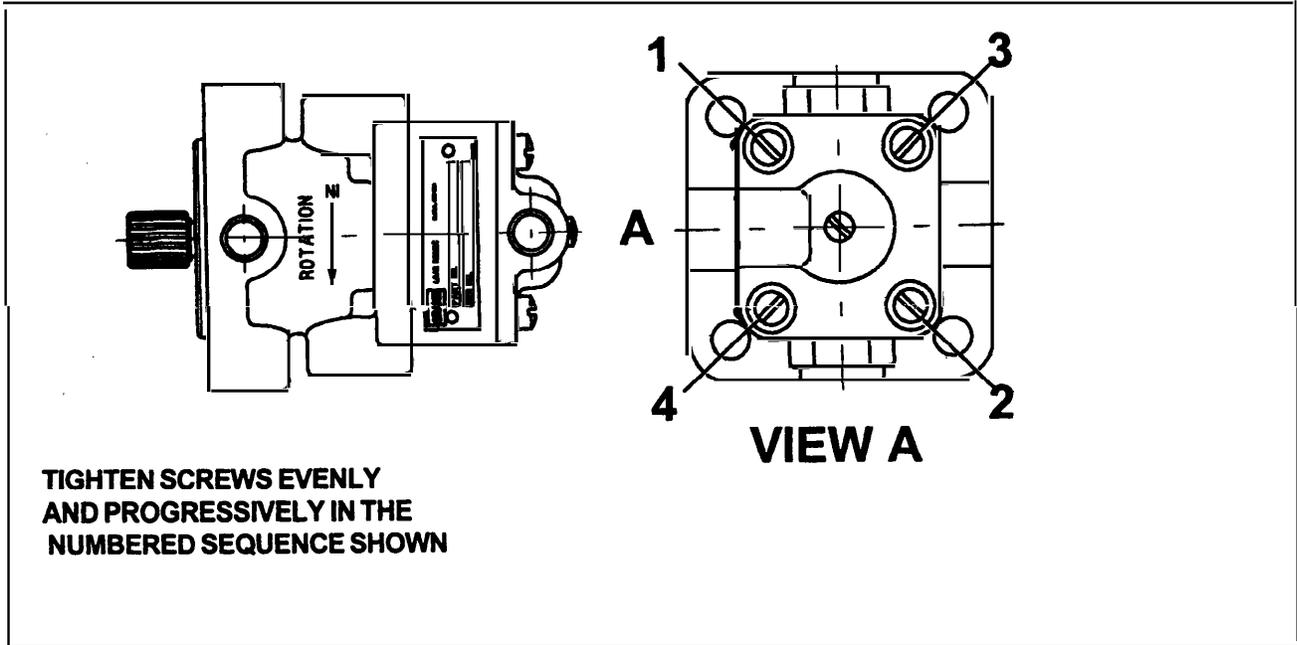
Torquing Sequence – RG17980 Series
Figure 1

There have been field reports of fuel leakage past the relief valve gasket on several of the above listed fuel pumps. This condition could result in a fire hazard, fuel flow fluctuation, or engine stoppage.

- (a) If pump is accessible without removing it from aircraft, the following check shall be performed.
- (b) Visually inspect the split line between the pump housing and relief valve housing for any evidence of noticeable gasket extrusion adjacent to the pump inlet & outlet ports. If there is evidence of noticeable extrusion, replace the pump per applicable engine maintenance instructions.
- (c) Check the tightness of relief valve cap attaching screws using a torque indicating screwdriver. Minimum torque shall be 23 inch-pounds. Torque shall be checked in the tightening direction.
- (d) If screws are loose, remove safety-wire and tighten screws evenly and progressively in a criss cross pattern to 23-25 inch-pounds torque in the sequence shown in figures 1 and 2.

- (a) Visually inspect the split line between the pump housing and relief valve housing for any evidence of noticeable gasket extrusion adjacent to the pump inlet & outlet ports. If there is evidence of noticeable extrusion, replace the pump per applicable engine maintenance instructions.
- (b) Check the tightness of relief valve cap attaching screws using a torque indicating screwdriver. Minimum torque shall be 23 inch-pounds. Torque shall be checked in the tightening direction.
- (c) If screws are loose, tighten screws evenly and progressively in a criss cross pattern to 23-25 inch-pounds torque in the sequence shown in figure 1 and 2.
