Service Letter No. 292

SUBJECT: PA-23 Drag Link Assemblies

MODELS AFFECTED: All PA-23 Apache Airplanes

Adjustment Procedure for the PA-23 Nose and Main Drag  
Link Assemblies, Part Numbers 19060-00 and 19059-00

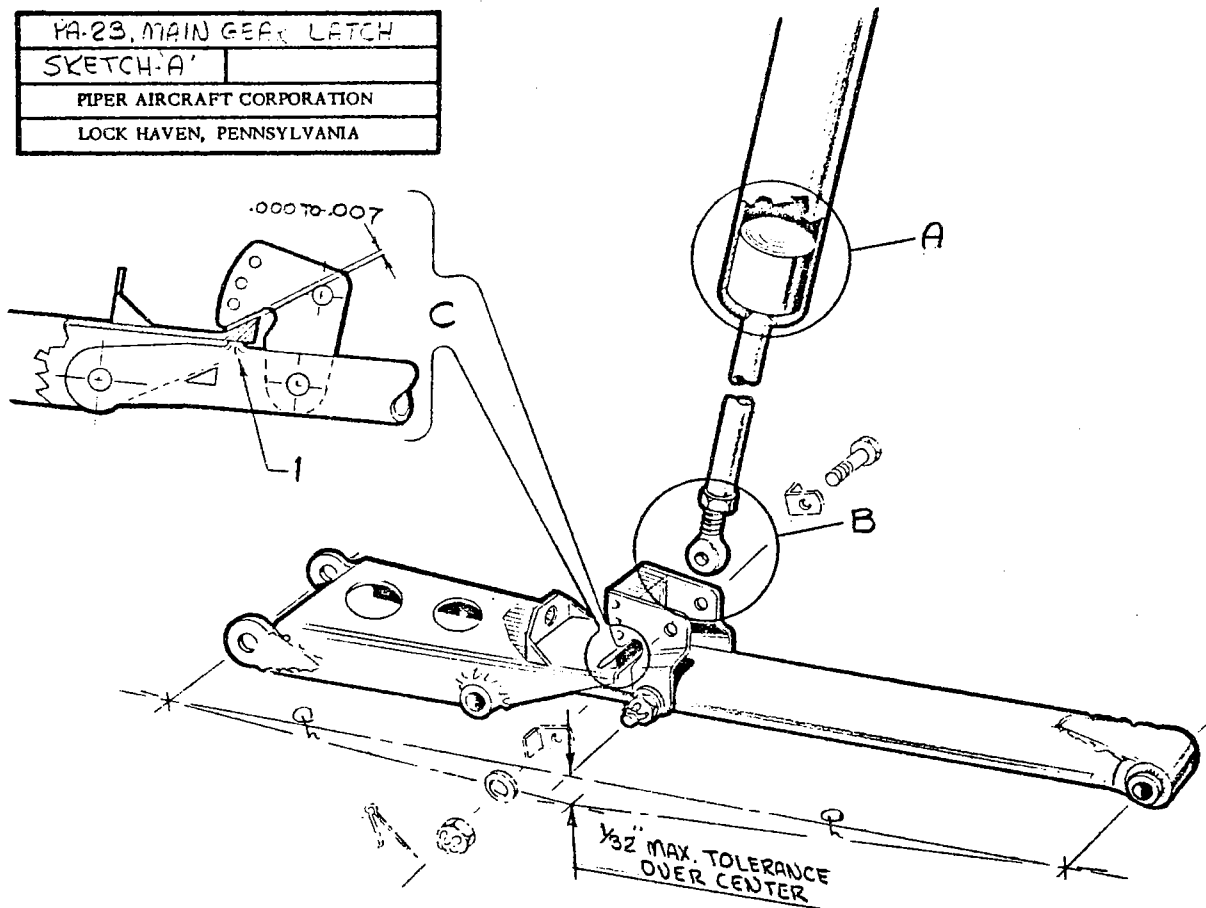
PA-23, MAIN GEAR LATCH	
SKETCH 'A'	
PIPER AIRCRAFT CORPORATION	
LOCK HAVEN, PENNSYLVANIA

It has been brought to our attention that there have been several cases of misadjustment of the landing gear drag link assemblies on the subject airplanes. This misadjustment could cause difficulty in the proper actuation of the landing gear assembly.

3. Remove the bolt connecting the actuating cylinder shaft rod end bearing to the down lock latch. (Item B - Sketch "A" and Item B - Sketch "B".)
4. Double check to make certain that the piston and shaft of the actuating cylinder is in the fully extended position by re-cycling the powerpak manually.

5. Check the alignment of both the main and nose gear drag links referring to Sketch "A" and Sketch "B". The alignment tolerance is  $1/32$ " past center and zero before center.

6. Alignment deviations can be corrected by adding to, or grinding off the weld shown at Point C1.
7. Loosen the lock nut on the rod end bearing at the end of the actuating cylinder shaft and adjust the rod end so that the attachment bolt is a push fit. This adjustment should be made with the latch springs detached and manually holding the latch in the closed position. Tighten lock nut and reassemble springs.
