SERVICE BULLETIN

No. 273

Piper Aircraft Corporation

Subject: Inspection of Turbocharger Tailpipe Clearance to Firewall
(See attached AiResearch Service Bulletin No. 14.1.8)

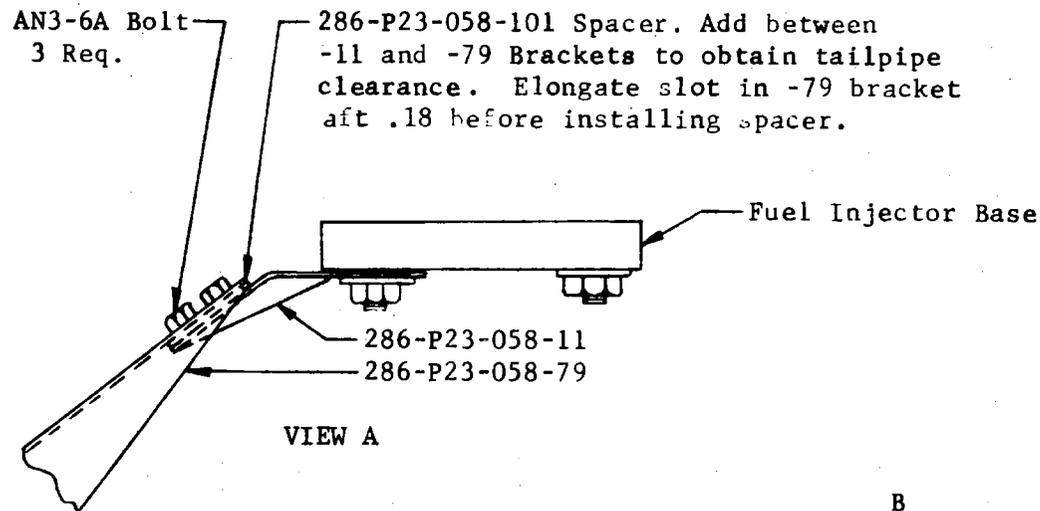
VIEW A

Inspect both the left and right engine tailpipes for sufficient clearance to the firewall. Cowl flap clearance should not be less than .12" or more than .38". The tailpipe should be generally centered in the nacelle cutout and should clear the structure by not less than .50" or more than .75".

1. Remove the cowl scoop and lower cowl(s).
2. Adjust turbocharger to get desired tailpipe clearance as outlined in the AiResearch Maintenance Manual (Ref. Pg. 19). (As revised)
3. If the desired clearance cannot be obtained, install spacer(s) P/N 286-P23-058-101; between the 286-P23-058-11 and -79 brackets to obtain a .75" clearance. See Fig. I on Page 2.
4. After installing the cowling adjust the aft cowl flap to clear the tailpipe by .12 min. and .38 max.

NOTE: Check clearance after running the engines to ensure that the tail pipe is not rubbing the firewall, and that the .50 min. and .75 max. clearance is maintained.

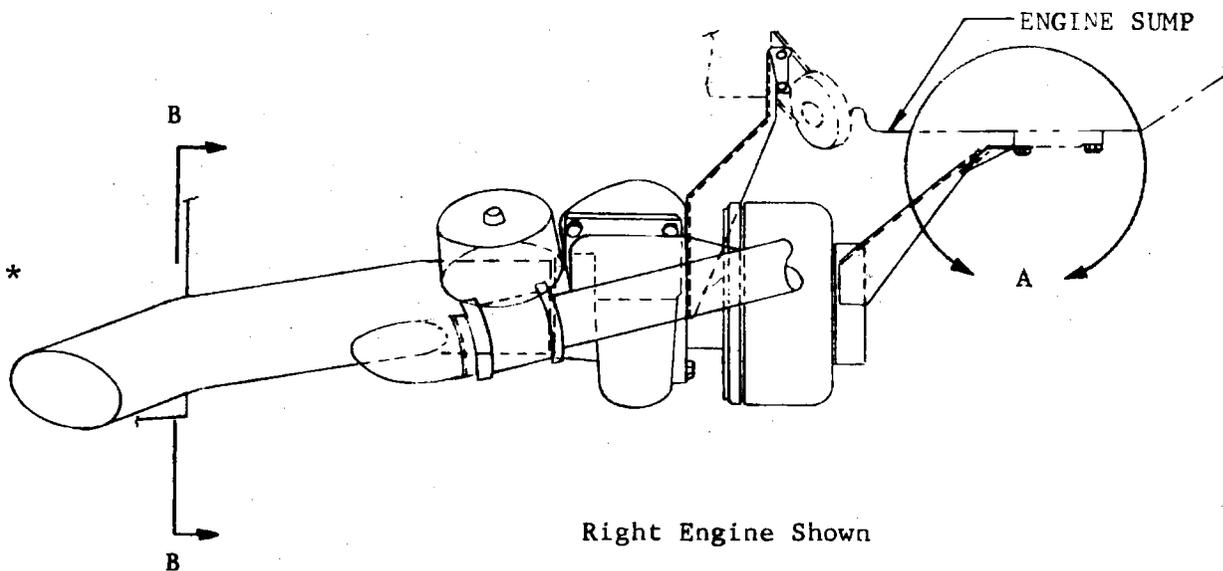
FIGURE I

Right Engine Shown

Left Engine Opposite
