SERVICE BULLETIN

No. 380

Piper Aircraft Corporation

Subject: Revised Pitch Servo Bridle Cable Installation

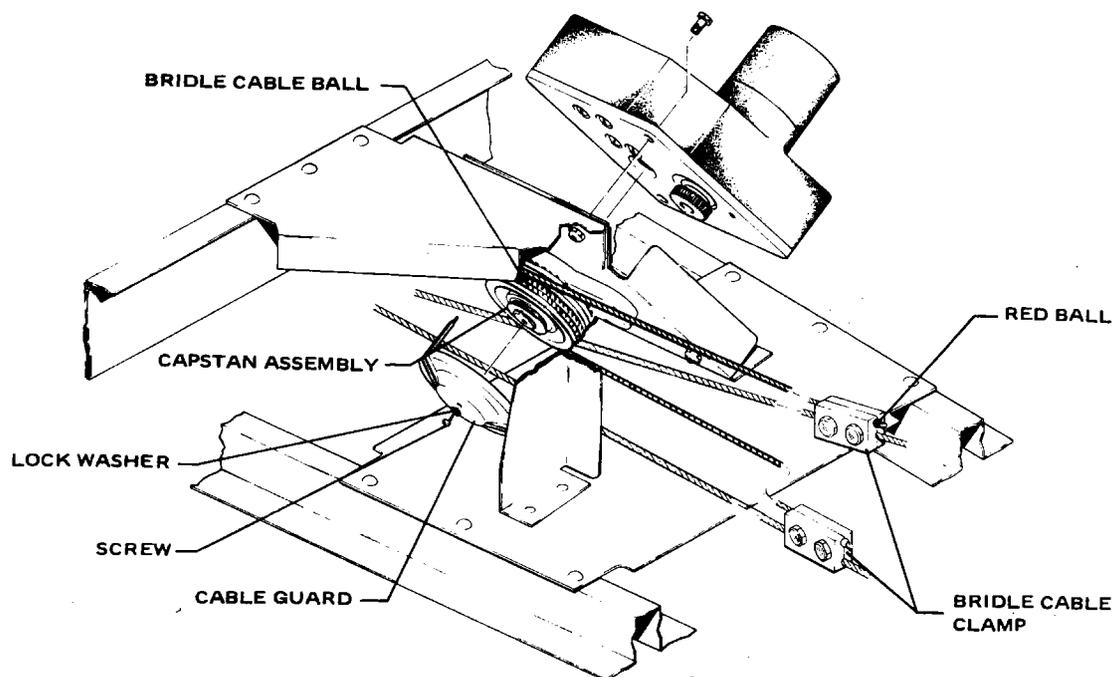
Purpose: The pitch servo bridle cable installation on recent production versions of the above referenced aircraft model has been revised. This revision requires a specified number of wraps of the bridle cable on the pitch servo capstan.

2. Ascertain the number of turns of the bridle cable around the pitch servo capstan. If the bridle cable is wrapped one (1) turn clockwise and one and one half (1 1/2) turns counterclockwise from ball on capstan, no further action is required. If installation is not in this configuration, proceed with step 3.

8. Rotate capstan as required to align the bridle cable ball in the capstan slot as shown in above sketch. Verify bridle cable is wrapped one turn clockwise and one and one half turns counterclockwise from ball on capstan.

10. Check for clearance of bridle cable clamps by moving the control wheel throughout its total travel and verify bridle cable is properly wrapped on the capstan as shown in above sketch.
