VSP-37  
July 7, 1982

VENDOR SERVICE PUBLICATION

Subject: Bendix Service Bulletins 615, 620, 621

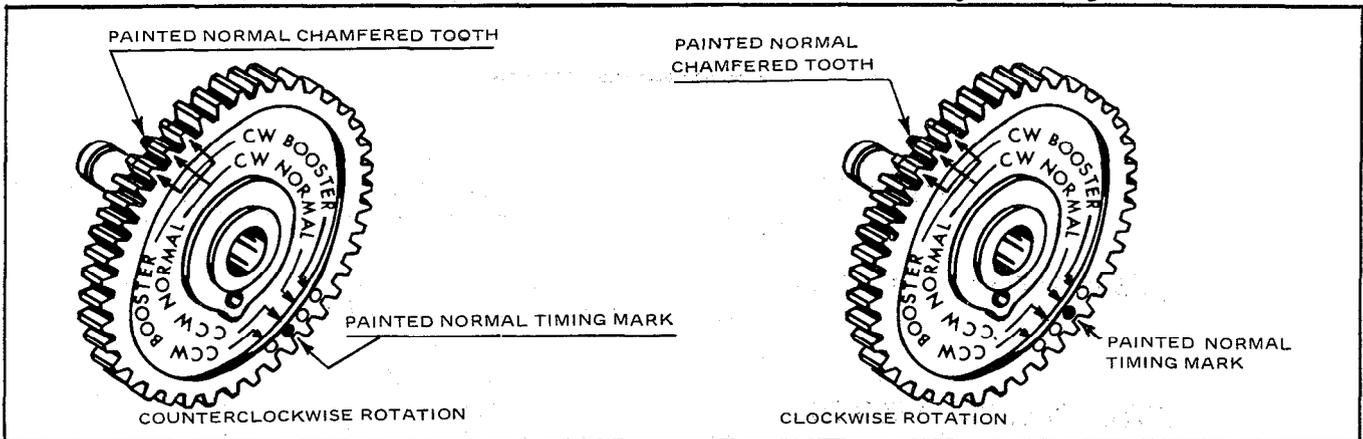
Figure 2. Modified 6 Cylinder Gears P/N 10-157197

1. Follow published procedures for distributor gear removal and inspection.
2. If old distributor gear, P/N 10-157197, which incorporated two different molded timing identification marks was used (see figure 1), proceed as follows:
  - a. Remove paint from booster timing positions with suitable solvent.
  - b. Locate normal timing tooth between CW and CCW booster chamfered teeth and paint this tooth and the applicable inner timing mark with red Dykem or red lacquer in accordance with figure 2 or figure 4 for appropriate gear.

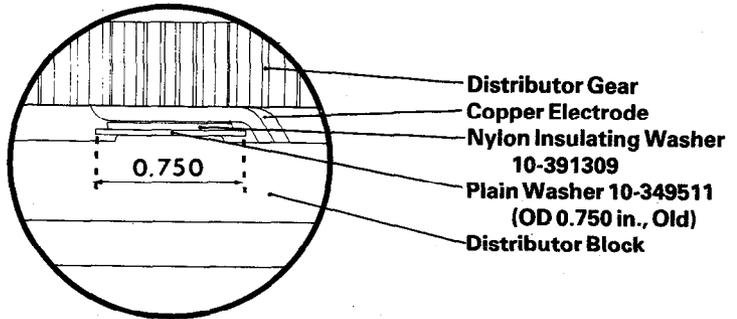
It has been determined that plain steel washer P/N 10-349511 installed on the gear axle between the nylon-insulating washer P/N 10-391309 and the distributor block bronze oil-lite bushing (see figure 2) can cause electrical flash-over in the distributor at altitude. Inspect for compliance as follows:

**Insulated Gear Configuration**  
*(Incorporating 10-357586 Kit parts with incorrect washer.)*  
**Figure 2**

1. Remove the top timing plug.
2. Using a concentrated light beam (a pen light or equivalent) look into the timing hole at the area between the distributor gear and the distributor block parts for existing washer configuration.
3. Current configuration should be as shown in figure 3.
4. Rework magneto whenever configuration is as shown in figure 2.
5. An acceptable configuration is shown in figure 1.

1. Remove magneto from engine.
2. Disassemble as required using procedures described in Bendix Overhaul Manual Form No. L-205-10 for S-20 and L-527-4 for S-200 series magnetos.
3. Remove retaining ring and plain washer. Discard retaining ring. Remove distributor gear from the distributor block.
4. Inspect the distributor block for burning or carbon tracking and serviceability. Replace if defective.
5. Remove old plain steel washer P/N 10-349511 (OD 0.750 in.) and nylon insulating washer P/N 10-391309 from the gear axle.
6. Reinstall nylon insulating washer P/N 10-391309 and install new plain washer P/N 10-606505 (OD 0.562 in.) on gear axle. See figure 4 for assembly order.
7. Wipe distributor gear axle clean, then reinstall it in the block. Place plain washer P/N 10-349511

on axle shaft and secure with new retaining ring P/N 10-92815-37.

8. Turn distributor gear 360° to insure there is no interference with gear rotation.
9. Reassemble the magneto using manuals referenced in step 2.
10. Inspect magneto for proper timing and assembly.

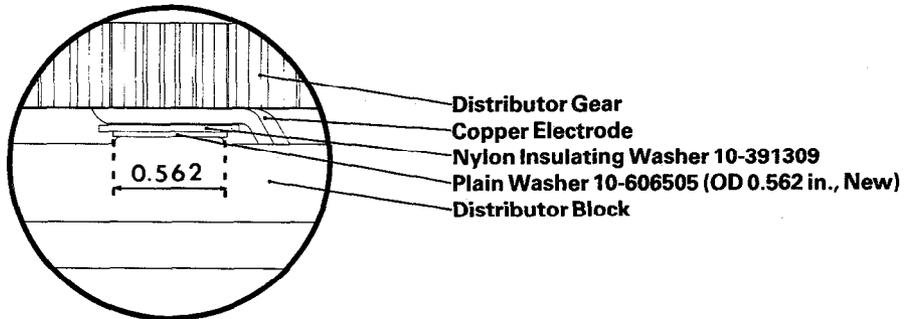
**Current Insulated Configuration**  
*(Incorporating 10-357586 Kit parts with correct washer.)*  
**Figure 3**
