# SERVICE *No.884* BULLETIN

April 8, 1988

Lock Wiring of V-Band Couplings

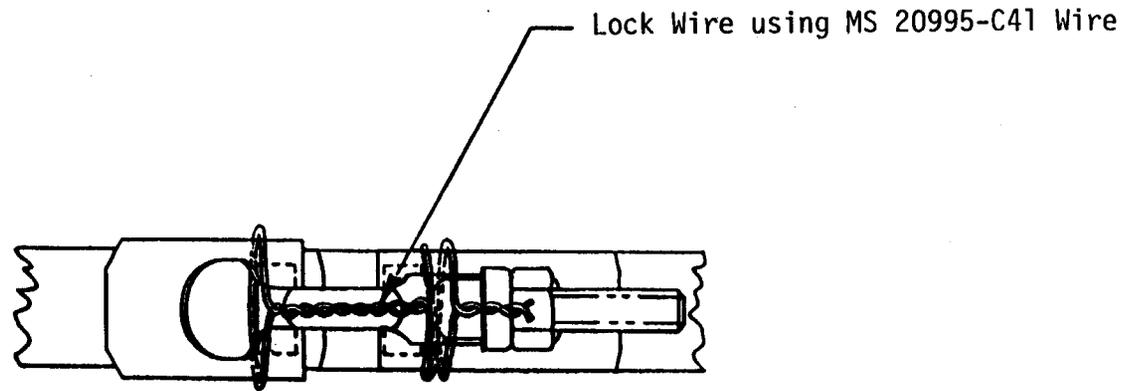
SKETCH "A"

**PURPOSE:** Reports have been received of broken "T-bolts" in the V-Band Couplings used in the exhaust, bleed air and cabin heat systems on various Piper Airplanes. The failure of a T-bolt can allow the coupling to separate, permitting hot exhaust gases or bleed air to be expelled, creating a fire hazard.

1. Refer to the applicable parts catalog to determine the number and location of V-Band Couplings on the affected aircraft.
2. Inspect all V-Band Couplings for security and integrity of T-bolts and lock wire (if installed). Refer to Sketch "A" attached.
3. If lock wire is damaged or missing, lock wire coupling using MS20995-C41 wire. Refer to Sketch "A".
4. Make an appropriate logbook entry of compliance with this Service Bulletin.
