Service Letter No. 336

SUBJECT: Modification of Oil Pressure Lines

MODELS AFFECTED: PA-23 and PA-23-160 Apaches Serials 23-1 to 23-1390 inclusive

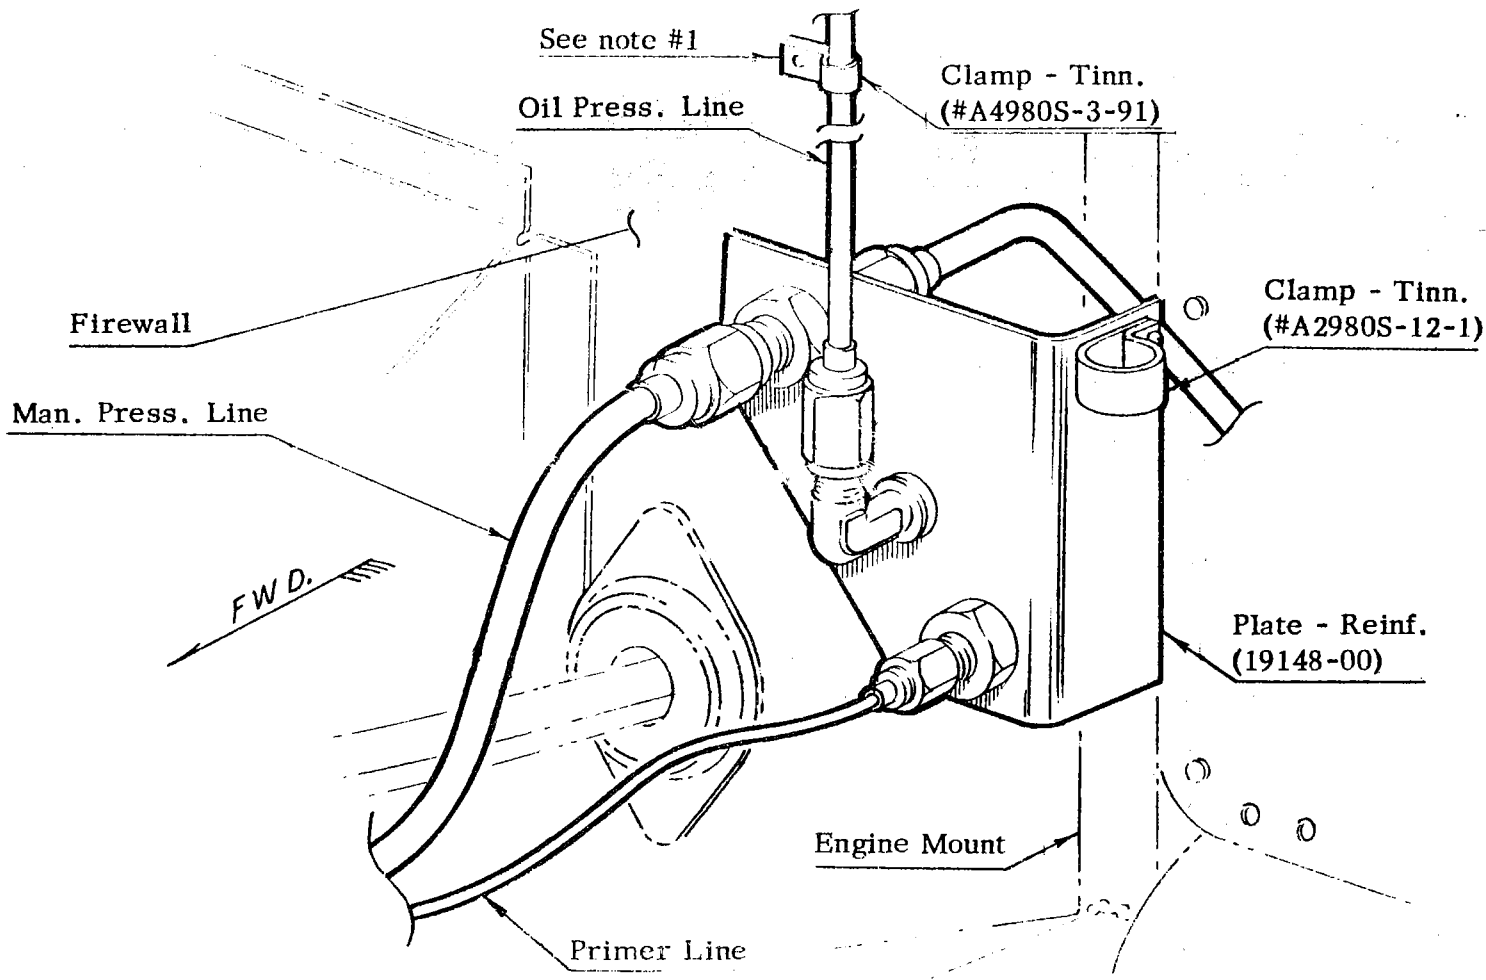
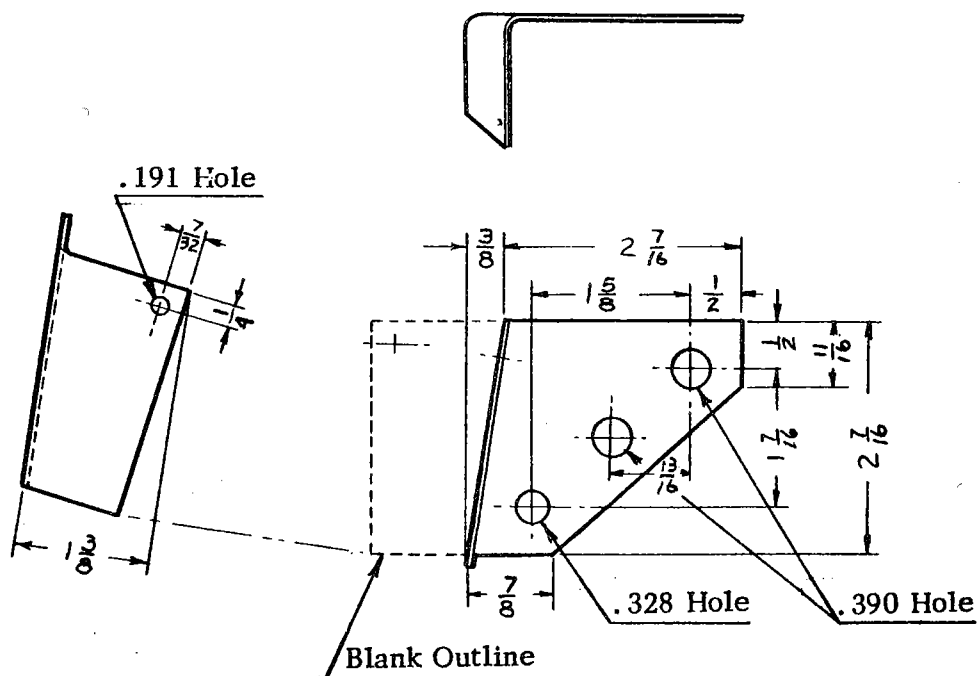
19148-00

This Service Letter is to advise that beginning with Apache Serial No. 23-1221 and up a clamp (Tinnerman [A-4980S-3-91]) was installed on the oil pressure line, each firewall, as indicated on the sketch shown on the reverse side of this Service Letter.

Further modification to each firewall was made, beginning with Serial No. 23-1391 and up. This is also shown on this sketch, plate #19148-00.

These modifications were made to provide a more rigid mounting of the oil pressure line on the firewall and to minimize the possibility of cracks or breaks developing in the oil pressure line flares.

Note #1 - Use existing screw that attaches firewall to engine mount.
