Service Letter No. 235

SUBJECT: Flap Spar and Stabilizer Spar Reinforcement

MODELS AFFECTED: PA-23, serial numbers listed below

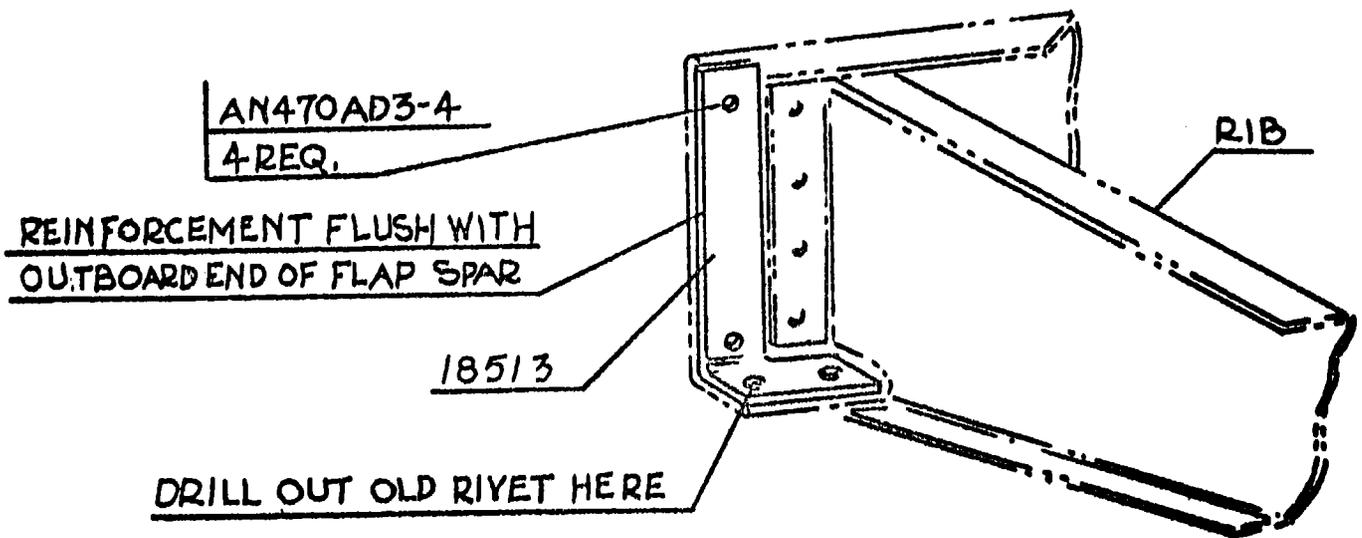
SKETCH-"A"

During the Service Inspection on some of the earlier PA-23 Apaches it was found that the flap spar was cracked at a point where the outboard hinge attaches. On all PA-23's, serial 23-1 thru 23-52 inclusive, it is requested that reinforcement, part number 18513-00, be installed in accordance with Sketch "A" on the reverse side of this letter. One (1) each of part number 18513-00 and four (4) each of rivets AN470-AD-3-4 are available through your nearest Distributor or Dealer at No Charge.
