SERVICE BULLETIN

No. 559

Piper Aircraft Corporation

Subject: Rudder Tail Light Inspection

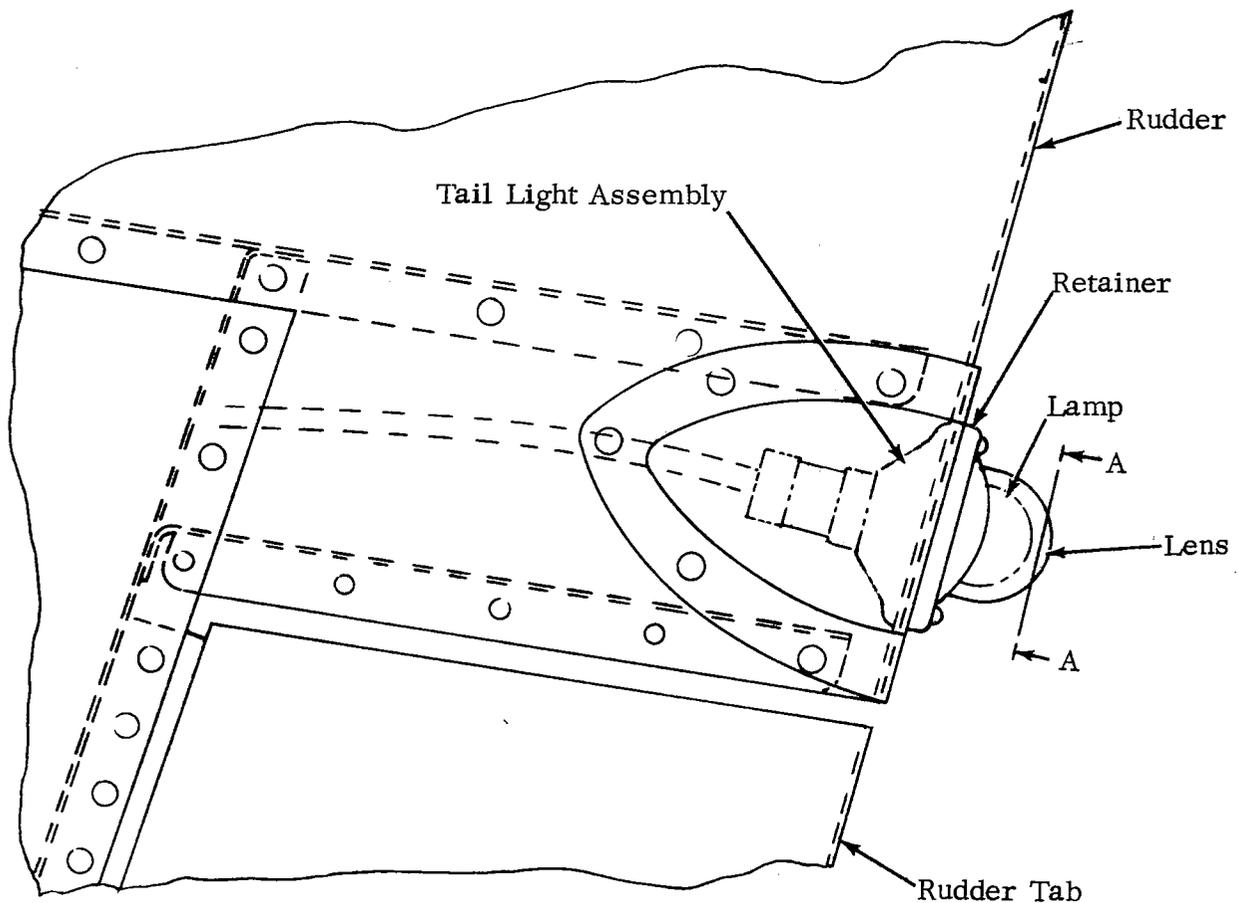
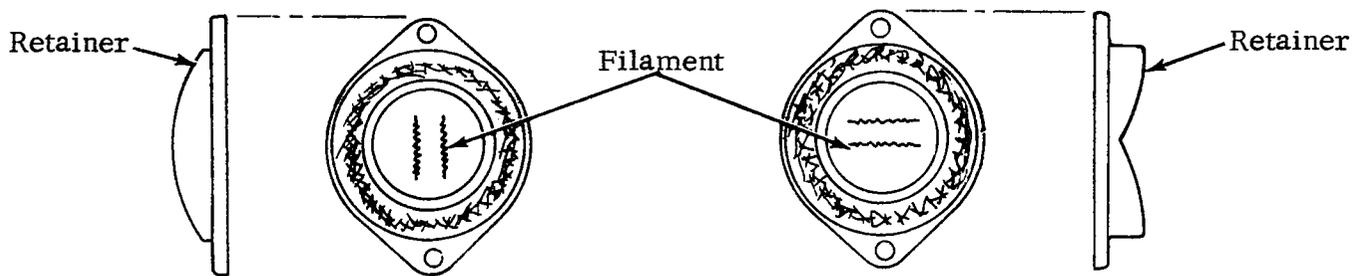
SECTION A-A

Purpose: It has been brought to our attention that the rudder mounted tail light assembly may be installed incorrectly on the above referenced group of aircraft; this condition causes an improper light arc, or "sweep" - as specified in the applicable FAR, due to the position of the lamp filaments with respect to the adjacent retainer shield (see attached sketch/instruction data for an illustration of this condition).

View of Correct Unit

View of Incorrect Unit

1. Remove tail light retainer and lens from rudder by removing the two screws.
2. Inspect lamp to determine if filaments are in a vertical or horizontal position and inspect retainer to determine if it is formed to shield both sides or top and bottom of lamp. Refer to Section A-A for views of correct and incorrect units.
 - a. If filaments are in a vertical position, and retainer is formed to shield both sides of lamp, correct tail light assembly is installed. Reinstall lens and retainer.
 - b. If filaments are in a horizontal position, and/or retainer is formed to shield top and bottom of lamp, incorrect tail light assembly is installed and must be replaced with a new assembly, Piper part no. 472 956.
3. Make proper logbook entry of Service Bulletin compliance.
