Piper Aircraft Corporation

November 17, 1971

Engine Controls Support Bracket Assembly Inspection

PA-23-150 and PA-23-160 Apache
PA-23-250 Aztec

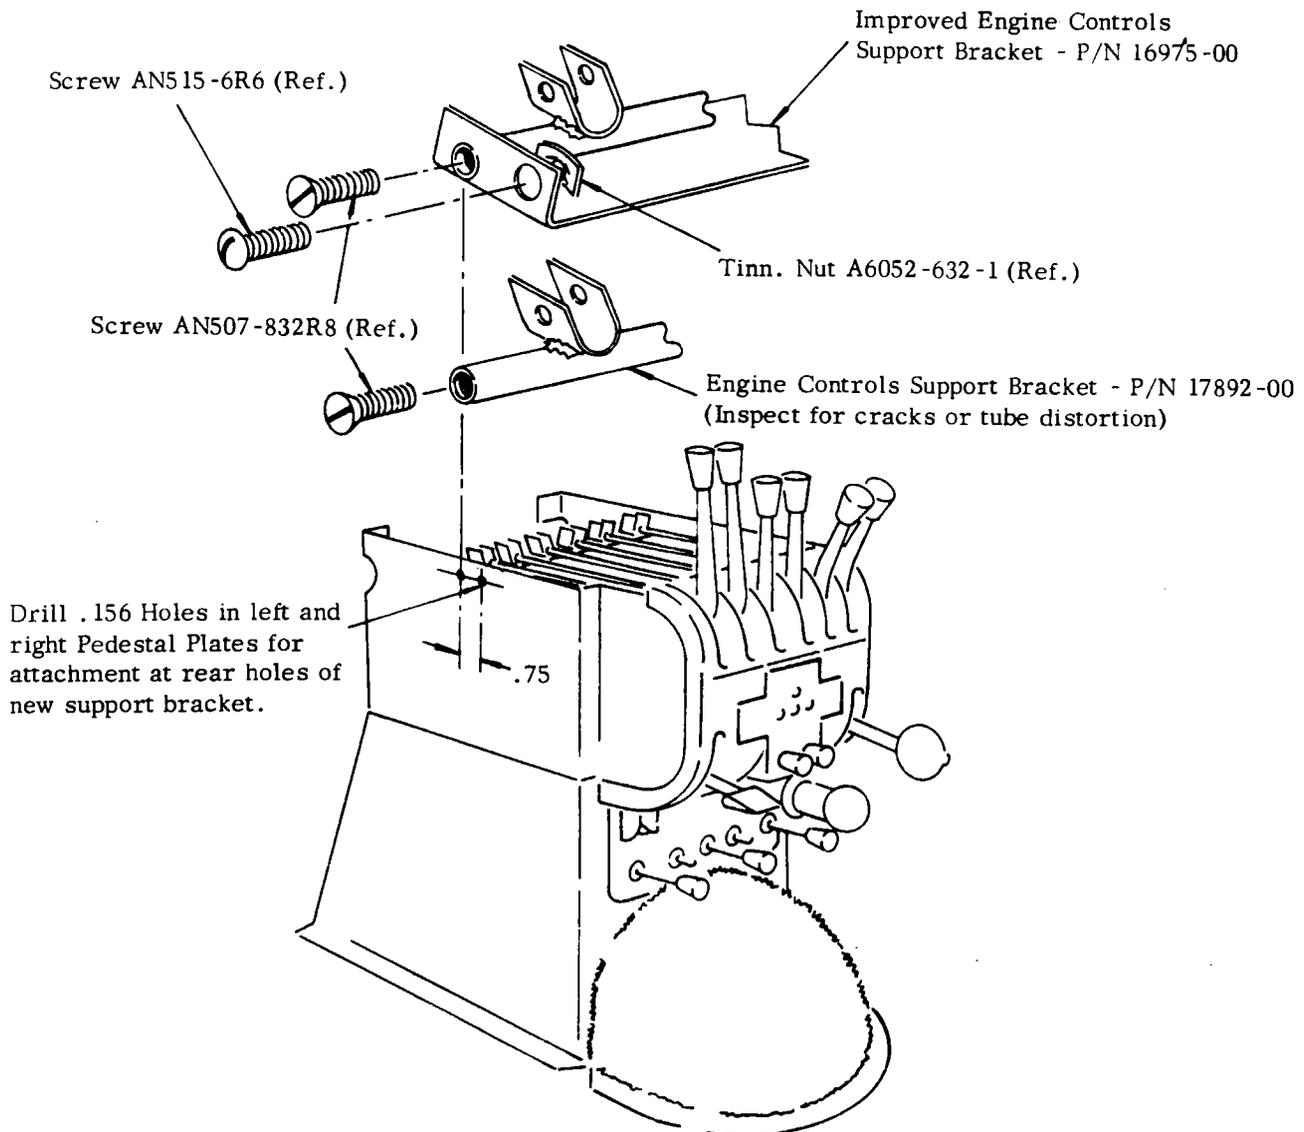
1. Several recent reports from our field organizations concerning the appearance of cracks on the engine control support bracket assembly on relatively high time aircraft indicate the need for a detailed inspection of the assembly in accordance with the information contained in the sketch/instruction sheet on the reverse side of this bulletin.

- Should the inspection reveal cracks and/or tube distortion, the existing engine controls support bracket assembly must be replaced with the improved Piper part number 16975-00 Engine Controls Support Bracket Assembly.

- Inspect the engine controls support bracket assembly, P/N 17892-00 to ascertain that the tube is not cracked or bent.
- Should inspection reveal a bent or cracked tube, it will be necessary to remove the existing bracket assembly and install an improved bracket assembly, P/N 16975-00.
