**BULLETIN**

NUMBER 176

**SUBJECT:** Elevator Control Tube Bellcrank Attachment

**MODELS AFFECTED:** PA-23 and PA-23 "160"  
Serial Numbers 23-1 to 23-1691 inclusive

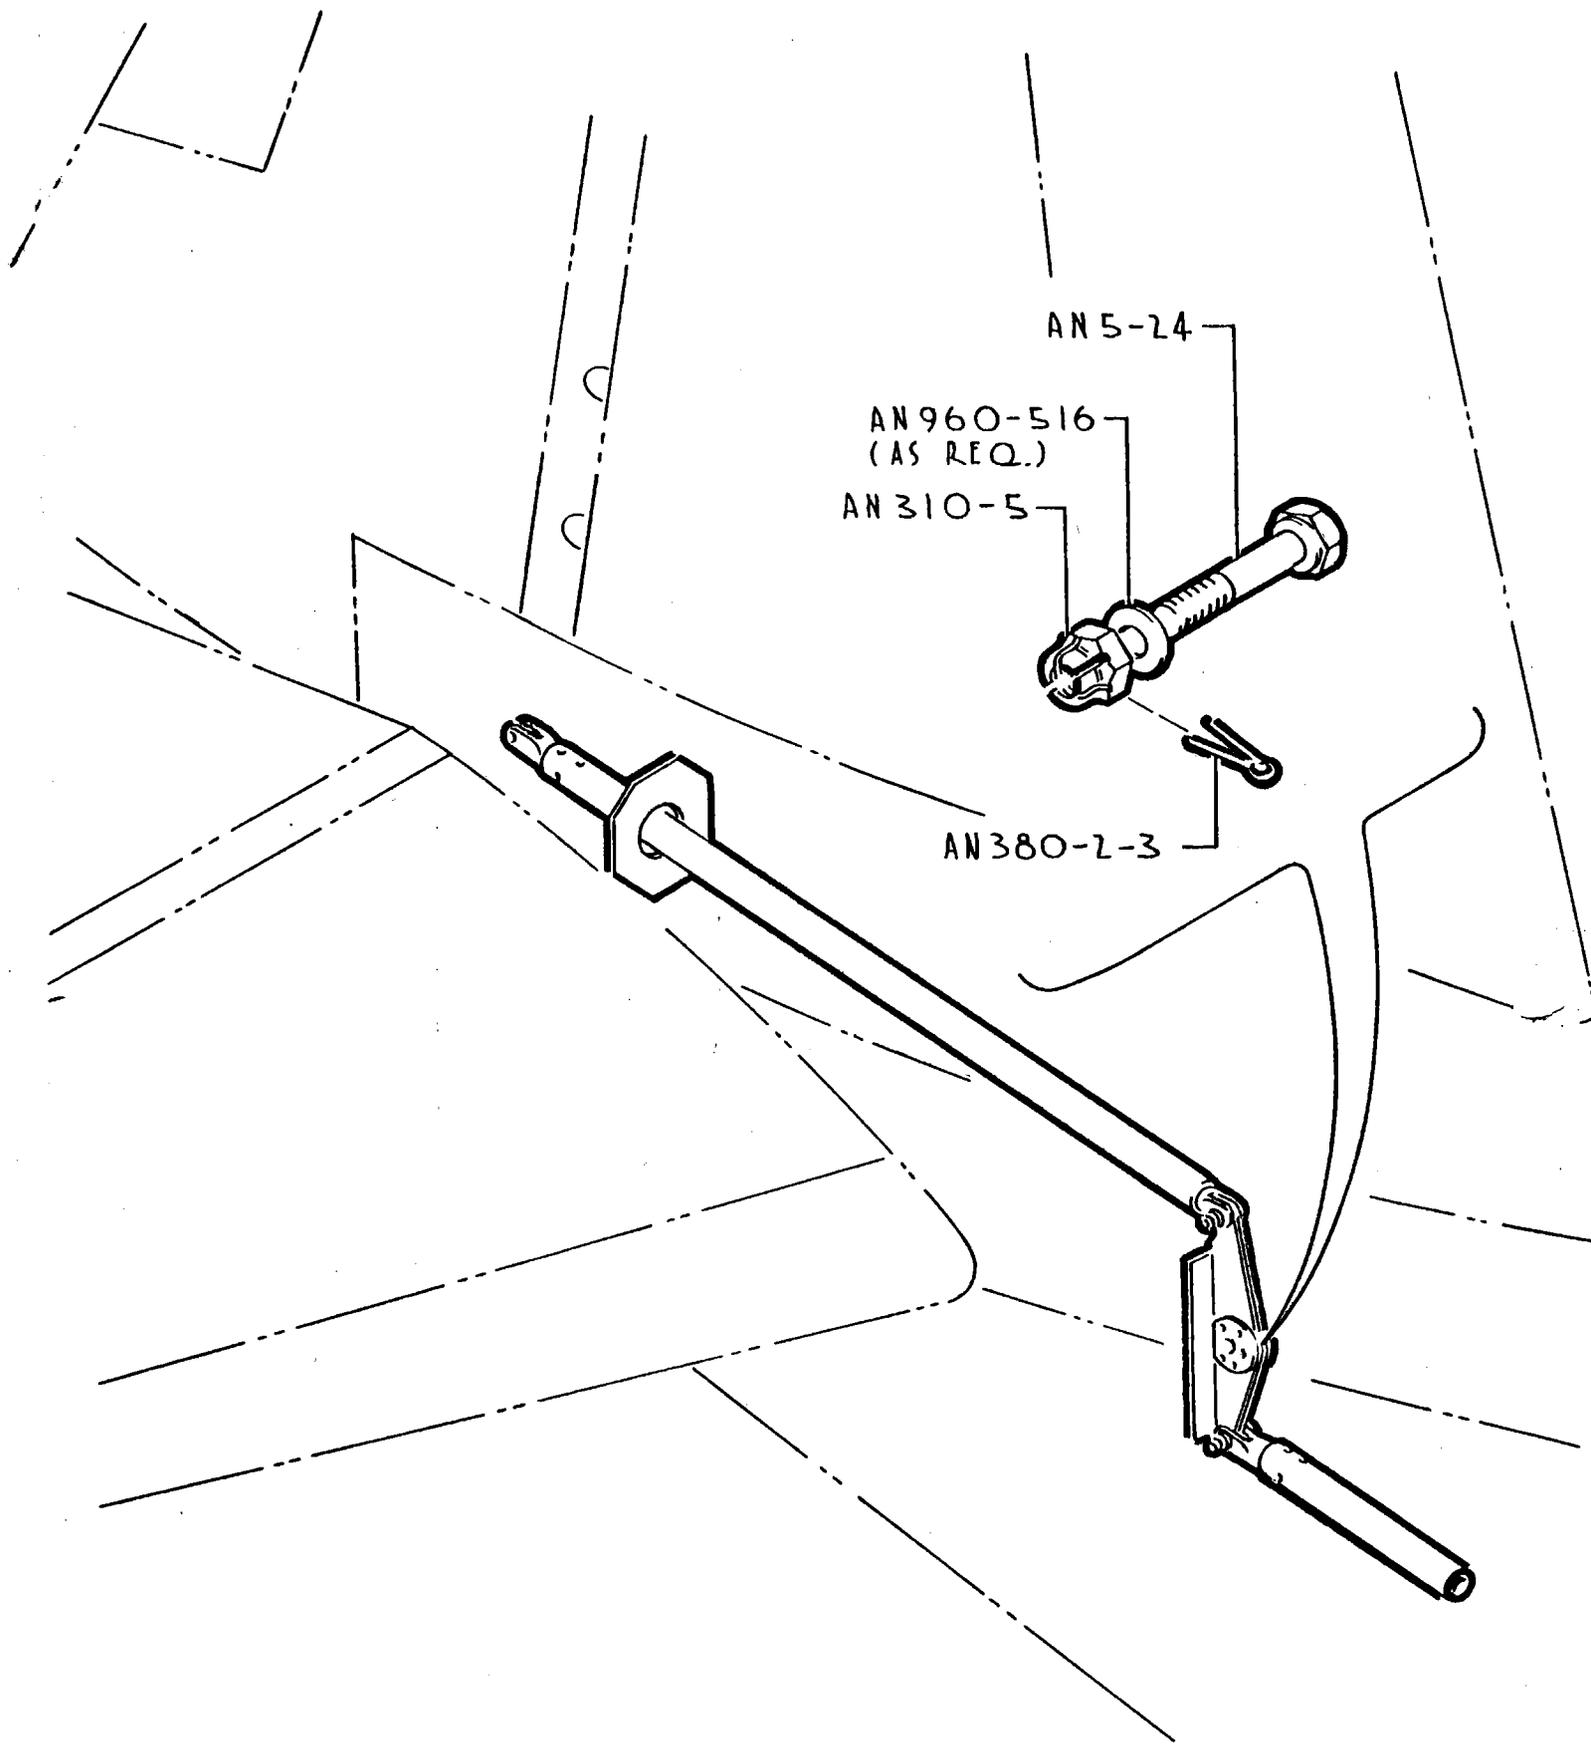
SERVICE BULLETIN NO. 176

A report has been filed with the Service Department that the self-locking nut on the elevator control tube bellcrank attachment bolt has become loose. To preclude the possibility of an occurrence of this nature, a castellated nut and cotter pin is now being installed at this point in current airplanes.

It is requested that a bolt (AN5-24), nut (AN310-5), cotter pin (AN380-2-3) and washer (AN960-516) be installed at the next 100 hour inspection per sketch shown on the reverse side of this bulletin.
