# SERVICE BULLETIN

No. 663

Piper Aircraft Corporation

Subject: Fuel Line/Electrical Harness Inspection

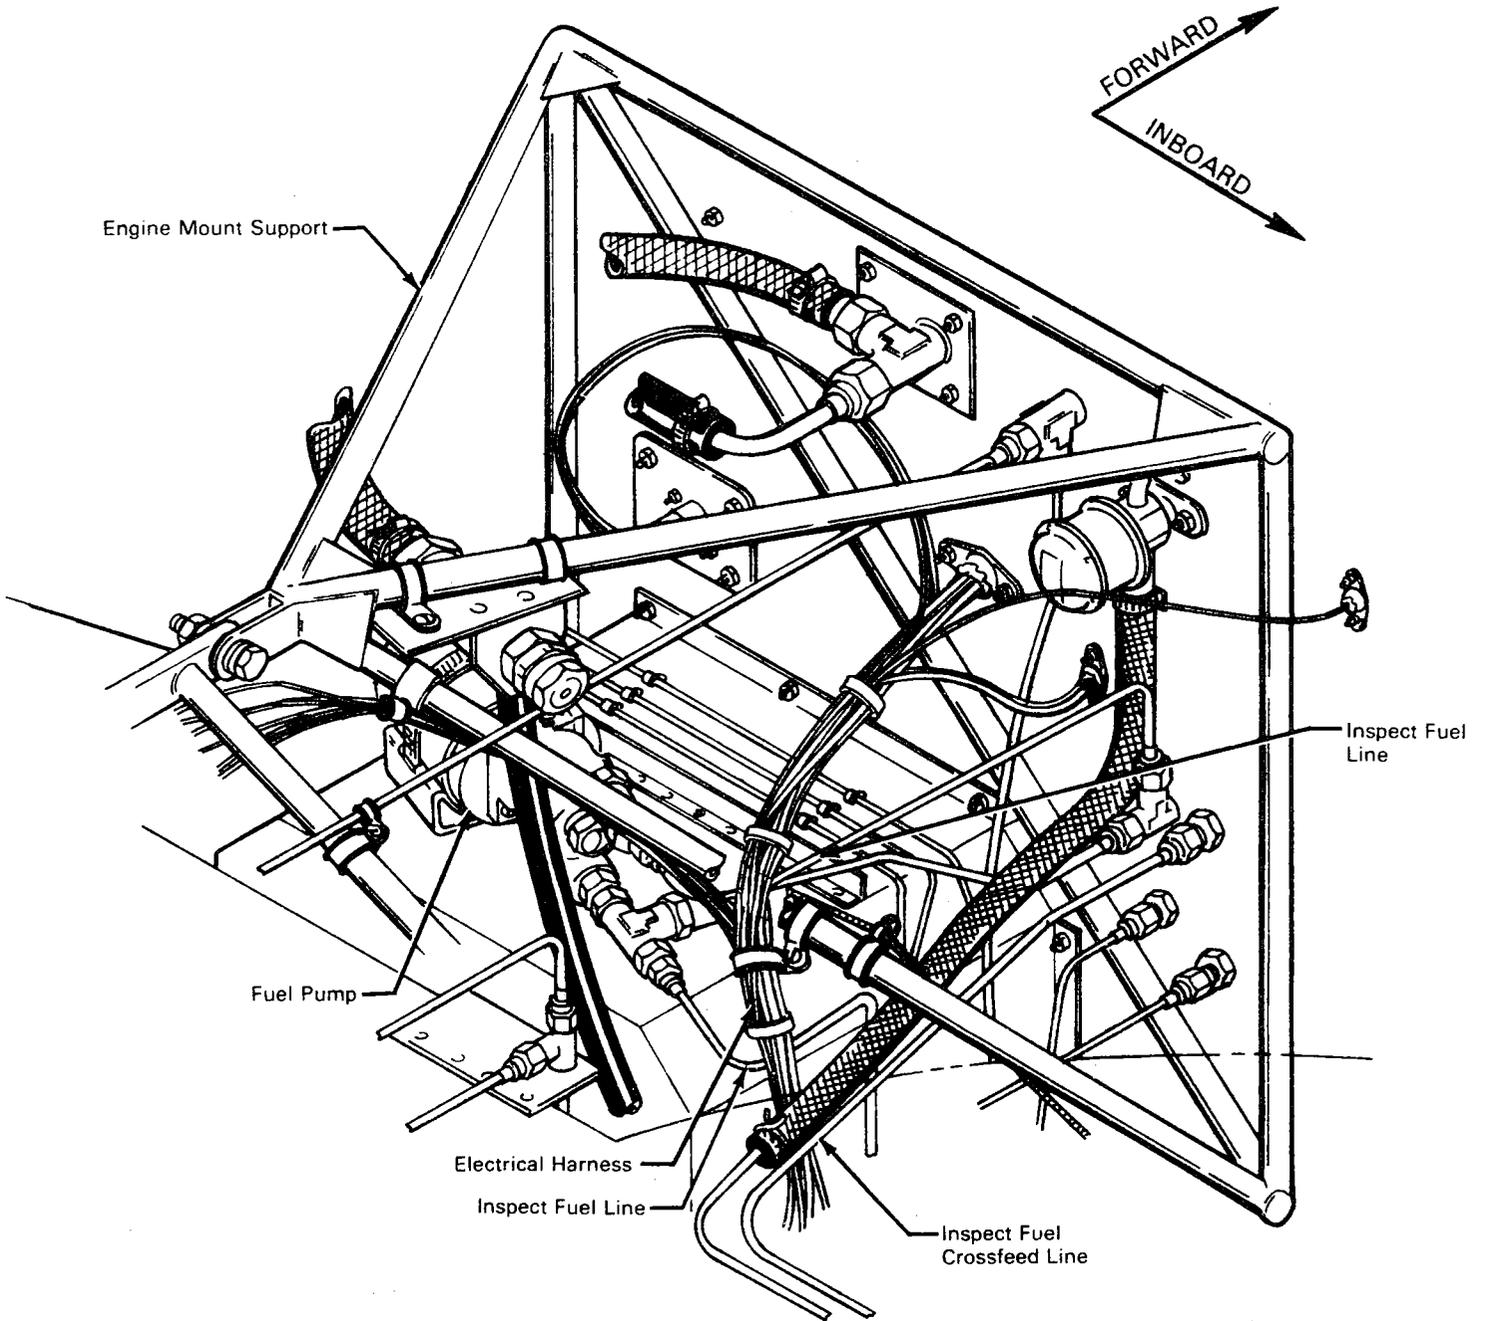
LEFT ENGINE NACELLE SHOWN  
RIGHT ENGINE NACELLE OPPOSITE

Field reports have been received of the electrical harness coming into contact with fuel lines from the electrical fuel pump in the area aft of the engine firewall. Such contact could result in chafing of the fuel line and, if uncorrected, could present a fire hazard.

1. Remove access cover assemblies to gain access to the area aft of the firewall.
2. Refer to attached sketch. Inspect to insure electrical wiring harness is not in contact with the fuel line in the area of the electrical fuel pump or the fuel crossfeed line.
3. If harness is in contact with a fuel line, reposition electrical harness and secure with ty-raps or clamps.
4. Inspect fuel lines for evidence of chafing. If fuel line is not in airworthy condition, replace it before further flight. Refer to Parts Catalog for appropriate replacement part.
5. Reinstall access cover assemblies.
6. Make appropriate logbook entry of compliance with this Service Release.

Only if fuel line is found to be damaged, refer to Parts Catalog for appropriate replacement part.
