# SERVICE LETTER

No. 815

Piper Aircraft Corporation

Subject: Radar Antenna Mounting Plate Inspection and Modification

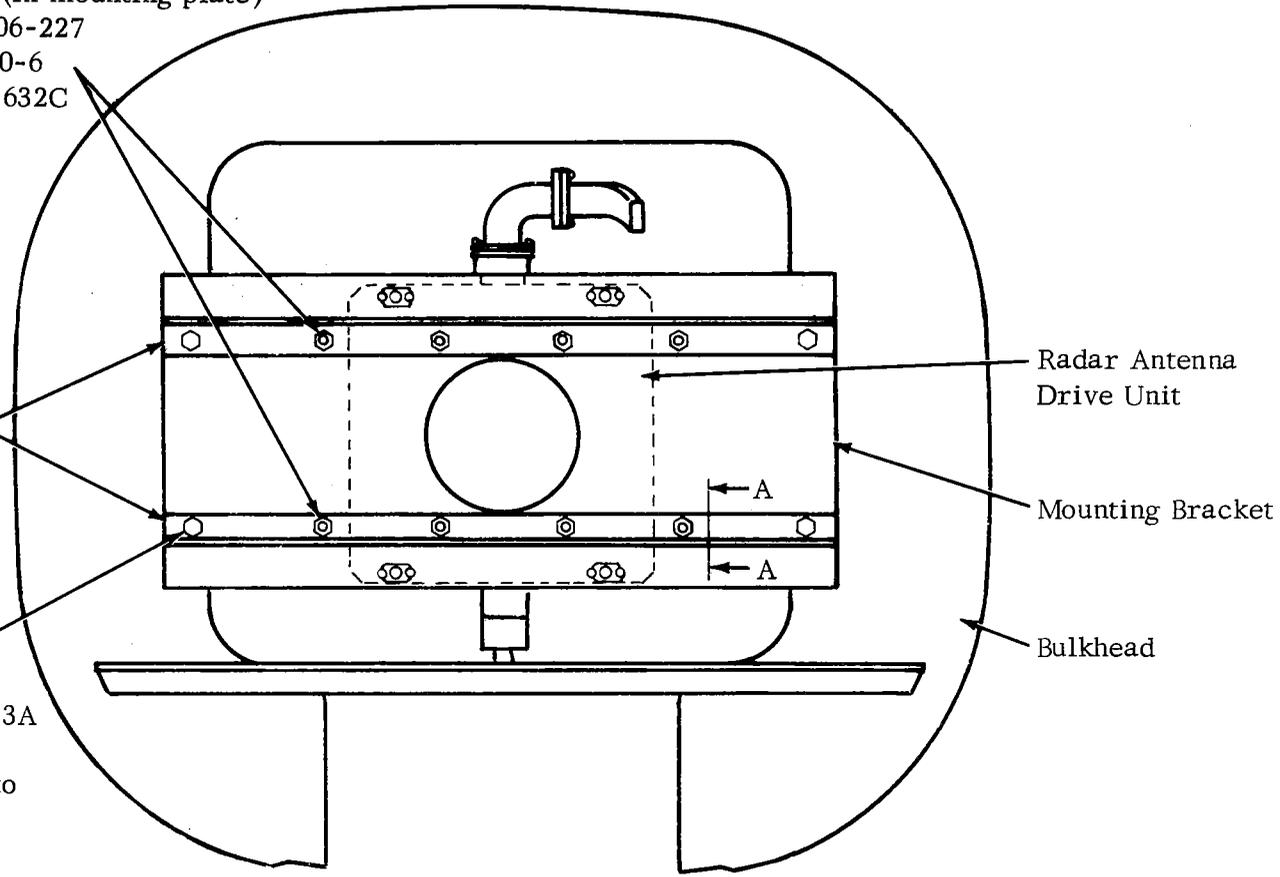
SKETCH "A"

Purpose: It has been brought to our attention that, under certain conditions, the Bendix RDR-150 Radar installed in the above referenced aircraft may not display an accurate weather outline on the instrument panel mounted indicator. It has been determined that this condition can be caused by the radar antenna mounting plate "flexing" during turbulence, distorting antenna scan.

REAR VIEW OF BULKHEAD STA. - 24.50

Drill .156 hole (in mounting plate)  
 Screw - MS35206-227  
 Washer - AN960-6  
 Nut - MS20365-632C  
 (8 req.)

Fabricate Angles  
 Per Figure 1

Existing Bolt - AN4-3A  
 (4 req.)  
 (.250 hole in Angle to  
 match .250 hole in  
 mounting bracket)

- a. MODIFICATION OF EXISTING BRACKET: (Refer to Sketch "A").
    - (1) Remove radar antenna drive unit mounting bracket from airplane.
    - (2) Fabricate two angles per Figure 1.

- (3) Locate and drill (4) .156 holes and (2) .250 holes in each angle per Figure 1.
    - (4) Locate and drill (8) .156 holes in mounting bracket, as shown using the two angles fabricated in step (2) and (3) as a template.

- (5) Attach the two angles to the mounting bracket using hardware as shown on Sketch "A".
    - (6) Reinstall mounting bracket assembly to bulkhead using existing hardware for attachment.
