**BULLETIN**

NUMBER 159

SUBJECT: Rudder Trim Tab Control Rod Attachment

MODELS AFFECTED: All PA-23 Apaches

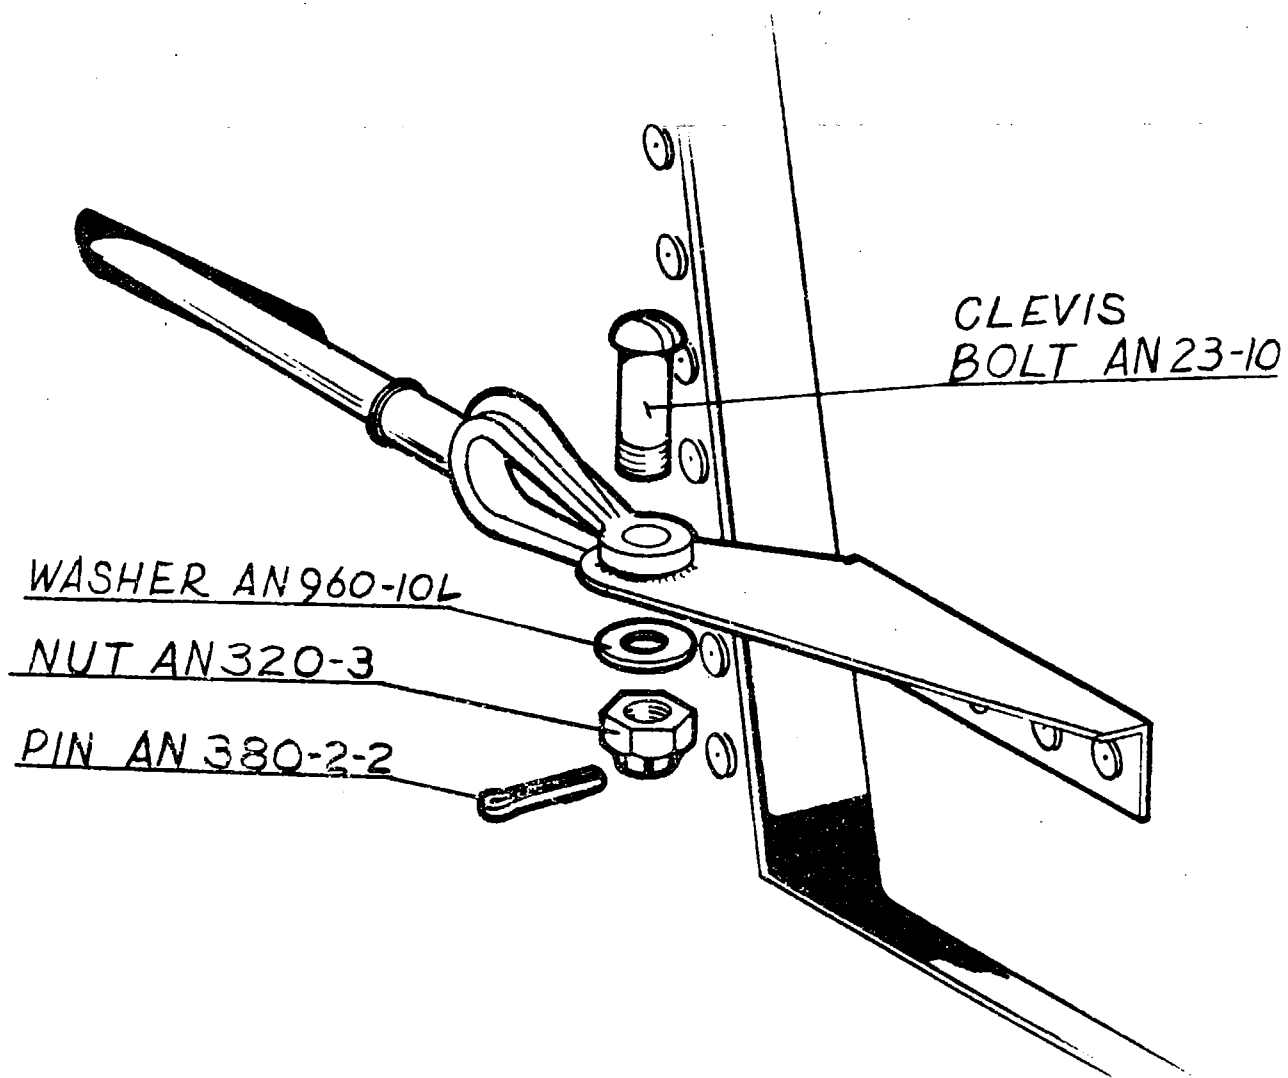
RUDDER TRIM TAB CONT. ROD ATTACH.

A report has been filed with the Service Department that the flat head pin that attaches the rudder trim tab control rod to the rudder trim tab has slipped out due to the loss of the cotter pin thus allowing the rudder trim tab control rod to become disengaged. To preclude a recurrence of this nature, a clevis bolt is now being installed in current production airplanes.

It is requested that this attachment point be checked at the next 100 hour inspection and if a flat head pin has been installed it shall be replaced by a clevis bolt (AN23-10), washer (AN960-10L), nut (AN320-3) and cotter pin (AN380-2-2) per sketch shown on the reverse side of this bulletin.
