SERVICE BULLETIN

No. 199A

Piper Aircraft Corporation

SUBJECT: Reinforcement of Stabilator Trim Tab Horns

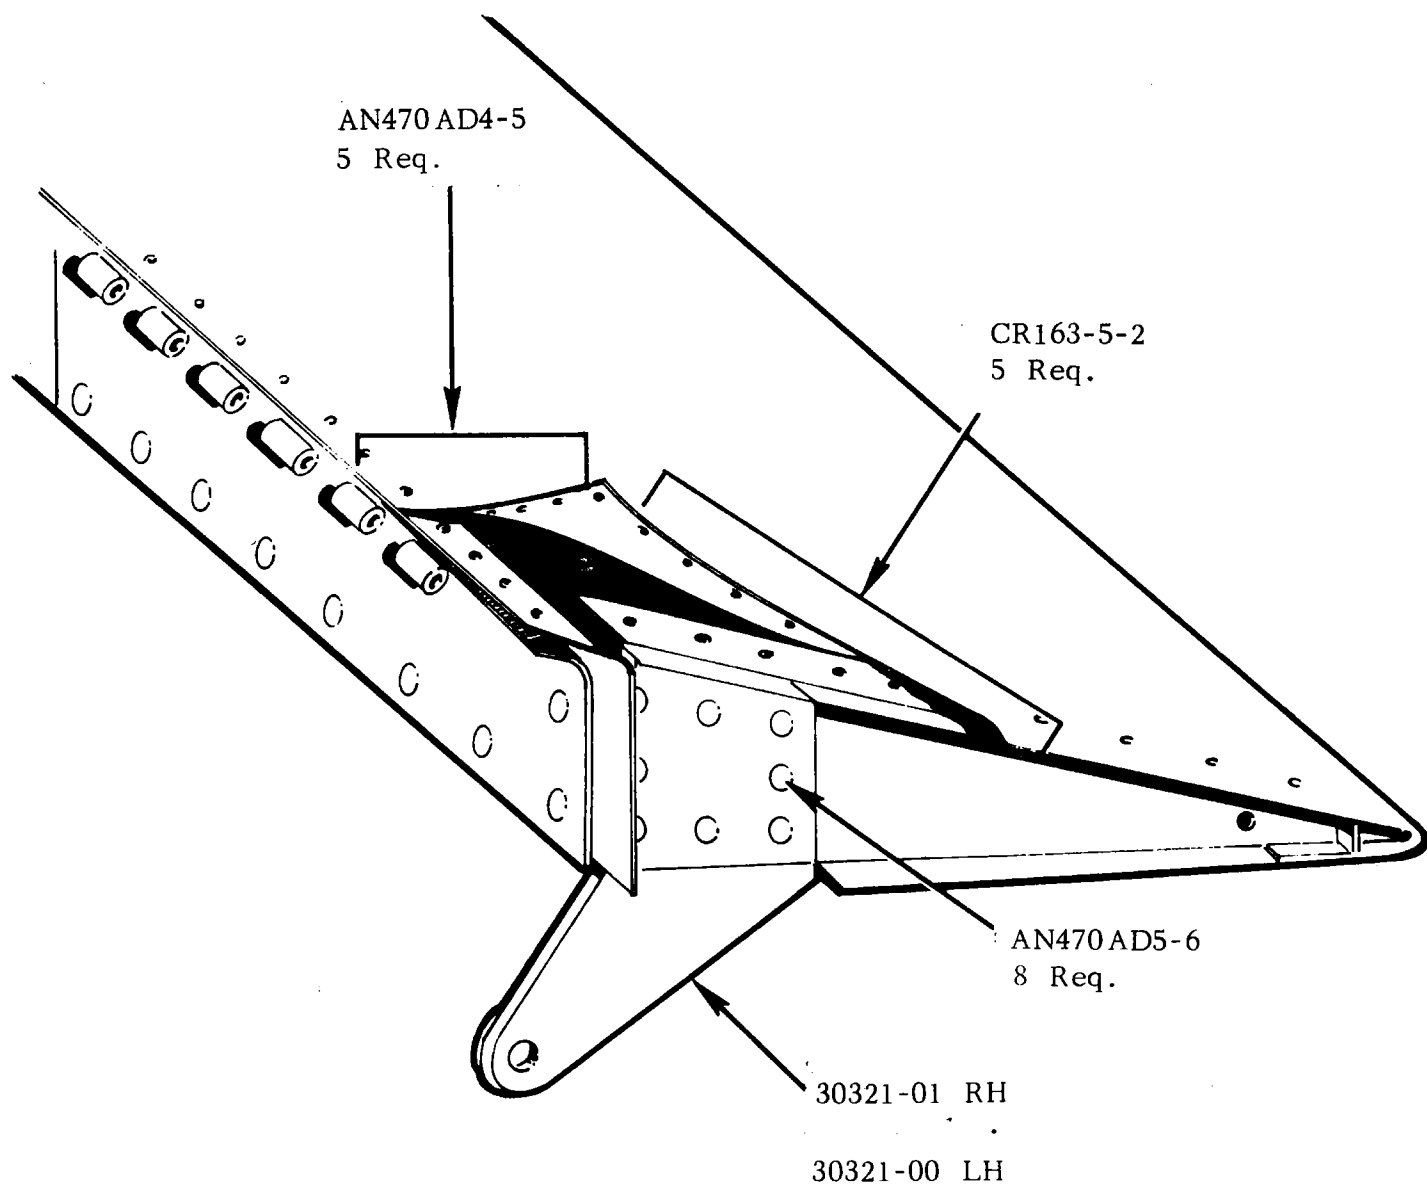
Sketch "A"

REPLACEMENT OF TAB HORN

If necessary add AN960-4 washer between internal bushing and tab horn assembly to maintain parallel position of tab horns. Torque bolt 3 to 35 in. lbs., check trim tab rod for freedom of rotation.

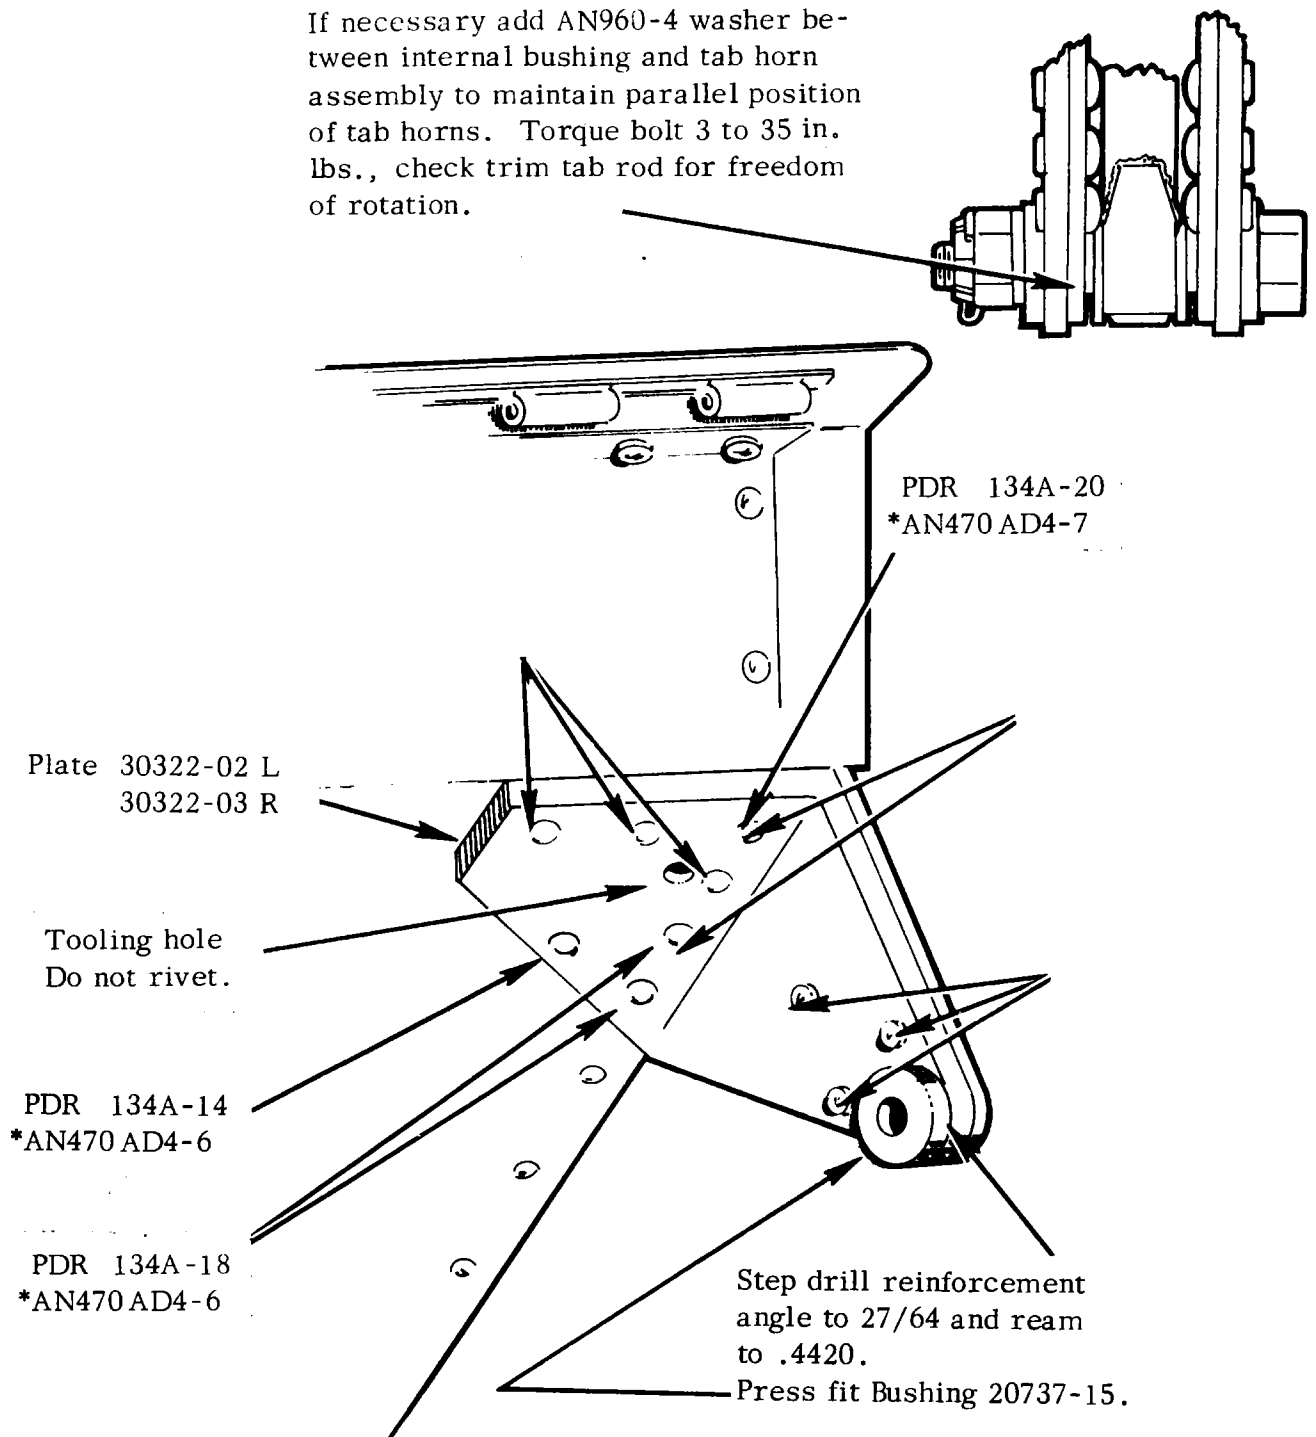
Sketch "B"

REINFORCEMENT OF TAB HORN
