Service Letter No. 305

October 1, 1958

MODEL AFFECTED: PA-24 Comanche, Serial Numbers Listed Below

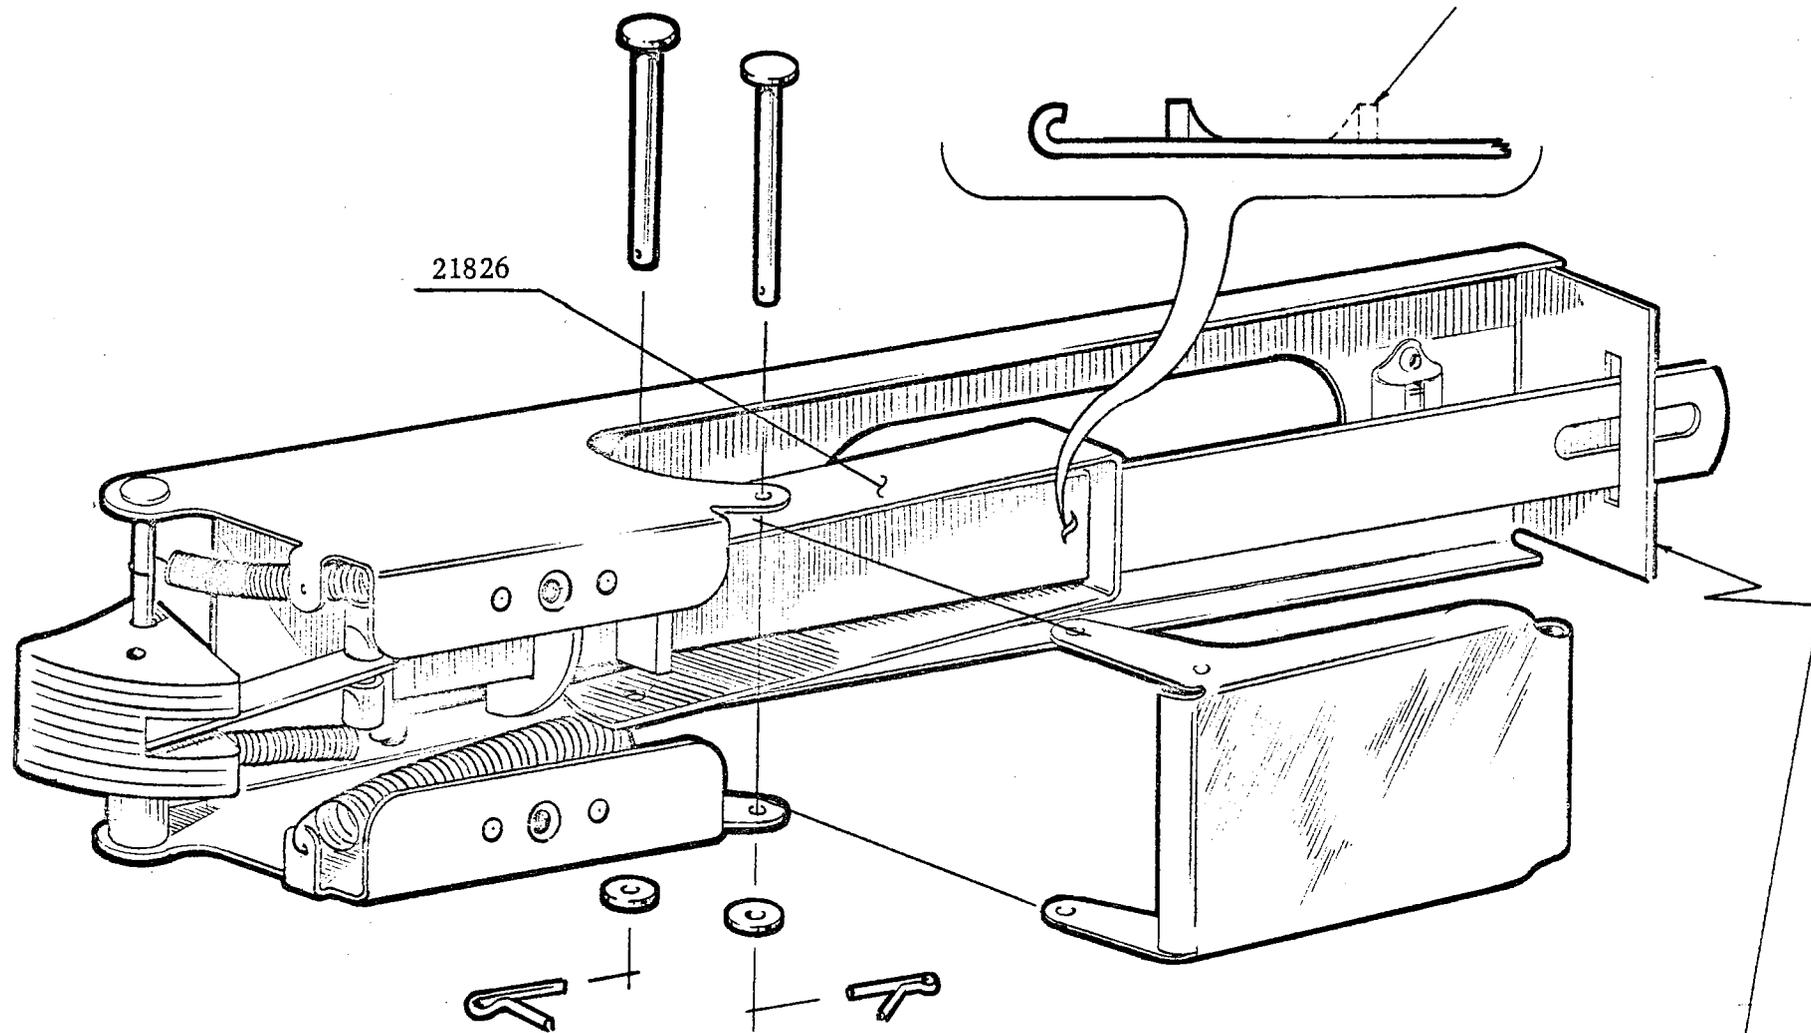
DOOR LATCH MODIFICATION	
SKETCH "A"	S. L. #305
PIPER AIRCRAFT CORPORATION	
LOCK HAVEN, PENNSYLVANIA

1. The main cabin door latch has been modified to provide a positive means of opening the door from the inside when it has been locked from the outside. We suggest that your door be revised as follows. Remove door latch assembly by loosening door trim upholstery and removing screws attaching latch plate and latch assembly to door frame. Disconnect latch pull rod from inside door handle and remove complete latch assembly. Modify latch assembly per Sketch "A" attached to this letter and install a new part number 21826.

21826

BEND BACK TO LIBERATE
 END OF ACTUATING PLATE
 TO INSTALL PART NO. 21826

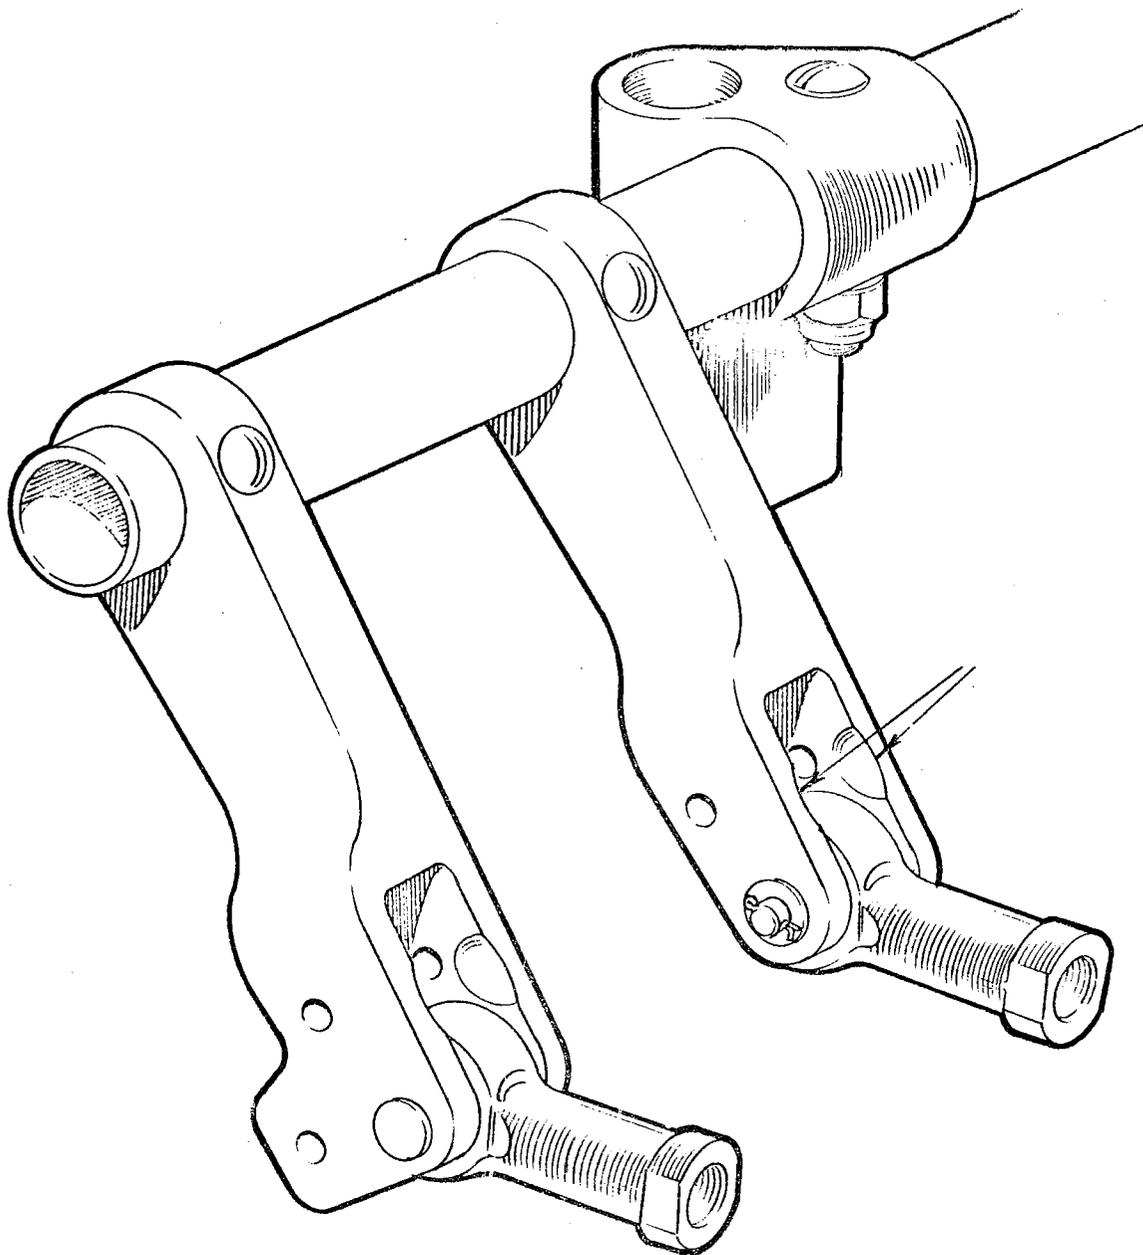
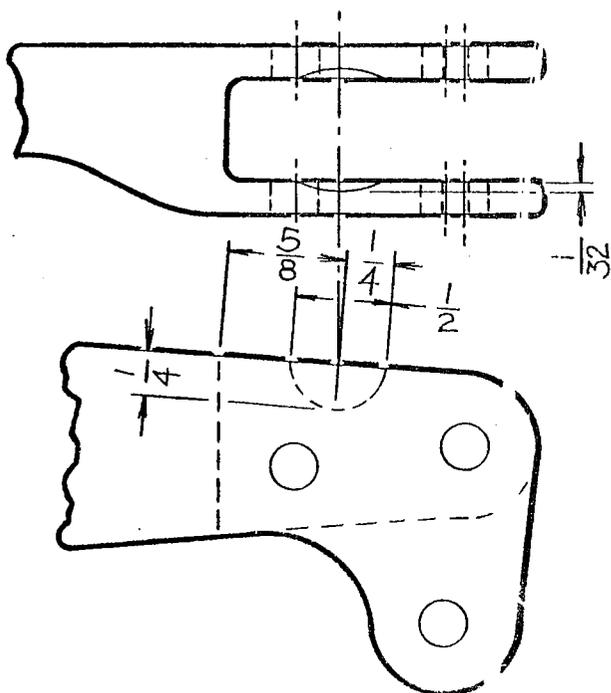
L. G. Retraction Tube Arms Modification	
SKETCH "C"	S. L. #305
PIPER AIRCRAFT CORPORATION	
LOCK HAVEN, PENNSYLVANIA

4. To prevent interference between the landing gear retraction tube arms and the retraction tube rod end bearings, the arms shall be modified per Sketch "C" attached to this letter.
