SERVICE BULLETIN

No. 280

Piper Aircraft Corporation
F.A.A. DOA EA-1 Approved

Subject: Case leakage of R. C. Allen 3" Artificial Horizon
(See attached R. C. Allen Inc., Service Bulletin No. 1.)

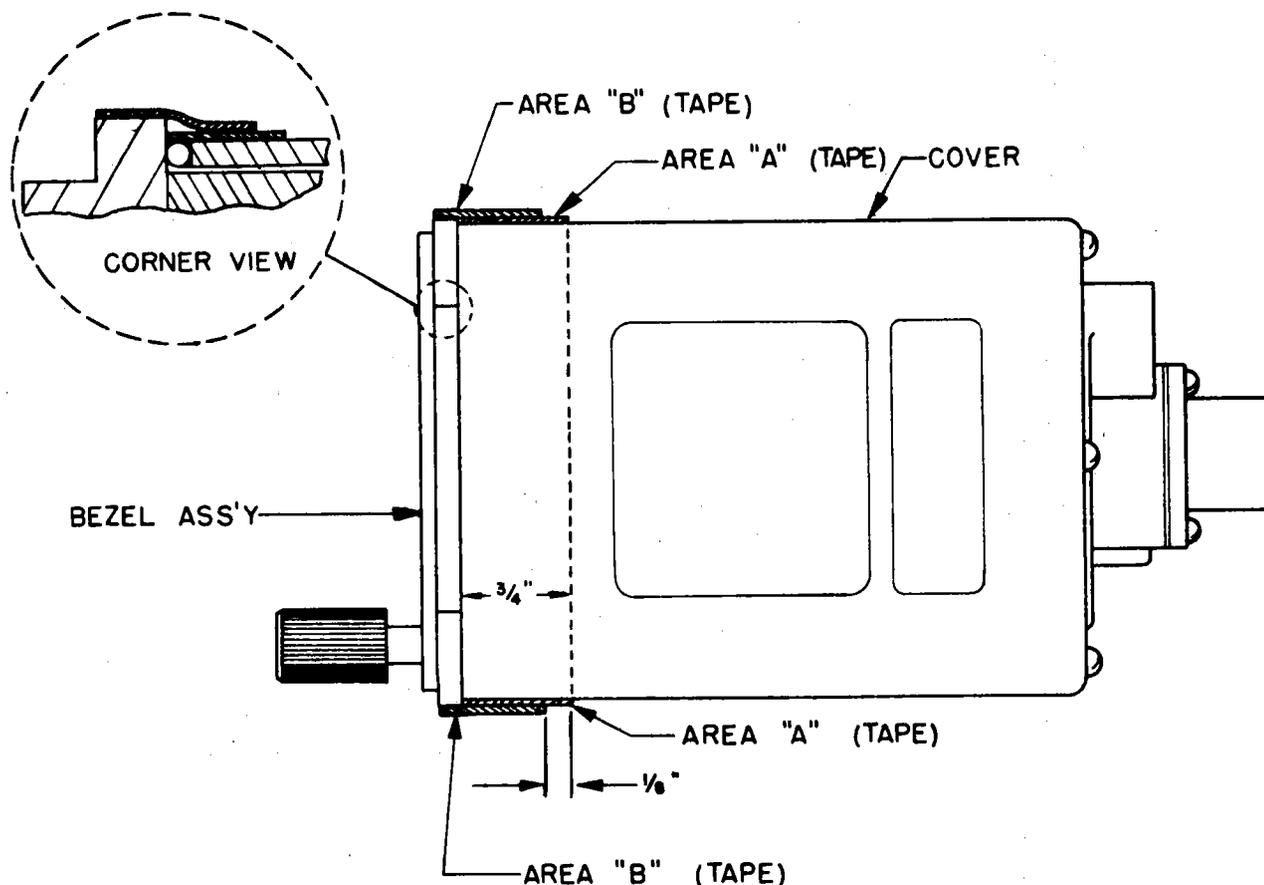
Figure 1. Application of Pressure Sensitive Tape.

Some deterioration of the gasket used to seal the case to the bezel has been experienced. Such deterioration may occur due to the action of ozone and/or the action of certain solvents to which the gasket may have been exposed. If not corrected, the deterioration may result in leaks which can lead to reduction of vacuum system pressure, sluggish horizon performance and eventually complete failure of the gyro system.

2. Refer to Figure 1 and apply one wrap of pressure sensitive tape, 3/4 inch wide, around the horizon as shown in Area "A". Pull the tape as it is being applied so that a slight amount of stretching occurs. The edge of the tape must butt against the rear surface of the bezel assembly and lay firmly against the cover. Overlap the tape approximately two inches.

3. Again refer to Figure 1 and apply one additional wrap of the tape over that just applied as shown in Area "B". Apply this wrapping so that the edge of the tape is flush with the front surface of the bezel assembly. Stretch as required so that the tape lays smoothly around the irregular corners of the bezel. Overlap the tape approximately two inches.
