# SERVICE LETTER

No. 575

Piper Aircraft Corporation

Subject: Nose Landing Gear System Inspection

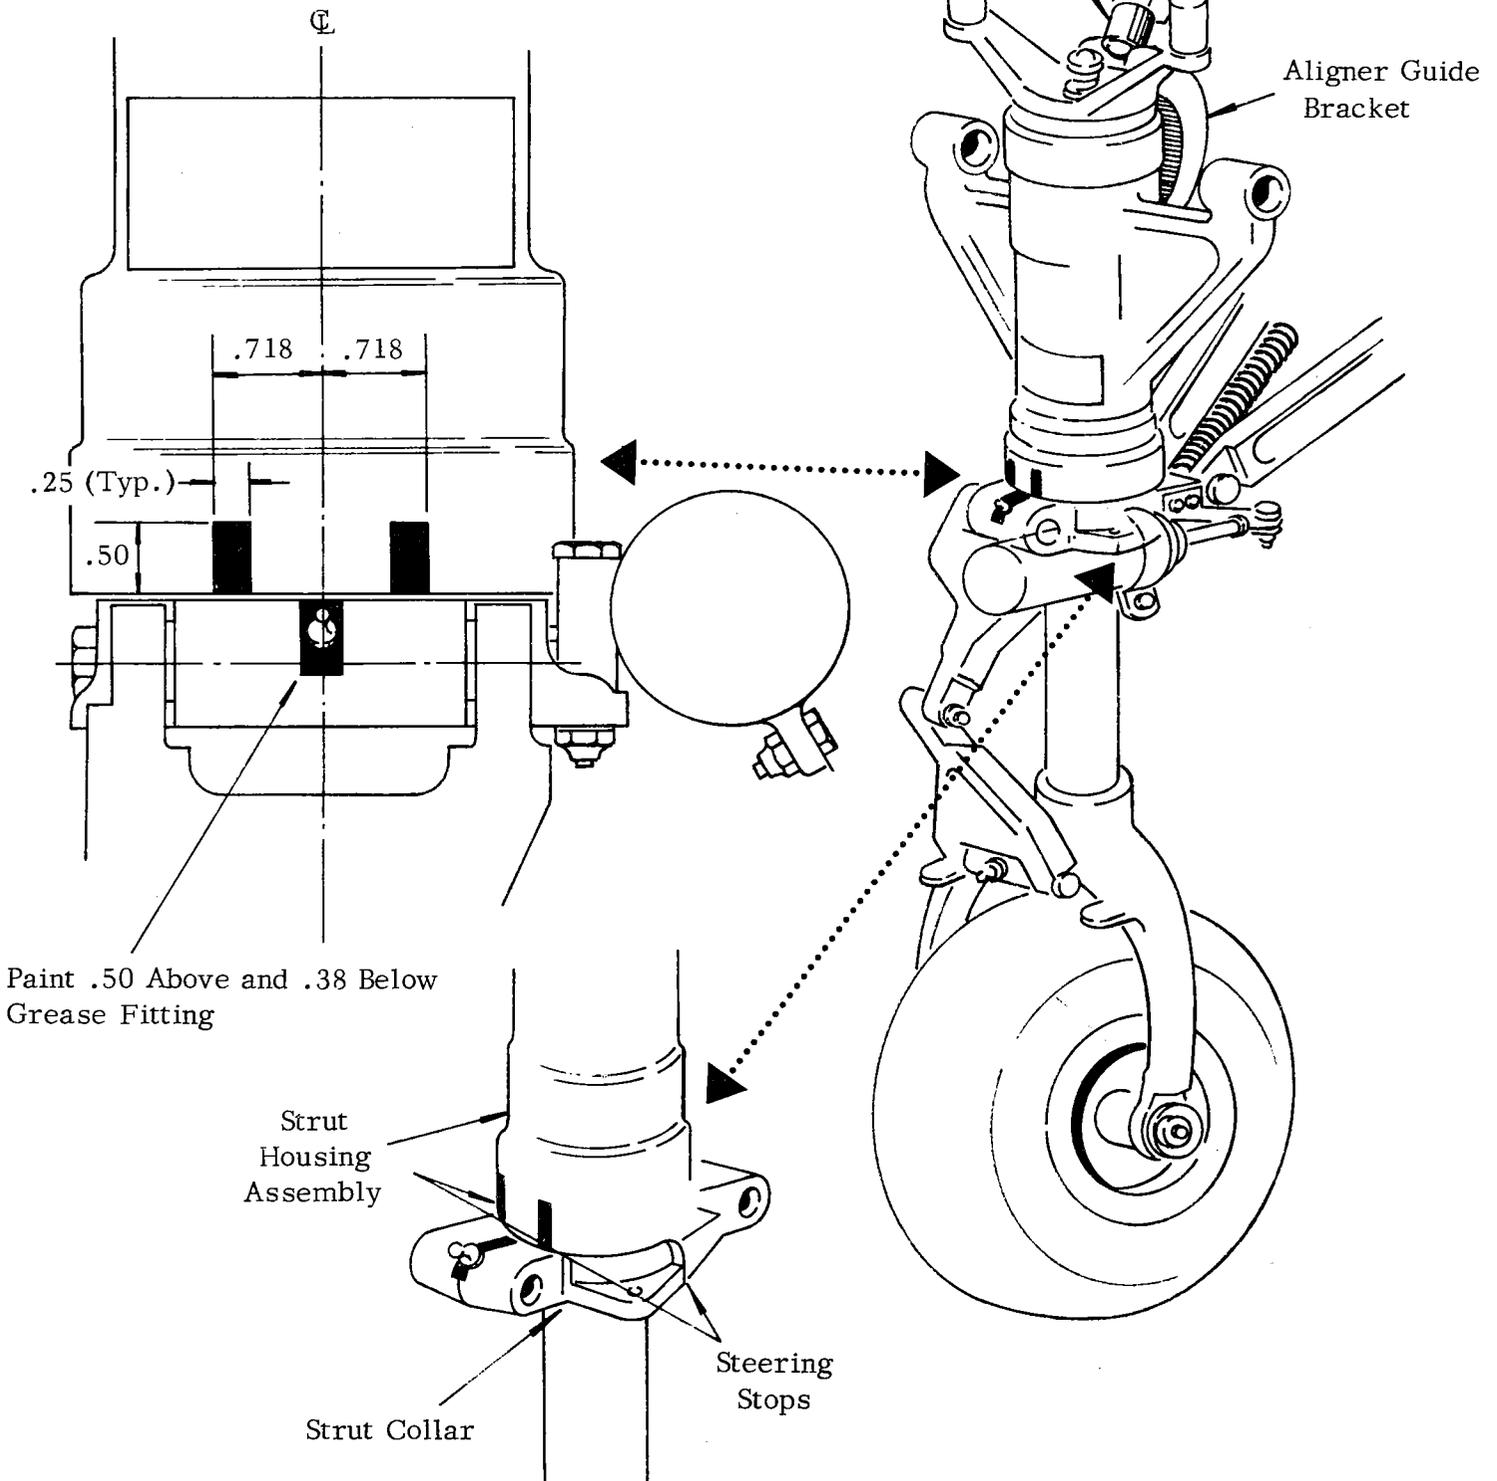
cycling, observe that the aligner roller is engaged within the nose gear aligner guide bracket channel (reference attached sketch for a pictorial description).

Note: Apply steering limit markings (red paint) on the strut assembly as shown.

- a. If the aligner roller does not engage within the aligner guide bracket during gear cycling as specified above, it will be necessary to recheck nose gear steering travel limits.
4. Apply steering limit markings on the nose gear strut housing as denoted on attached sketch.

Paint .50 Above and .38 Below Grease Fitting
