# SERVICE BULLETIN

No. 527

Piper Aircraft Corporation

Subject: Electric Trim Switch Modification

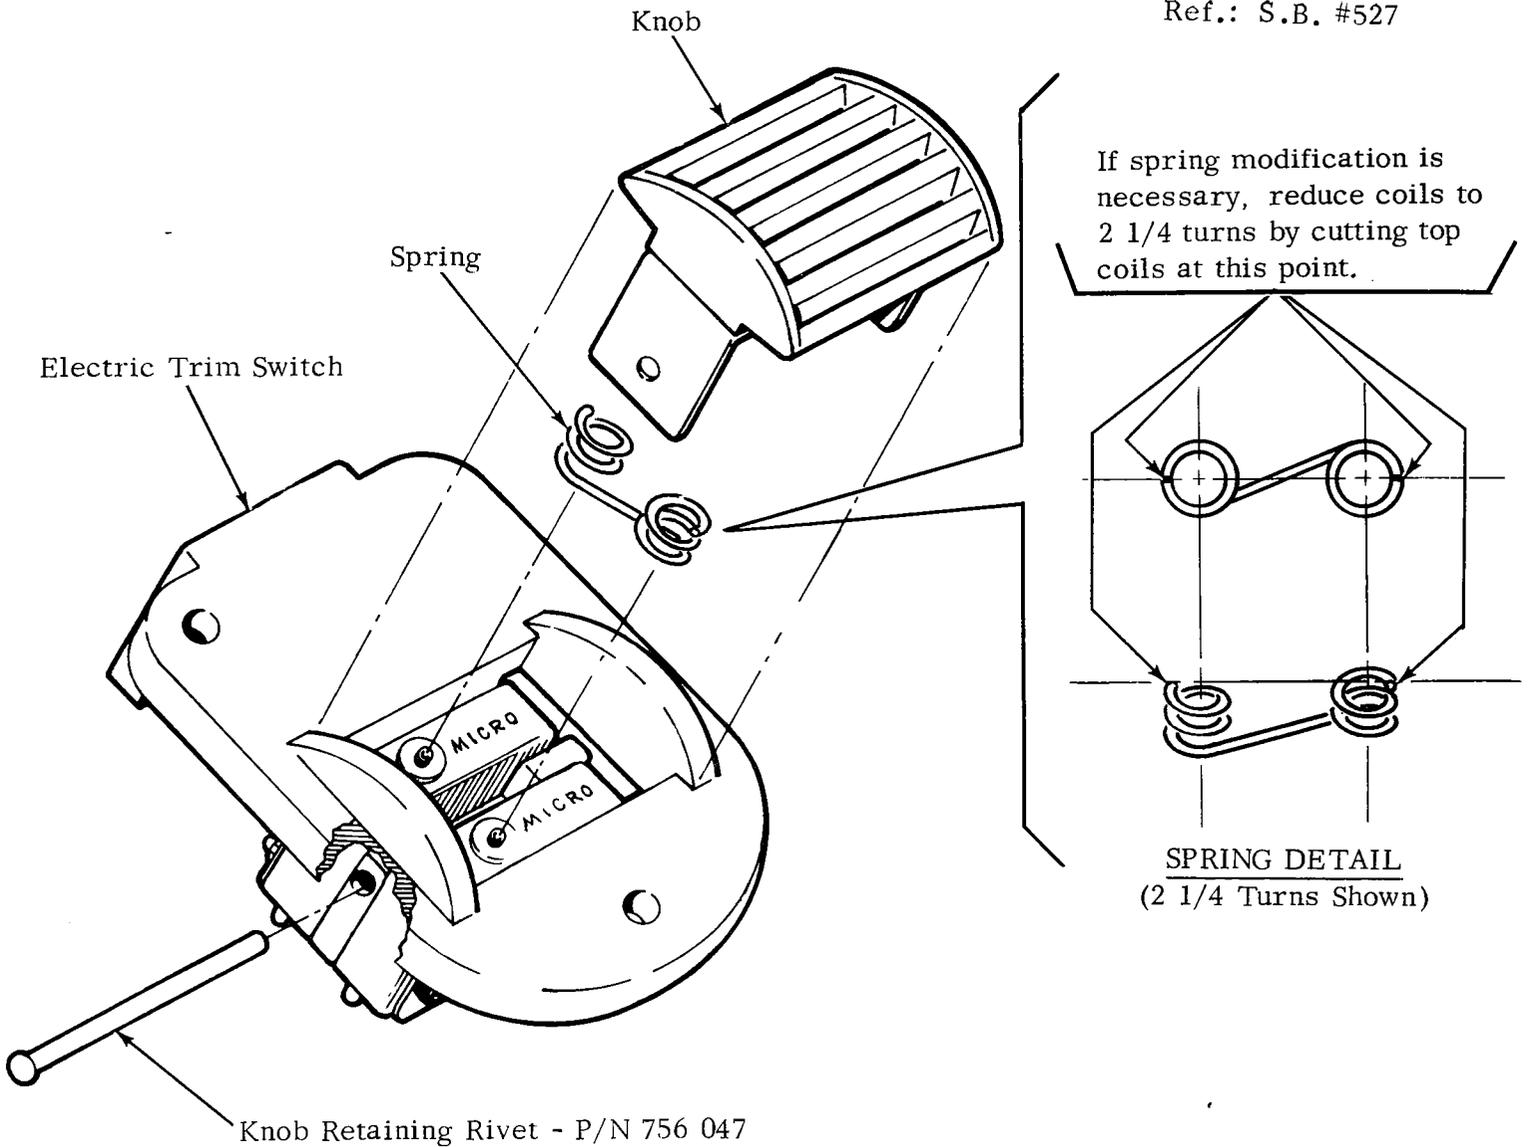
Purpose: Field reports describe a condition wherein the pilot's control wheel mounted "rocker" type electric trim switch tends to "hang up" in the "FWD"/"NOSE UP" or "AFT"/"NOSE DOWN" mode; i.e., fails to return to the "neutral" position following removal of thumb pressure. This condition occurred on some aircraft modified in accordance with Service Bulletin No. 331. Subsequent investigation revealed that the switch return coil springs supplied with Piper Kit No. 760 505 (Electric Trim Switch Modification), per Service Bulletin No. 331 and subsequent production modified models--for a period of time--had an excessive number of coils, which may cause the end of the coil spring to become caught between the switch "rocker" actuator and the micro switch body, thus preventing spring assisted return of the switch to "neutral".

To remedy--and prevent--this condition, this service release provides instructions to modify the electric trim switch return spring by reducing the number of coils (from 2 1/2 turns to 2 1/4 turns--reference attached sketch/instruction sheet for an illustrated view of this condition).

1. Carefully remove placards from electric trim switch.
2. Remove two screws which secure the switch to the control wheel and remove switch.
3. Remove knob retaining rivet by filing peened or crimped head and carefully knocking out.

4. Remove knob and spring from switch.
5. Inspect spring to determine if coils consist of 2 1/4 turns as shown in above detail or 2 1/2 turns.
  - a. If coils consist of 2 1/4 turns, proceed to Step 6.

- b. If coils consist of 2 1/2 turns, modify spring by cutting 1/4 turn from top of coils before proceeding to Step 6. Refer to spring detail above.
6. Place spring (P/N 757 685 - Scott #10004324) over micro-switch buttons with open ends of spring facing up. Spring coils must be concentric with micro-switch buttons and shoulders, and must not rest upon them.

7. Place knob in position and depress slightly so that the new retaining rivet (P/N 756 047 - Scott # 36270) can be installed. Take care not to dislodge spring from position.

8. Test switch action.
9. Crimp or peen end of retaining rivet to retain.
10. Reinstall switch on control wheel with existing screws and cement placards to switch.
