# SERVICE LETTER

No. 637

Piper Aircraft Corporation

Subject: Rajay Service Letter No. 19, dated September 5, 1972.

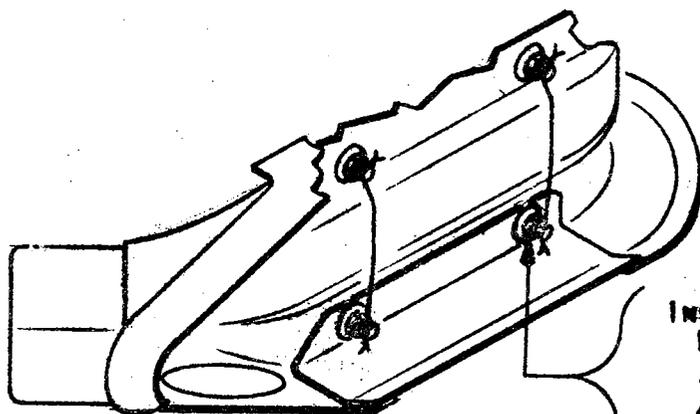
THERE HAVE BEEN ISOLATED REPORTS OF THE TURBOCHARGER INDUCTION DUCT RETAINING STUDS BACKING OUT AND BEING INGESTED INTO THE COMPRESSOR SECTION OF THE TURBOCHARGER. TO PRECLUDE THIS FROM OCCURRING ON ANY FUTURE INSTALLATIONS, A REVISED ASSEMBLY WILL BE USED AS SHOWN BELOW:

Instructions: Remove existing studs and nuts which secure the induction air duct to the engine and install new hardware as specified on Rajay Service Letter No. 19.

INSTALL:  
NAS 183-4-8 STUD  
AN 310-4 NUT  
4 EACH REQUIRED  
SAFETY WIRE (.030 DIA.) PER  
MS 33540 TOP TO BOTTOM AS SHOWN  
2 PLACES
