Service Letter No. 370

SUBJECT: Modification to Engine Breather Line

MODELS AFFECTED: PA-24 and PA-24 "250" Comanches - Serial Numbers 24-2175, 24-2299 to 24-2675 incl., 24-2677 to 24-2801 incl., 24-2803, 24-2804, 24-2806, 24-2808 to 24-2888 incl., 24-2890 to 24-2935 incl., 24-2937, 24-2939 to 24-2943 incl., 24-2945 to 24-2948 incl., 24-2950 to 24-2956 incl., 24-2958 to 24-2966 incl., 24-2969 to 24-2982 incl., 24-2984, 24-2986 to 24-2989 incl., 24-2991, 24-2992, 24-2994 to 24-3005 incl., 24-3007 to 24-3009 incl., 24-3011, 24-3012, 24-3014, 24-3016, 24-3018, 24-3020 to 24-3023 incl., 24-3027 to 24-3040 incl., 24-3042, 24-3043, 24-3046 to 24-3049 incl., 24-3052, 24-3055, 24-3059, 24-3060, 24-3062, 24-3068.

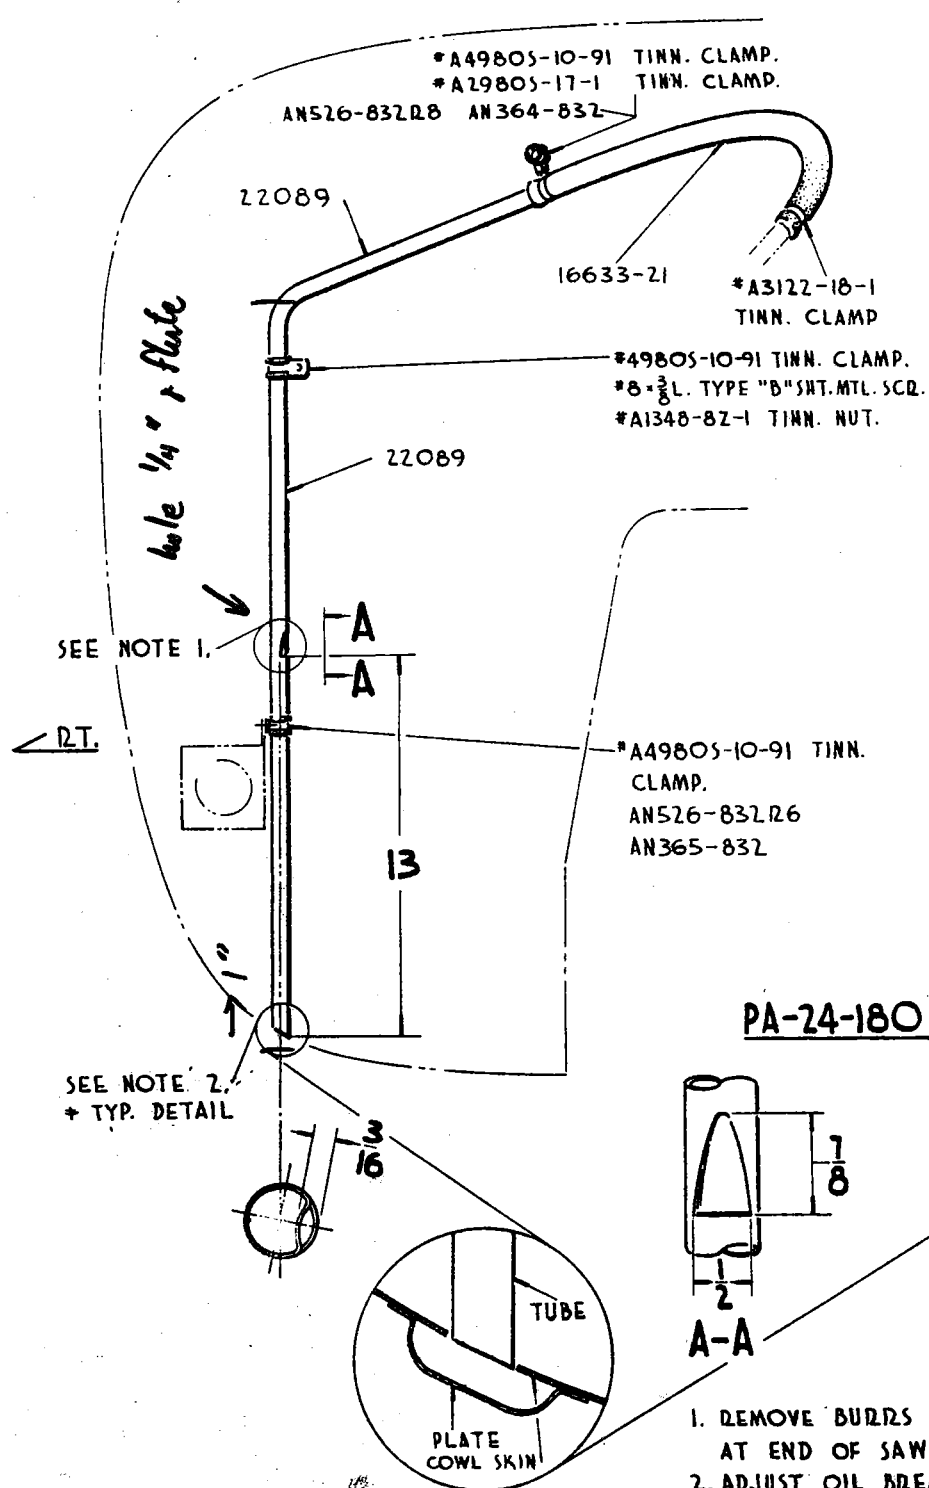
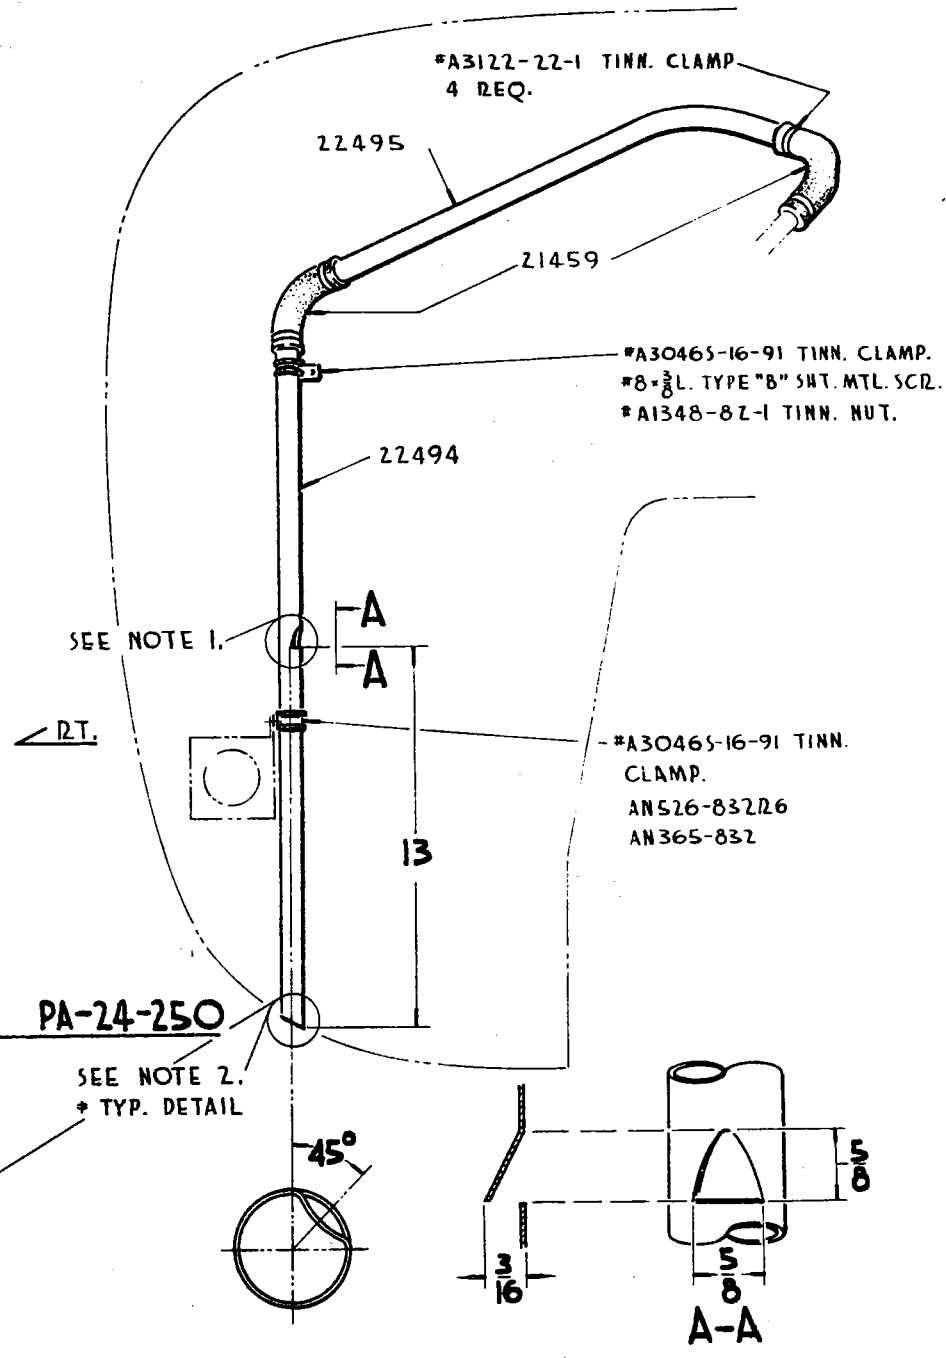
SERVICE LETTER NO 370

A few reports have been filed with the Service Department indicating that the engine breather line on the subject aircraft may extend below the opening in the bottom cowl.

The engine breather line should be inspected and, if necessary, adjusted so that it is flush with the bottom cowl. Refer to sketch on the reverse side of this Service Letter. The adjustment of this breather line, flush with the bottom cowl, will prevent the accumulation of ice at the opening of the engine breather line and in the scoop into which it vents.

As a precautionary measure, for operations in extensive icing conditions it is recommended that the engine breather line be modified to provide an alternate vent. This modification consists of a saw-cut across the engine breather line and forming the area above the saw-cut as shown in the sketch on the reverse side of this Service Letter.

NOTE: CARE SHOULD BE EXERCISED WHILE FORMING THE VENT
SO THAT THE TUBE IS NOT FLATTENED OR DISTORTED.

1. REMOVE BURRS THAT MAY BE FORMED AT END OF SAW SLOT.
2. ADJUST OIL BREATHER TUBE FLUSH WITH SKIN.
