VSP-30  
May 20, 1981

VENDOR SERVICE PUBLICATION

Subject: Bendix Service Bulletins 599A, 609A, 610,  
613, 614

**SERVICE BULLETIN NO. 599A**  
(Supersedes Service Bulletin No. 599)  
Engineering Aspects are  
FAA Approved

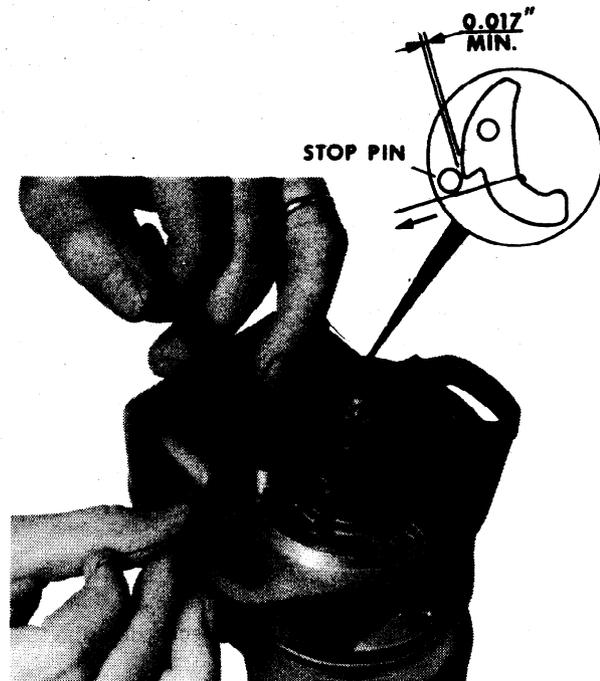
Figure 2. Checking Flyweight to Stop Pin Clearance

c. While pulling flyweight outward, insert feeler gages to measure the clearance between the heel of the flyweight and the stop pin, assuring a minimum of 0.017 inch exists.

d. If less than 0.017 inch clearance exists, this is cause for immediate rejection of the impulse coupling cam assembly, or possibly the entire impulse coupling. Refer to the applicable Magneto Overhaul Instructions for inspection procedures to determine if other impulse coupling parts are still serviceable.

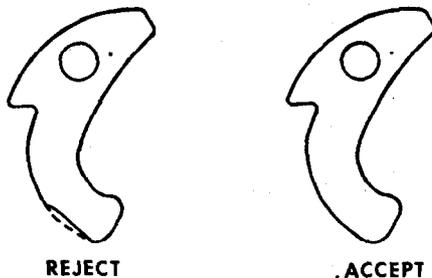
Figure 6. Flyweight Tail Condition Check

4. Flyweight tail condition must be given a visual examination to determine if flyweight is still serviceable. The surface at the apex of the beveled edge must blend smoothly with the outer contour of the flyweight. No flattening, denting or chipping is permissible. Any irregularity of this surface is cause for immediate rejection of the cam assembly. (See figure 6)

6. If the impulse coupling is found to be unacceptable as a result of any of the preceding checks described, replace the entire impulse coupling assembly or worn parts according to instructions of applicable Bendix publications.
7. When inspection of the impulse coupling assembly is being performed, the stop pins in the magneto flange or housing must also be examined. Visible damage or wear in the area where the flyweight contacts the stop pin is cause for repair or replacement of the magneto, stop pin, housing or flange depending on magneto. (Reference latest revision of Bendix Overhaul Manuals Publication Forms L-205, L-645, L-945 and L-1019.)
8. When inspection procedures outlined in this bulletin have been completed, an appropriate notation must be made in the Engine Log Book referencing magneto serial number.

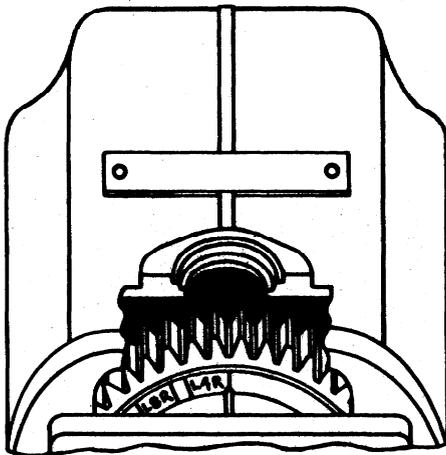
Figure 2. Alignment of Timing Marks on Distributor Gear – 4 Cylinder, Right Hand Rotation

**GENERAL INFORMATION:**  
Field reports indicate that a quantity of remanufactured S-1200 magnetos have been discovered with the large distributor gear mistimed. To avoid damage to the distributor block and resultant ignition difficulty, the magnetos involved should be examined according to the applicable inspection method listed below.

7. If timing marks are not aligned remove magneto from engine and follow instructions in Method "B".

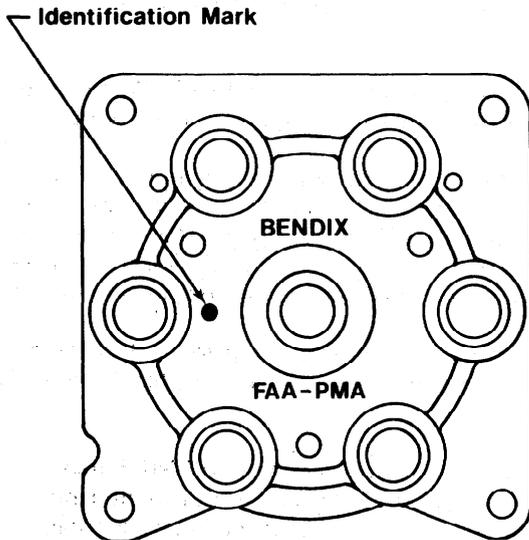
Figure 1. Location of Identification Mark

1. To announce the availability of an improved Diallyl Phthalate (DAP) green distributor block incorporating a new design "Gripper" oilite bushing.
2. To alert users of a possible loose oilite bushing in the original green DAP distributor block. Field reports indicate that the bronze oilite bushing in the current green distributor block may become loose and turn within the block. This condition could wear the block enough to cause the distributor gear to become mistimed resulting in rough engine operation.
3. To provide instructions for inspection and/or replacement of the original green distributor blocks with the new "Gripper Bushing" green distributor blocks as required.

The new "Gripper Bushing" will eliminate the possibility of the bushing becoming loose. The "Gripper Bushing" block can be identified by a circular shaped mark 0.188 inch  $\pm$  0.031 inch in diameter raised 0.010 inch to 0.030 inch above the surface of the block. This mark is located on the tower side of the block, as indicated in figure 1.

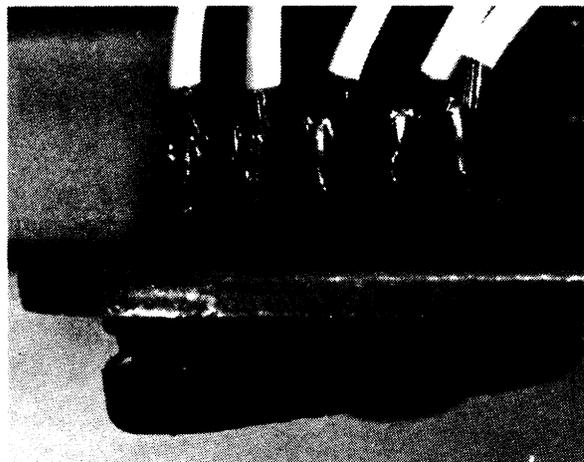
Figure 1 Defect

Bushing (connector), P/N 10-382943, may become loose in the vibrator plate and cause the grounding of both magnetos with possible loss of ignition. See figure 1 (defect).

1. Remove starting vibrator from the airframe.
2. Remove cover to expose the internal surface of the terminal bushing (connector).
3. The surface around the terminal bushing must be clean, dry, free of oil, dirt and grease.
4. Reseat the terminal bushing in the mounting plate to its full extent.
