SERVICE BULLETIN

No. 324

Piper Aircraft Corporation

Vacuum Pump Adapter Drive Assembly

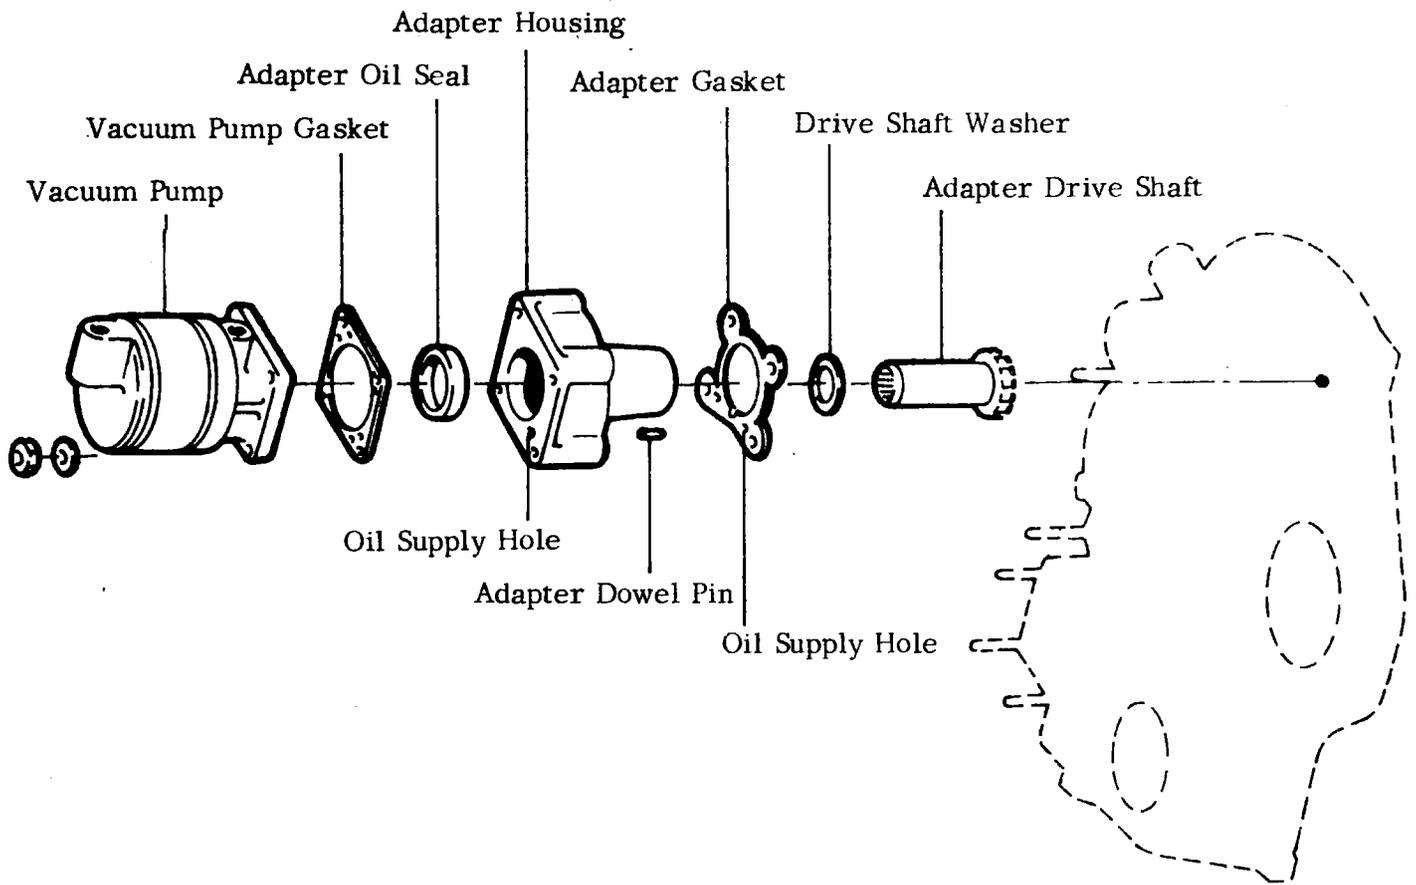
Service Bulletin 324

To provide instructions for an inspection of the vacuum pump adapter drive assembly (reference attached sketch for an illustration of the area to be inspected).

- I. Remove vacuum pump and vacuum pump adapter assembly from engine.
- II. Remove drive shaft from adapter housing and inspect the shaft for any sign of aluminum pick up on shaft at either end of shaft where it contacts adapter bearing bore.
- III. Inspect the adapter housing for the following:
 - a. Any evidence of inadequate lubrication resulting from foreign chips in oil supply hole.
 - b. Omission of oil supply hole.
 - c. Improper location of dowel.
 - d. Improper indexing of drive adapter assembly to accessory pad.
- IV. Inspect gasket, Lycoming part number 61183, for omission of oil transfer hole.

IF ANY DISCREPANCIES ARE FOUND, DO NOT ATTEMPT TO REPAIR. Contact your local Lycoming Regional Representative or Lycoming Service Department for further instructions.

- V. If the above referenced inspection procedure discloses no discrepancies, clean and lubricate (with SAE 50 oil) all parts that were inspected and reinstall on engine; torque all nuts to 50 to 70 inch pounds.
