Service Letter No. 352

SUBJECT: Modification of Windshield Defroster System

MODELS AFFECTED: PA-24, PA-24-250 Comanches, Serial Nos. 24-2299 to 24-2338, 24-2340, 24-2341, 24-2342, 24-2344 to 24-2360 inclusive, 24-2363 to 24-2369 inclusive, 24-2371 to 24-2379 inclusive, 24-2381, 24-2383 to 24-2396 inclusive, 24-2398, 24-2399, 24-2400, 24-2402, 24-2405, 24-2406, 24-2409, 24-2411 and 24-2412.

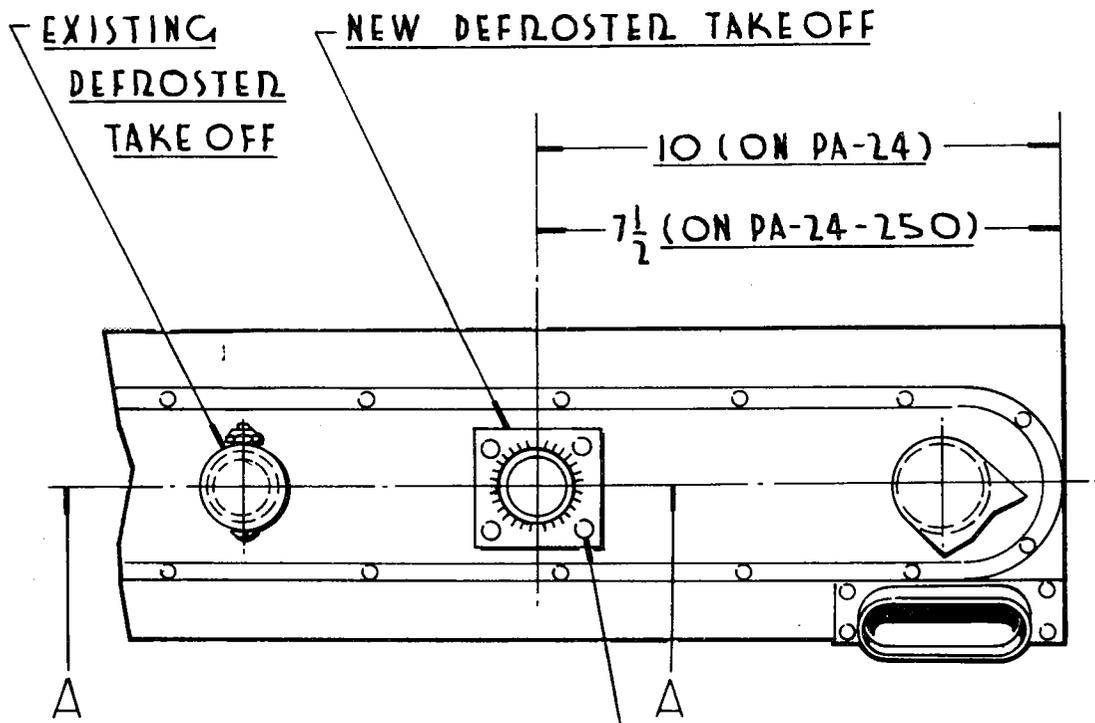
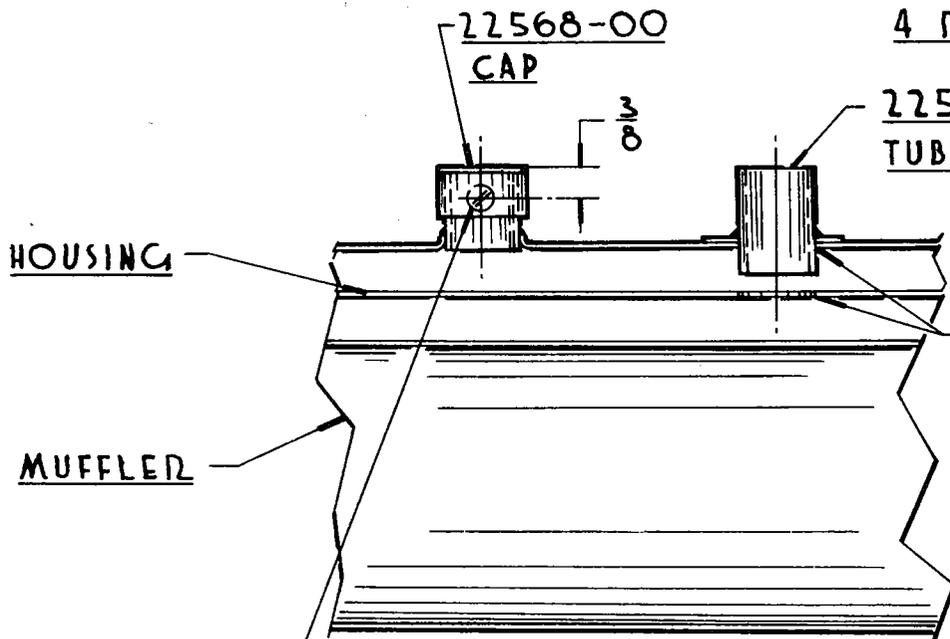
SERVICE LETTER NO 352

The defroster system as installed on the subject airplanes is capable of delivering hot air to the windshield at a temperature high enough to distort the windshield glass if used on a warm day.

The modification of these defroster systems may be accomplished by referring to the sketch on the reverse side of this Service Letter.

PDR134A-6 RIVET
4 REQ.

1 1/4 HOLE (IN DUCT + HOUSING)
(USE EXTREME CAUTION TO
AVOID PUNCTURE OF MUFFLER)

.166 HOLE (THRU)
AN515-8228 MACH. SCR.
AN364-832 S.L. NUT
