SERVICE LETTER

No. 565

Piper Aircraft Corporation

Subject: Rear Cabin Dome Light Mounting Screw

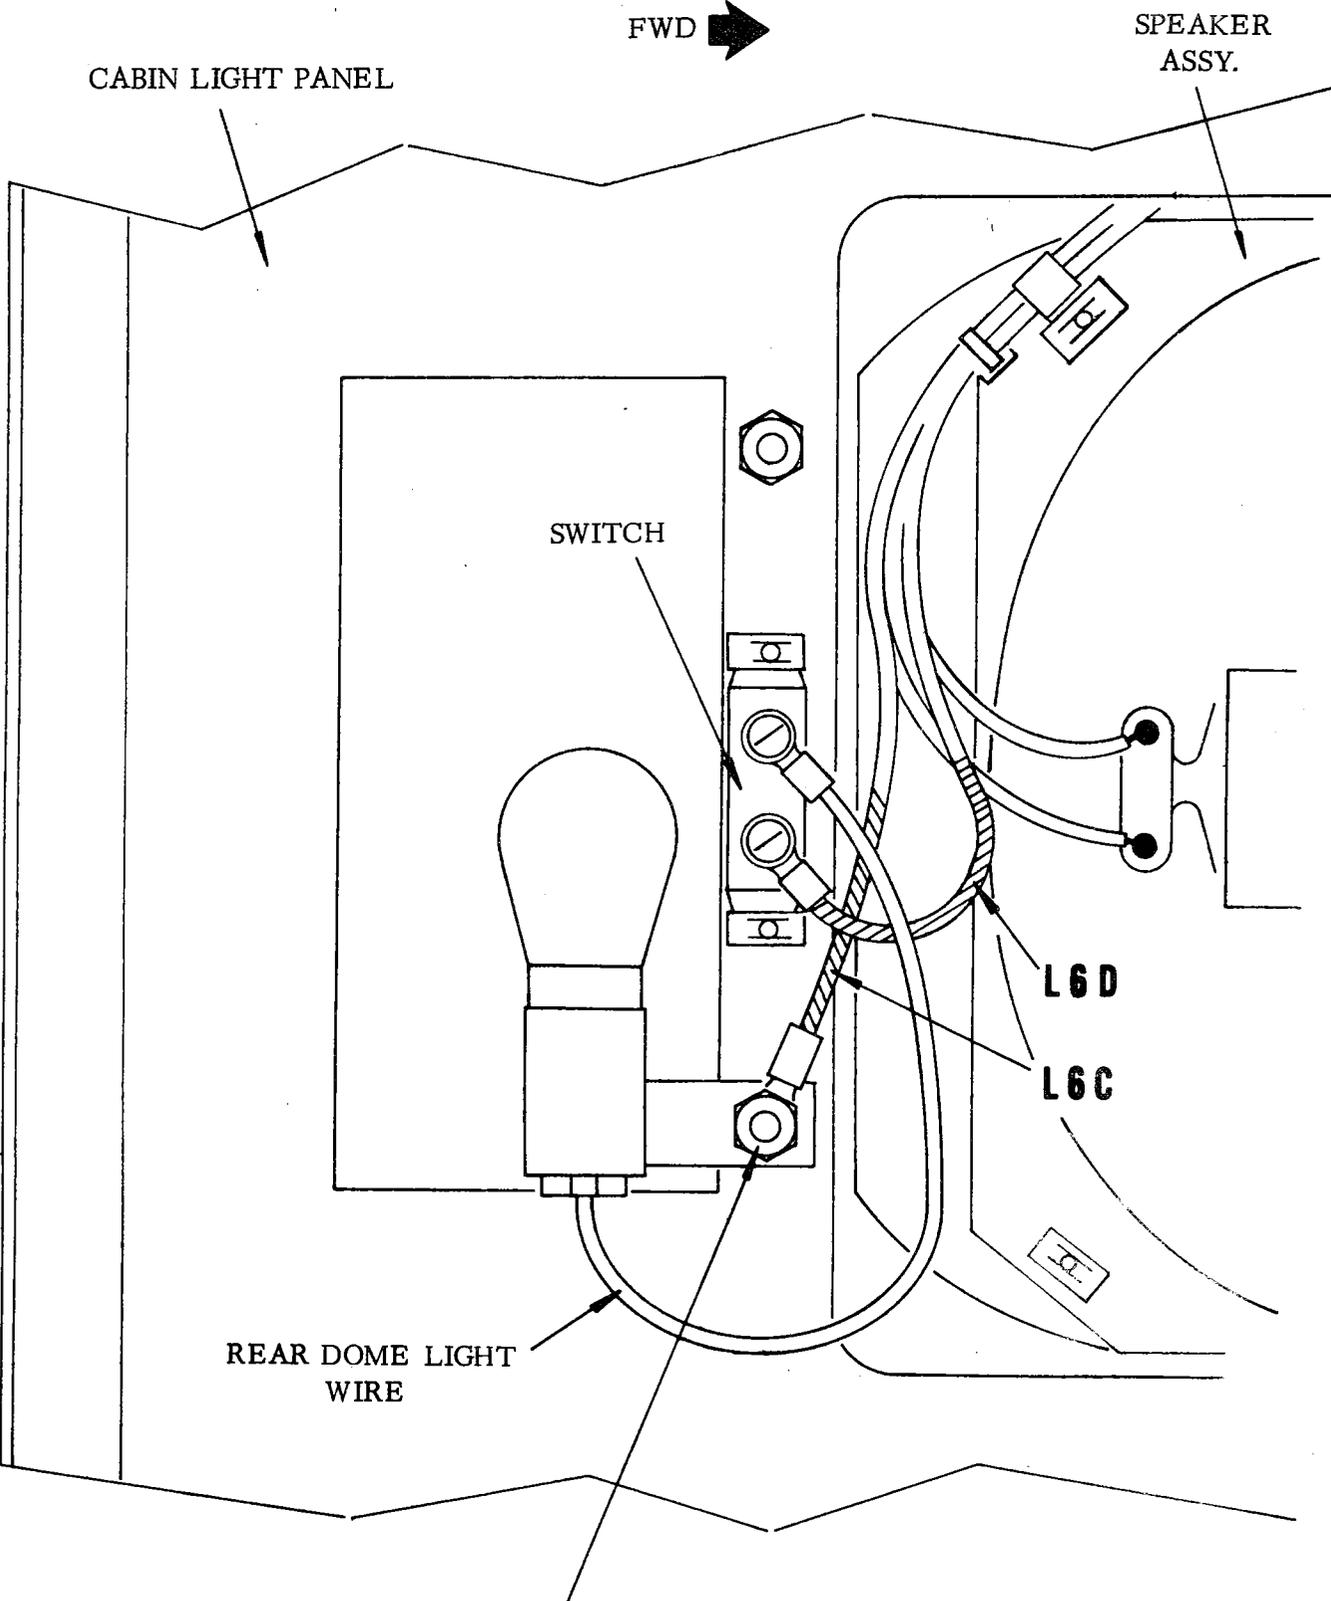
Purpose: To determine if a voltage potential exists at the rear cabin dome light mounting screw.

APPLY THE VOLT METER
LEAD TO THE HEAD
OF THIS MOUNTING SCREW.

1. Apply volt meter leads to the rear cabin dome light mounting screw and to an appropriate airframe ground (as indicated in sketch on reverse side of this letter).
2. Turn the aircraft master switch on, and check to see if the volt meter registers a voltage reading.
3. If a voltage reading does exist, it will be necessary to lower the cabin light panel and revise the rear cabin dome light wiring per the sketch on the reverse side of this letter.
4. If a voltage reading is not apparent per numbers one and two, above, no further action is required.
